**Case Study 10**

**Newaukum River,  
Lewis County, Washington**

Issued August 2007

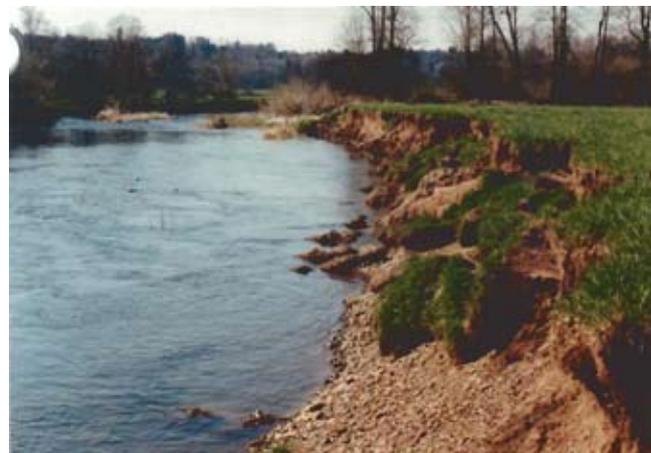
**Figure CS10–1** Typical conditions that existed at the project sites prior to design treatments

Figure CS10–1 shows typical conditions that existed at the project sites prior to design treatments. Table CS10–3 lists site characteristics, stream classification (Rosgen 1996), treatment measures used at each site, and a summary of current conditions. Descriptions in this case study are generally limited to four of the sites which represent the range of site conditions, techniques used, and experience gained. The four sites selected are the Nygard, Teitzel, Fitzgerald, and Olson.

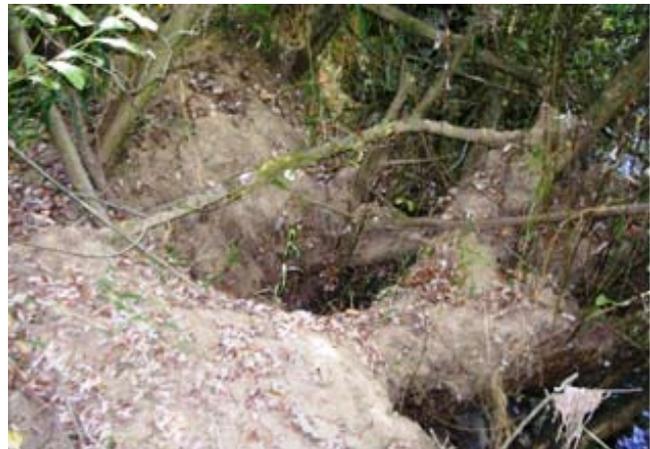
(b) Willow development above toe rock. There appears to be some loss of fine soils at the interface.

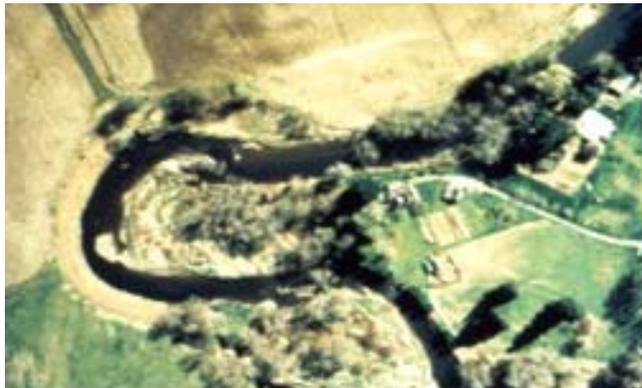
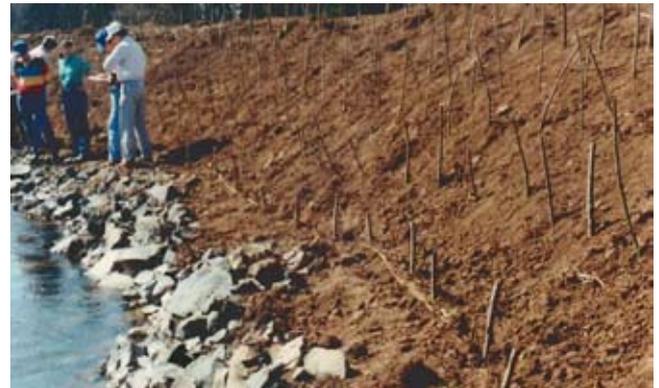
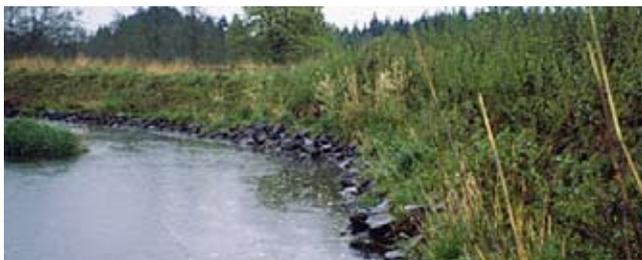
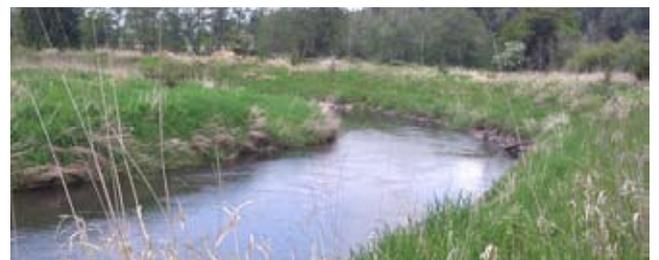
**Figure CS10-5** Teitzel site

The Teitzel site, with the lowest R:W ratio, was initially treated with narrow (approximately 12-in-wide) rock and brush (RB) structures at 8- to 10-foot intervals. These failed in the first season during an over-bank flood event. Following the flood, the bank was reshaped and treatments applied as indicated in table CS10-4. The live stakes produced an extensive stand of woody bank cover the first year after repair. This was followed by an extremely dry year and infestation of the willow borer, which killed off 80 to 90 percent of the willows. Natural recovery was further decimated by beaver activity in subsequent years. Currently, the bank is stable with heavy grass cover, but no woody vegetation (fig. CS10-5).

(b) 1992, after installation of live stakes. Note the fascine just above the toe rock.

Sometimes, even with proper maintenance, establishment of vegetative treatments can be difficult. The Teitzel site was also restaked after the willow borer infestation, but did not recover. Beaver activity and southern exposure at this site exacerbated the situation. In the fall of 2005, the banks were well grassed, but with no woody cover. It appears from table CS10-4 that soils and perhaps soil fertility have played a role at this site. Those sites with Chehalis silt loam soil series and south or east facing slopes did not fair well for establishment of woody vegetation.

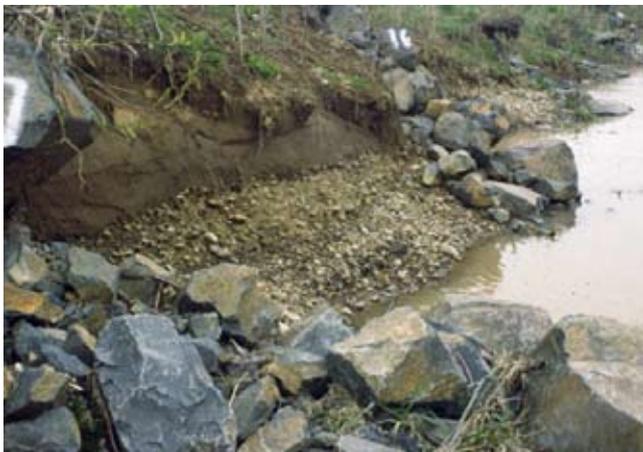
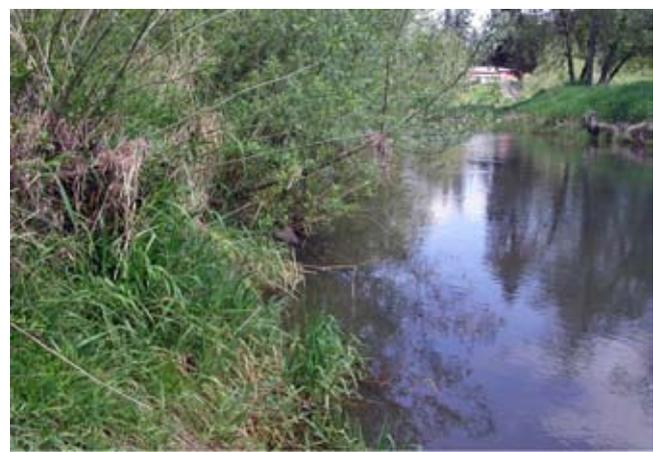
**Figure CS10-6** Fitzgerald site, photos taken from similar view points. Initial erosion at toe adjacent to RB; structures filled with sediment as vegetation developed

The Fitzgerald site is a near linear reach (highest R:W ratio), at the opposite end of the spectrum for curve radius. In the first years of monitoring, the RB structures appeared to be on the verge of failure with

considerable erosion and scour of loose bank material (sand-gravel lenses) adjacent to the structures. As the willows in the RB structures developed, the roughness element is believed to have slowed the near-bank velocity and allowed for sediment deposition. Currently, the thalweg has moved away from the toe, and significant sediment deposition has occurred along this reach. Woody vegetation is dense at the RB structures and between structures as evident in figure CS10-6.

The effectiveness of toe rock is further demonstrated at the Olson site where bank scour has occurred at locations where there are small interruptions in the rock toe. Surprisingly, only a single line of rock has protected the toe along segments of this site. This contrasts with the Fitzgerald site where the RB structures were installed without toe rock. Although initial scour occurred adjacent to the RBs, this site now appears to be very stable. The differences in the R:W ratios should be noted. The Fitzgerald site with  $R:W \approx 20$  and the Olson site with  $R:W \approx 8.8$  are both relatively linear reaches. The results from these two sites seem to indicate that toe rock may not be necessary for high R:W ratios, other factors being equal.

A stable toe is critical to establish a good stand of woody vegetation on the upper banks. However, as noted in this study, factors such as an insect infestation or other natural events can destroy juvenile plantings. It is important that maintenance be a part of plant establishment. This was demonstrated on the Nygard site after the insect infestation wiped out most of the willows on the upper portion of site. Live staking was repeated to replace willows lost from insect infesta-

tion. The results are clearly evident in figure CS10-6, as the willows are now well established. Maintenance is an issue that is often neglected after the initial project installation. When live materials are used, it is important that follow-up care is provided through the establishment period.

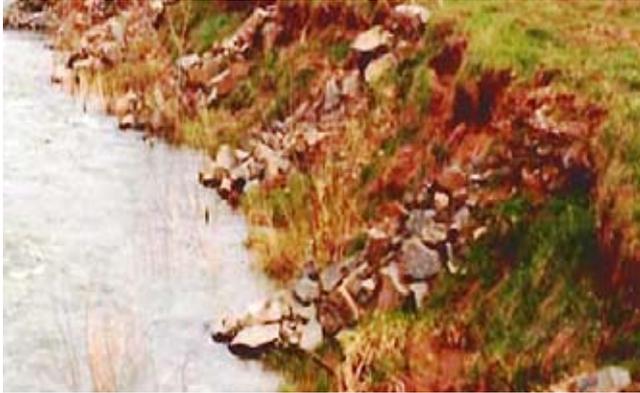
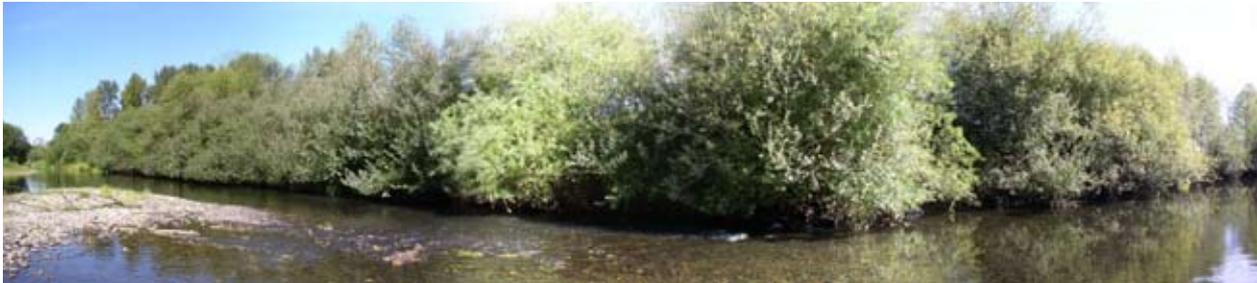
**Figure CS10-7** Nygard site

The Nygard site has a moderate R:W ratio and perhaps is the more consistent of all the sites in steady progress towards stability. It, too, has experienced the flood events and dry seasons, but lower losses (50%) from infestation of the willow borer and not significantly affected by beaver activity. The treatment at this site combines toe rock with the RB structures in the upper curved portion of the reach. Very little bank shaping was done at this site, other than what occurred during excavation of the rock and brush trenches. The steep bank slope was still evident during the site visit in 2005. As figure CS10-7 shows, the water level was above the toe rock. The RBs continue downstream through a shallower bend without toe rock. The thalweg remains at the toe of the bank in the upper curved reach. The willows are dense and extend out over the stream providing heavy shading over the thalweg.

(b) Panorama of right bank on outside of curve. The appearance of an inside curve is due to stitching of several photos.

It is almost a certainty that the Nygard and Teitzel sites would have failed without toe rock. Visual inspections in the fall of 2005 indicated that the thalweg continued to flow along the toe of bank. Even at low flow, the water depth along the toe was estimated at 4 to 5 feet. Without the rock toe protection, the bank would likely undercut during seasonal high water events with upper bank sloughing as flow subsides. The upper bank sloughing would be slowed because of dense vegetation, but slope failures would likely occur.
