**Case Study 11**

**Streambank Stabilization in the Red River Basin, North Dakota**

*By David B. Rush, Environmental Projects Coordinator, Red River Regional Council, Grafton, North Dakota; Frank W. Beaver, Assistant Professor of Geological Engineering, and Jason Warne, Graduate Research Assistant, Department of Geology and Geological Engineering, University of North Dakota, Grand Forks, North Dakota*

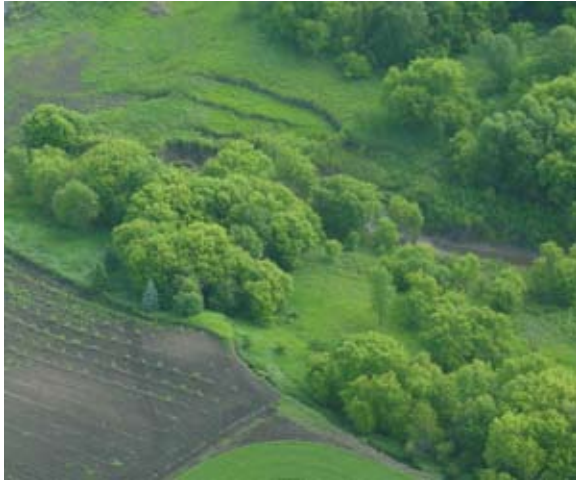
(a) Rotational failure near Reynolds, ND

These clay soils cause significant geotechnical problems, especially where they are unconfined. Because of the low-gradient and underfit nature of rivers in the valley, sinuosities are very high ( $>1.5$ ), creating meanders with a very low radius of curvature. In tight meanders, higher velocity flows are forced against the outside of the channel, eroding the slope toe and steepening the bank. This natural process leads to frequent slope failures along the Red River and its tributaries. The two most common types of slope failure are rotational slumps and flow slumps (fig. CS11-3), with creep and earth flows occurring to a lesser extent.

**Figure CS11-3** Types of slope failures

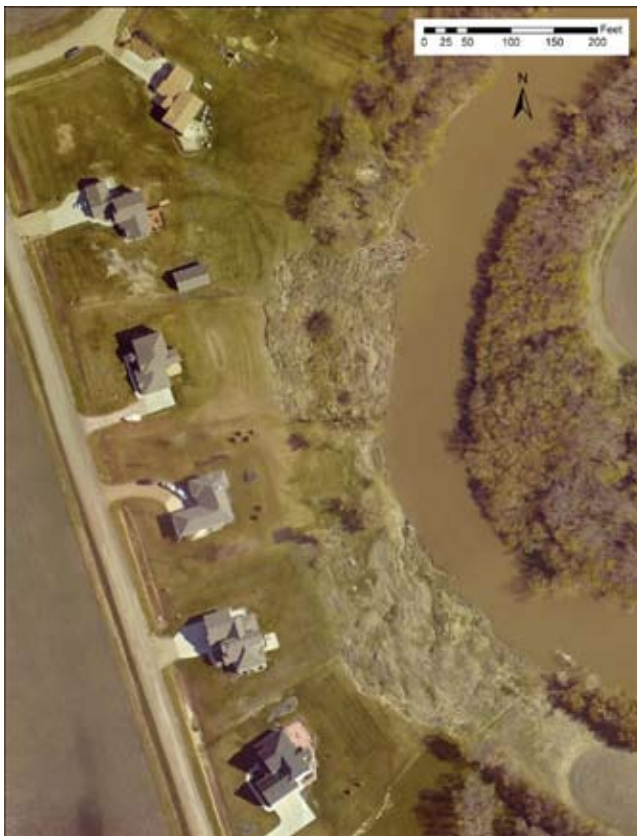
Enhanced soil moisture, a critical factor of slope stability, is frequently the result of development. Removal of the moisture-loving native plants and trees, installation of lawn sprinkler systems, and septic drain fields may double or triple the amount of moisture these soils typically receive annually. Local hydrology is altered as homeowners seek to move water away from their houses and, logically, toward the river. However, water from gutters, sumps, and yard drains only helps to saturate the already wet slopes (fig. CS11-4 (UND Energy and Environmental Research Center)).

**Figure CS11-4** Slump flows caused by septic drain fields near Fargo, ND

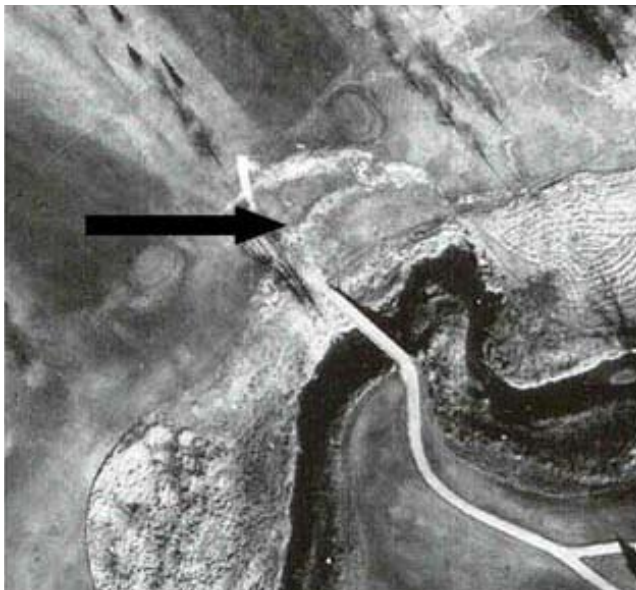
Evidence of the slumping that had damaged the golf cart bridge was visible in aerial photographs as early as 1997 (fig. CS11-6). As the 330-foot-long rotational failure settled toward Cole Creek, it unearthed the wooden bridge pilings, narrowed the creek channel, and raised the channel bottom (fig. CS11-7).

**Figure CS11-6** 1997 aerial photo of Grand Forks Country Club slump, marked by arrow

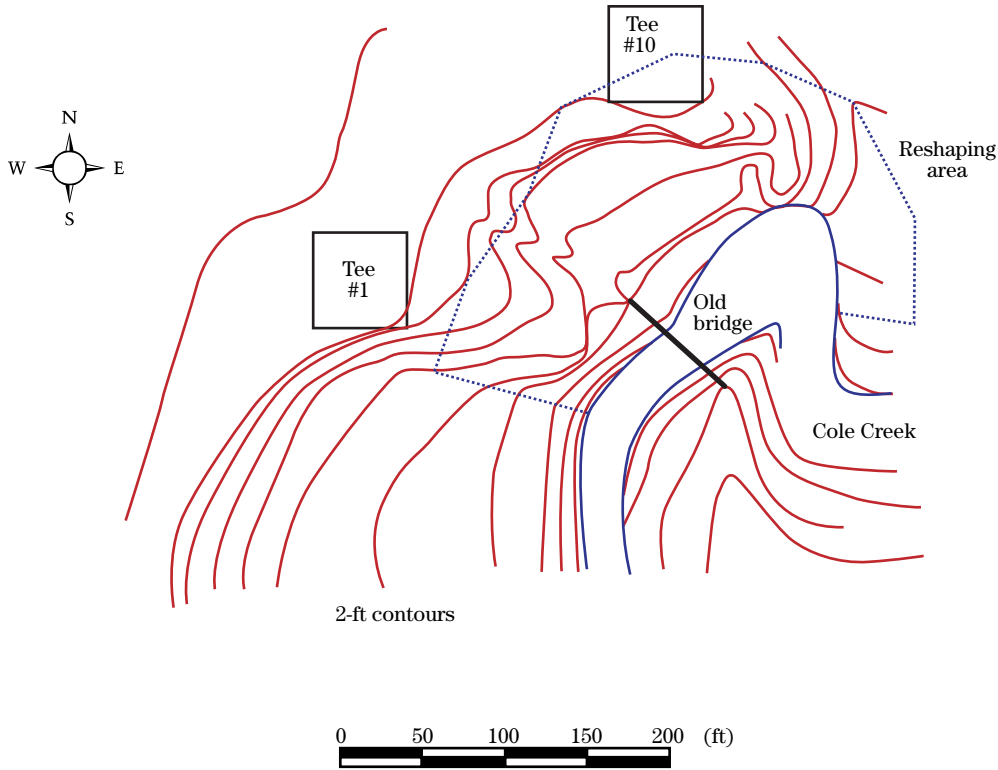
The narrowing of the channel at this point increased flow velocities, causing accelerated bank and channel scouring downstream (fig. CS11-8). A survey of the slump area showed the channel banks to be as steep as 2H:1V or greater and the slope grade to average

5H:1V (fig. CS11-9). A geotechnical report produced for the design for the new golf cart bridge suggested that the rotational failure could be 100 feet wide and 45 feet deep (CPS 2000).

**Figure CS11-9** Topographic map of the slope failure prior to restoration

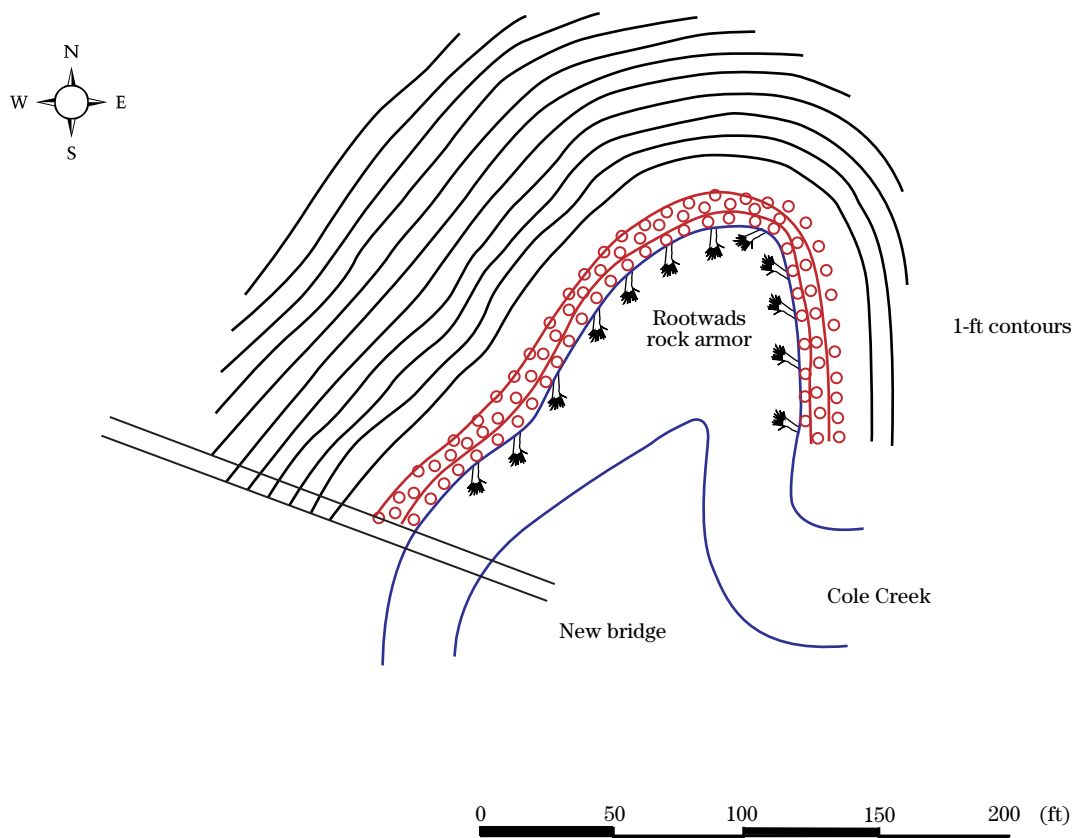
**Figure CS11-10** Design contours for grading and stabilizing slope failure

Typical efforts to stabilize this type of failure may call for keying significant quantities of rock riprap into the slope toe and channel bottom, balancing the forces causing the rotation. This method has been effective, but can be expensive, not as aesthetically pleasing, and may exacerbate downstream erosion problems. To address these concerns and balance the slump block, the project engineer called for reshaping the existing slope to a 7H:1V or 8H:1V grade and removing an estimated 10,000 cubic yards of soil from the top of the slump, reducing the loading weight. See the grading and restoration plan in figure CS11-10 and also the soil bioengineering and planting plan in figure CS11-11. Toe protection was also an essential aspect of keeping the reshaped slope in place. Rootwads were selected to be installed within a band of rock armor (105 yd<sup>3</sup>).

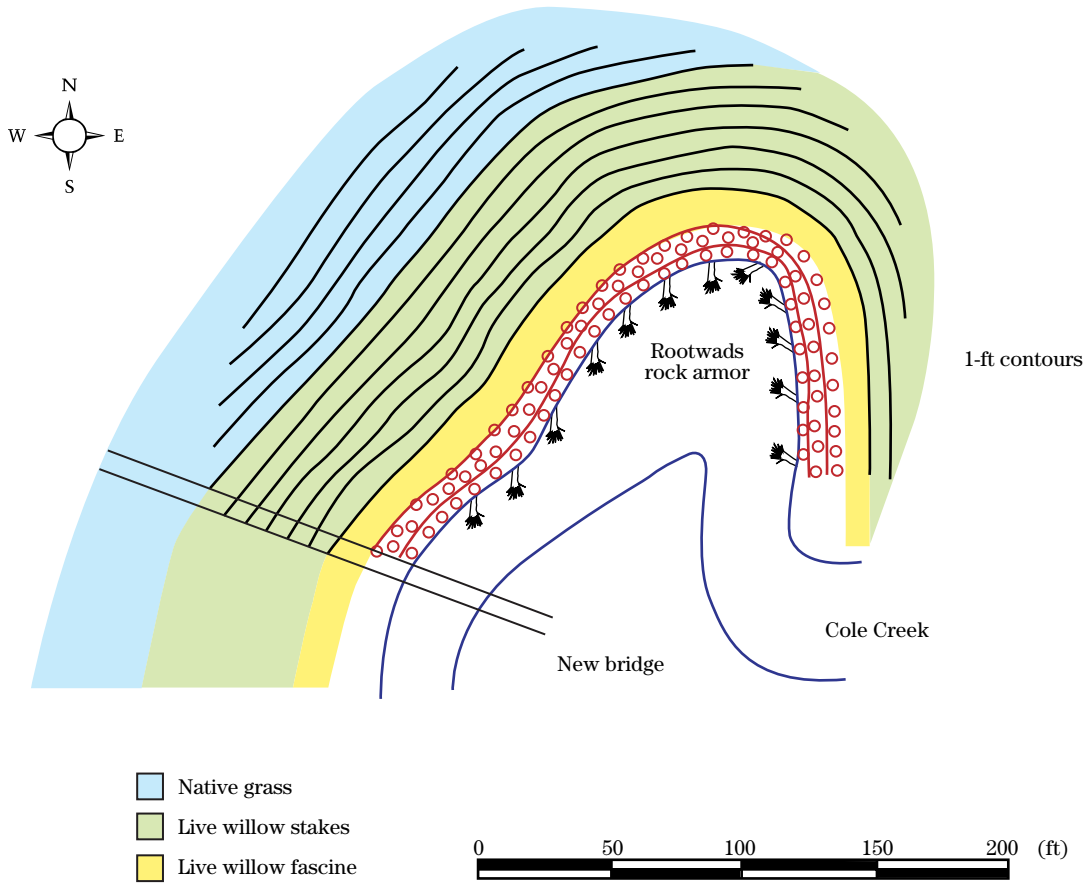
Figure CS11-11 Soil bioengineering and planting plan

Moisture management was another factor that was considered as a solution to stop the slumping. Both natural and human sources were supplying water to the slope. Floodwaters, record precipitation during the last decade, and irrigation for the tee box and fairway above the slope combined to saturate the soils, add weight, and lubricate the slickensides in the clay soils. The project sought to solve this issue through irrigation management and the installation of deep-rooted, moisture-wicking vegetation. The plan developed by a North Dakota Forest Service riparian forester called for 2,400 dormant live sandbar willow stakes to be installed over a 7,200-square-foot area (fig. CS11-11).

An aggressive revegetation and soil bioengineering plan was also developed for the site (fig. CS11-11). To deflect energy from flood flows, increase the root mass at the toe, and improve the aesthetics, a live wil-

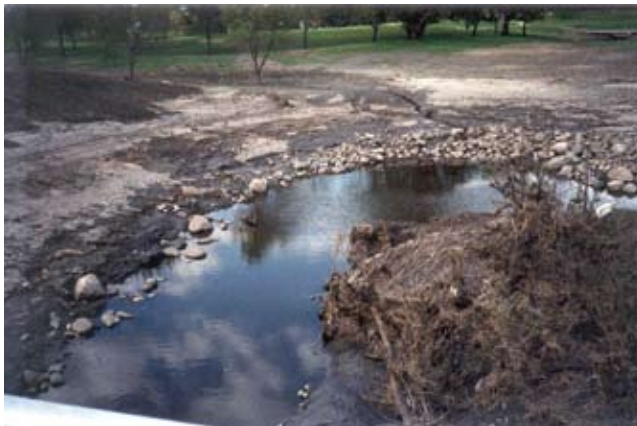
**Figure CS11–12** Downstream view of Cole Creek, May 2002, prior to planting

In March of 2001, the slope reshaping and rock and rootwad installation had been completed during the construction of the new golf cart bridge (fig. CS11–12). The plant materials were installed in June and by

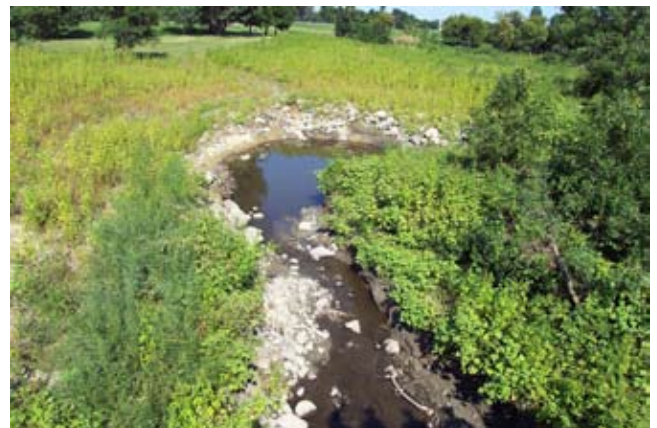
August were growing vigorously (fig. CS11–13). Total cost for the work was \$33,400, with the excavation accounting for over half of the expense. With the exception of the native grasses being replaced with Kentucky bluegrass and irrigation continuing as before, the stabilization appeared to be holding.

**Figure CS11–13** Downstream view of Cole Creek, August 2002, after planting

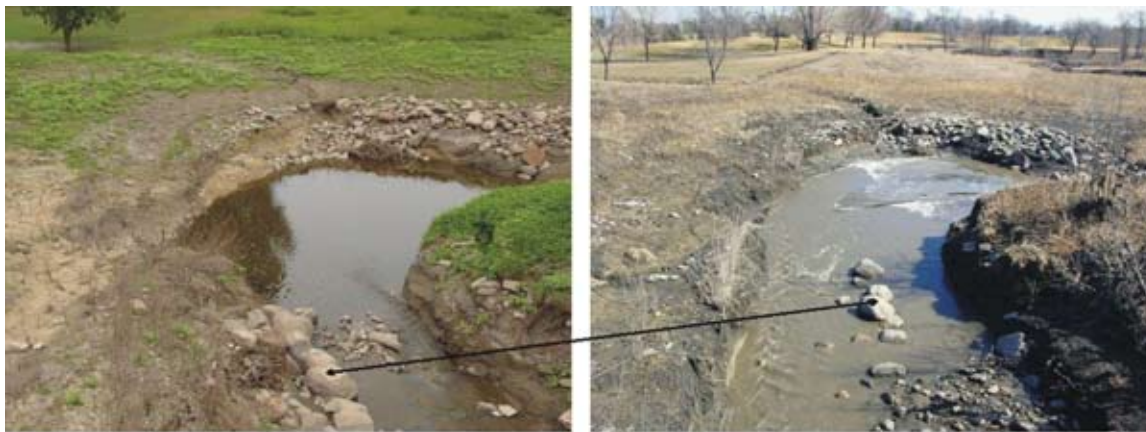
had been washed away or slipped into the channel (fig. CS11-14). Portions of the fascine and entire rootwads had been pulled from the bank. Without toe protection and sufficient counter-balancing weight, the saturated slope began to move, rotating 2 feet and narrowing the channel by 4 feet. The force of the rotation had even bent the bridge piers that were set 80 feet into the clay.

**Figure CS11-14** Views of Cole Creek looking downstream from the new cart bridge

(a) Arrows indicate the same rocks in the stream

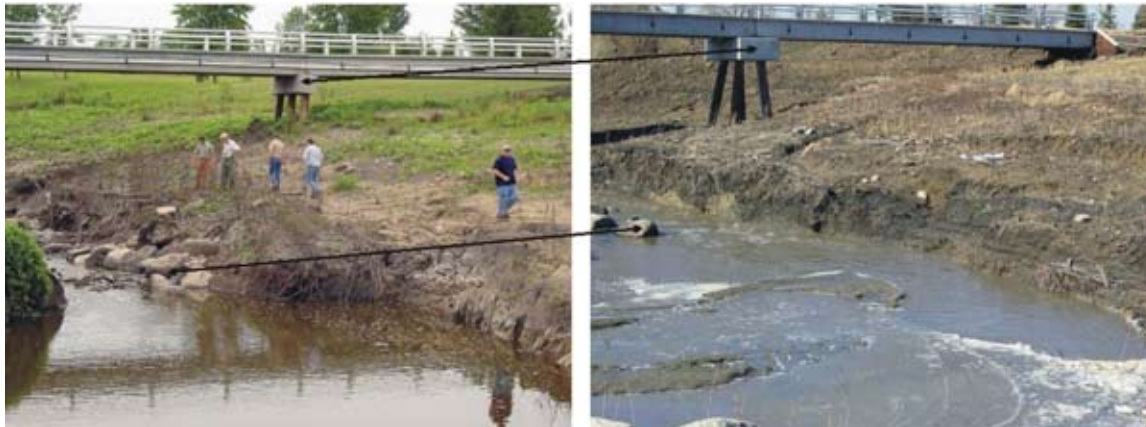
(b) Views of Cole Creek looking back upstream towards the bridge

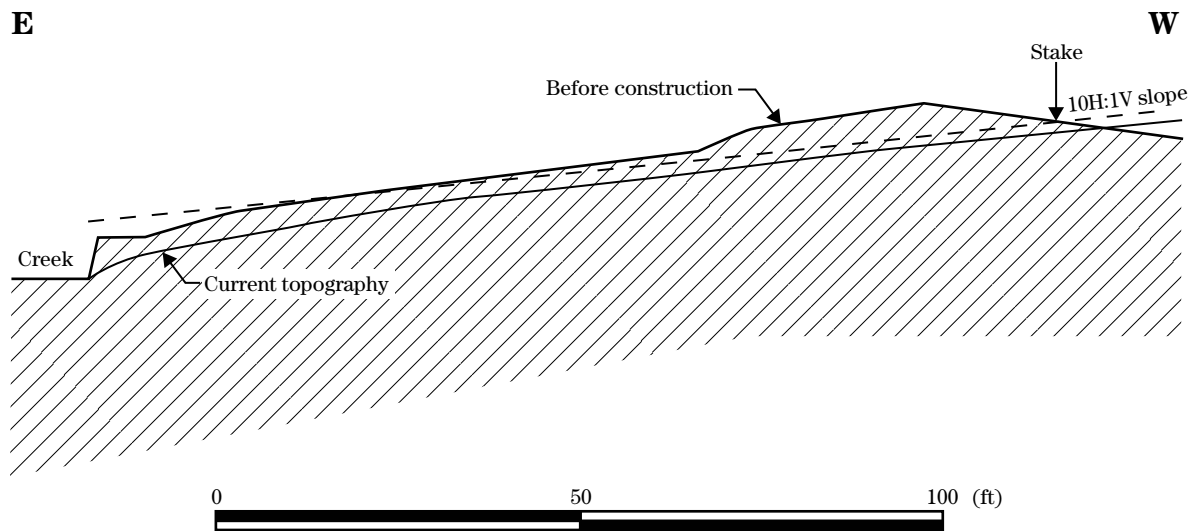
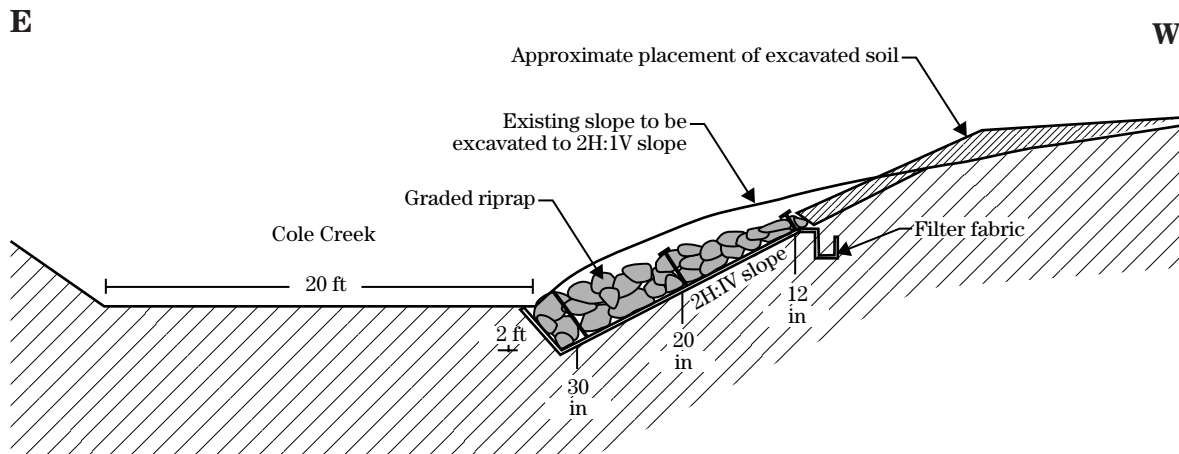
**Figure CS11-15** Cross section of the slope showing the slope grade before construction and during repairs. The planned 10H:1V grade is shown for reference. Note that fill from the excavation will be placed directly above the rock.

that the slope be graded to at least 8H:1V and possibly 10H:1V, based on stable grades observed up and downstream of the site. It was also recommended that 325 cubic yards of rock riprap be placed over geotextile along the entire reach (fig. CS11-15). The rock was to have a  $D_{50}$  of 10 inches and would be keyed into the toe, extending 12 to 15 feet up the slope. The wedge of rock would protect the toe to bankfull events and above and add counter-balancing weight.

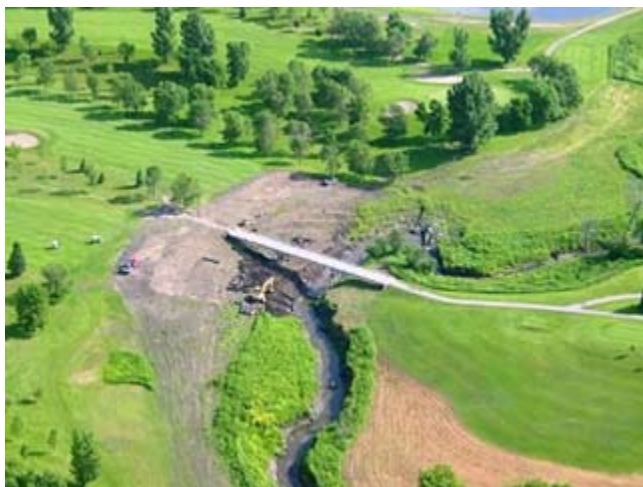
**Figure CS11-16** Aerial view of slope grading and earthwork to place rock toe

Construction began in early June 2003 and was completed within 10 days (figs. CS11-16 through CS11-18). A nearly 10H:1V grade was achieved by removing material from the top of the slope, as well as placing fill above the rock toe. Total cost for the repairs was nearly \$26,000, bringing the grand total for the site to \$59,400. Table CS11-1 shows a breakdown of the

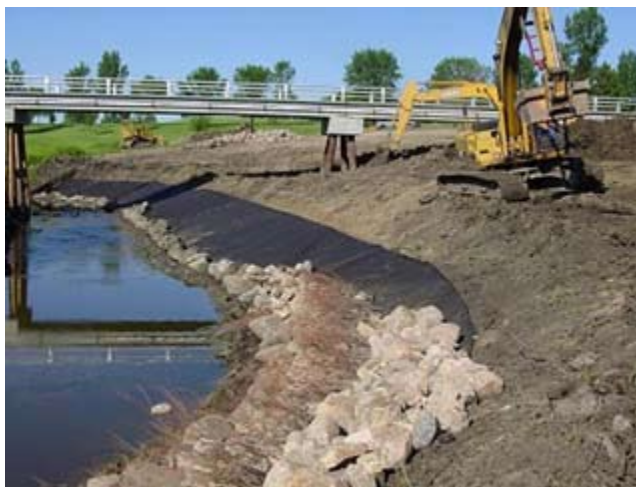
**Figure CS11-17** Rock toe being placed over geotextile. A layer of live willow branches is visible within the rock toe.

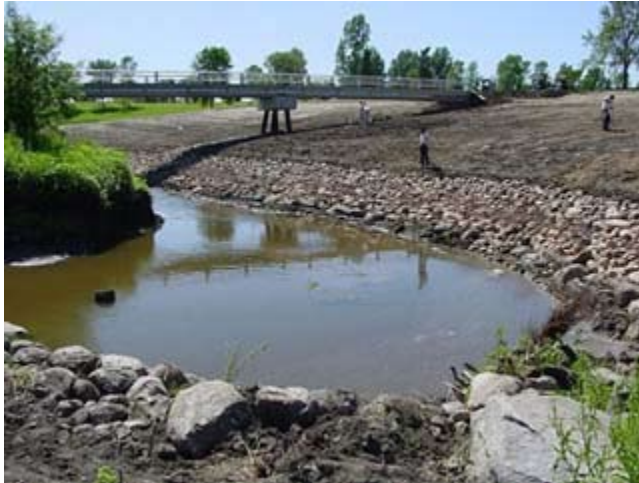
(a) Looking upstream toward the cart bridge

**Figure CS11-18** Completed stabilization

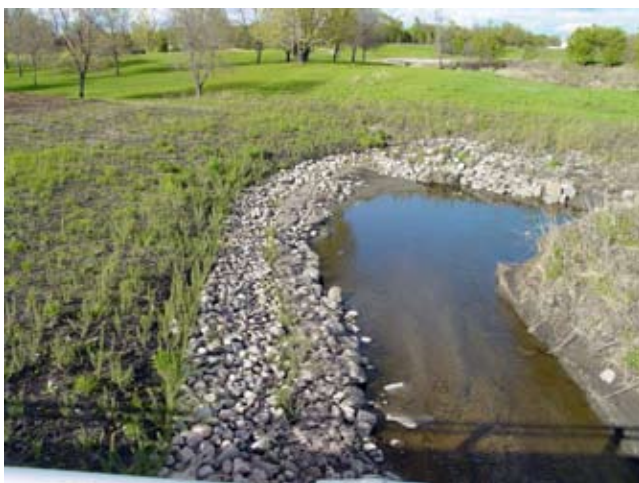
(a) Looking downstream into the meander

Repairs to the site appear to be functioning well; the vegetation is flourishing, channel erosion is limited, and the rotational slope failure is stable (fig. CS11-19).

**Figure CS11-19** Slope stabilization and soil bioengineering project in May of 2004
