Case Study 11

Streambank Stabilization in the Red River Basin, North Dakota

By David B. Rush, Environmental Projects Coordinator, Red River Regional Council, Grafton, North Dakota; Frank W. Beaver, Assistant Professor of Geological Engineering, and Jason Warne, Graduate Research Assistant, Department of Geology and Geological Engineering, University of North Dakota, Grand Forks, North Dakota

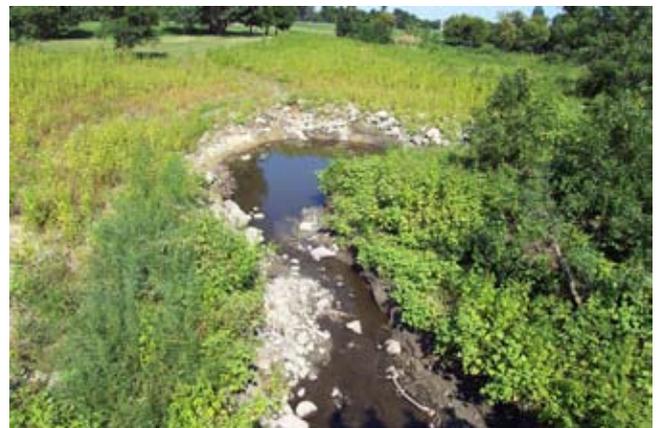
August were growing vigorously (fig. CS11–13). Total cost for the work was \$33,400, with the excavation accounting for over half of the expense. With the exception of the native grasses being replaced with Kentucky bluegrass and irrigation continuing as before, the stabilization appeared to be holding.

Figure CS11–13 Downstream view of Cole Creek, August 2002, after planting

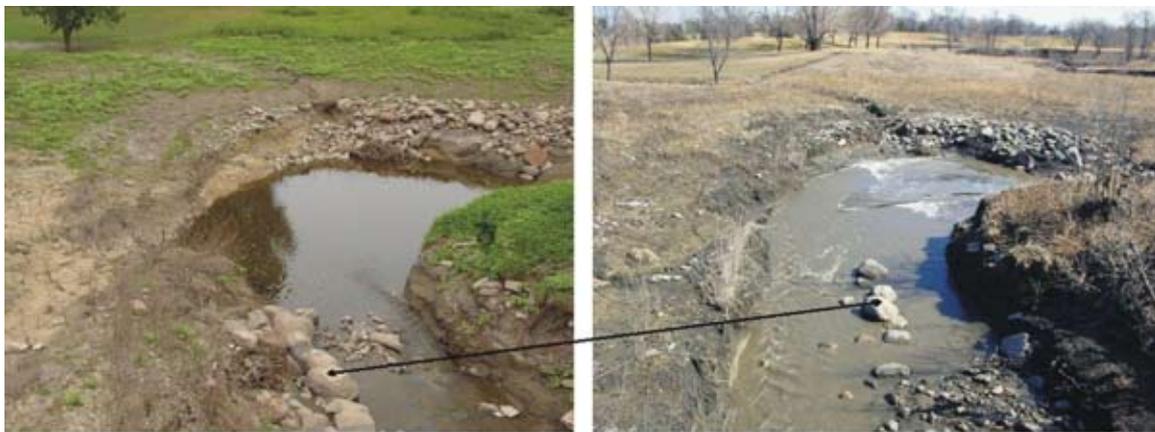
Figure CS11-14 Views of Cole Creek looking downstream from the new cart bridge

had been washed away or slipped into the channel (fig. CS11-14). Portions of the fascine and entire rootwads had been pulled from the bank. Without toe protection and sufficient counter-balancing weight, the saturated slope began to move, rotating 2 feet and narrowing the channel by 4 feet. The force of the rotation had even bent the bridge piers that were set 80 feet into the clay.

(a) Arrows indicate the same rocks in the stream

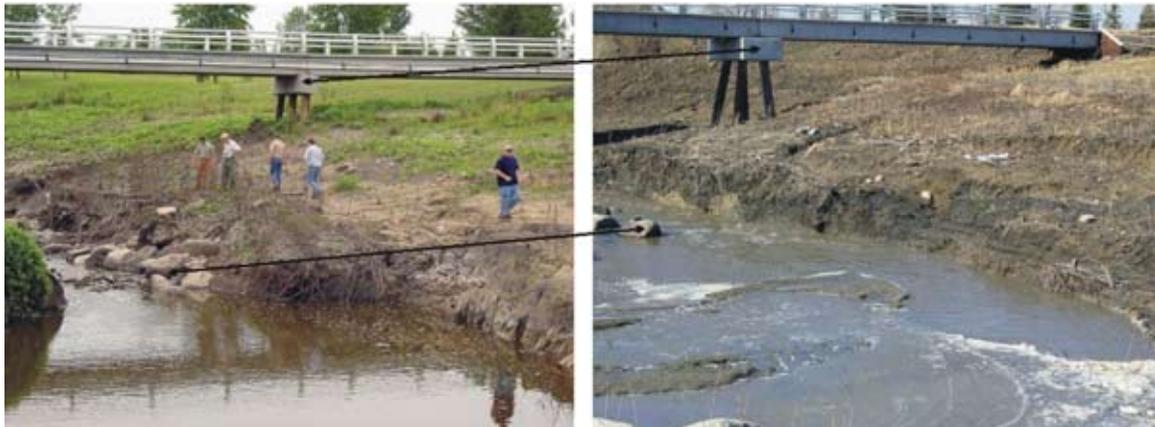
(b) Views of Cole Creek looking back upstream towards the bridge

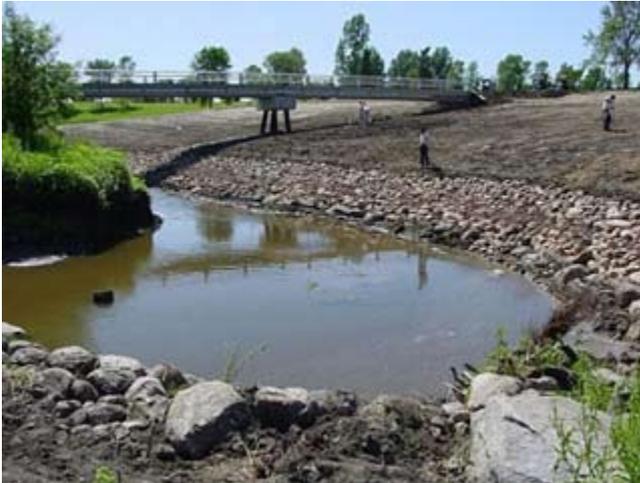
Figure CS11-18 Completed stabilization

(a) Looking upstream toward the cart bridge

Construction began in early June 2003 and was completed within 10 days (figs. CS11-16 through CS11-18). A nearly 10H:1V grade was achieved by removing material from the top of the slope, as well as placing fill above the rock toe. Total cost for the repairs was nearly \$26,000, bringing the grand total for the site to \$59,400. Table CS11-1 shows a breakdown of the

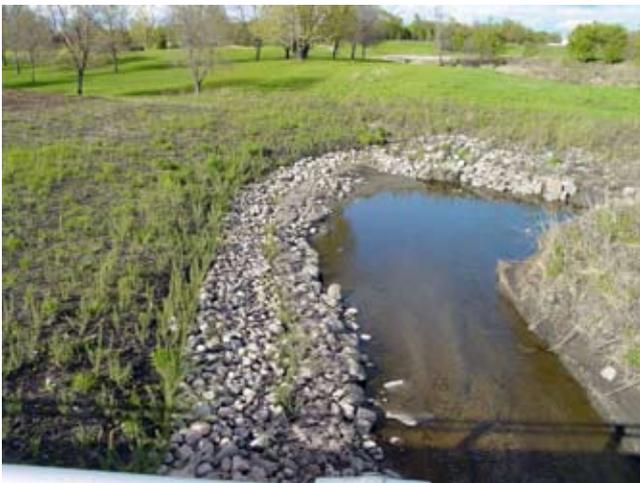
Figure CS11-19 Slope stabilization and soil bioengineering project in May of 2004

Repairs to the site appear to be functioning well; the vegetation is flourishing, channel erosion is limited, and the rotational slope failure is stable (fig. CS11-19).

(a) Looking downstream into the meander
