**Case Study 13**

**Owl Creek Farms, North Branch of the  
Kokosing River, Knox County, Ohio**

*By David Moore, Burgess & Niple, Inc.*

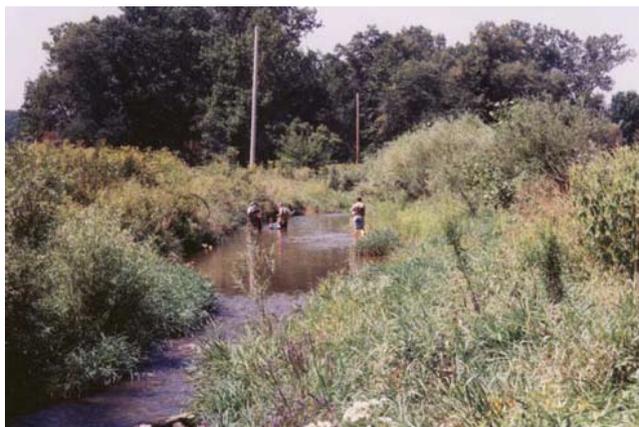
**Figure CS13-2** Owl Creek—after

In the third year of monitoring, the project is meeting or exceeding stated goals for fish and macroinvertebrate community quality, habitat quality, and vegetation survival. The vortex rock weirs, bank stabilization measures, live willow plantings, and mowing and grazing restrictions all have performed better than expected. The least successful feature of this project was the survival of riparian tree seedlings. The tree seedlings should have been better protected from competition, or not planted at all, to allow natural succession to occur.

The vortex rock weirs performed better than anticipated in creating scour pools and attracting fish and macroinvertebrates. Of key importance was the skillful installation of anchor rocks that were well keyed into the bank. The property owner was a skilled equipment operator. The live willow stakings were very successful in stabilizing banks, improving cover, and even providing some shading benefits in the first growing season. Simply ceasing mowing and precluding grazing next to the stream are effective aquatic habi-
