Case Study 15

**Streambank Stabilization in the
Guadalupe River Basin,
Santa Clara County, California**

Streambank Stabilization in the Guadalupe River Basin, Santa Clara County, California

*By John McCullah, Watershed Geologist,
CPESC, and Kaila Dettman, Watershed Hydrologist
of Salix Applied Earthcare*

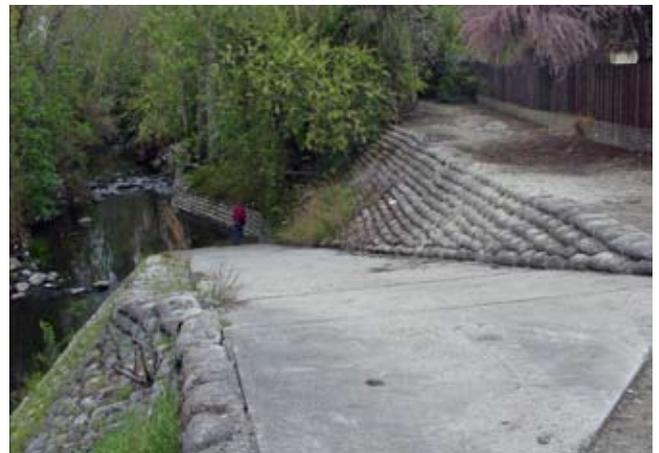
The original restoration work involved removing the damaged concrete access ramp and the sack concrete wall (fig. CS15-1) and replacing the structures with more habitat-friendly treatments. Restoration of the streambank included complete removal of the access ramp. Biotechnical techniques were installed on

Figure CS15-1 Damaged access ramp and wall

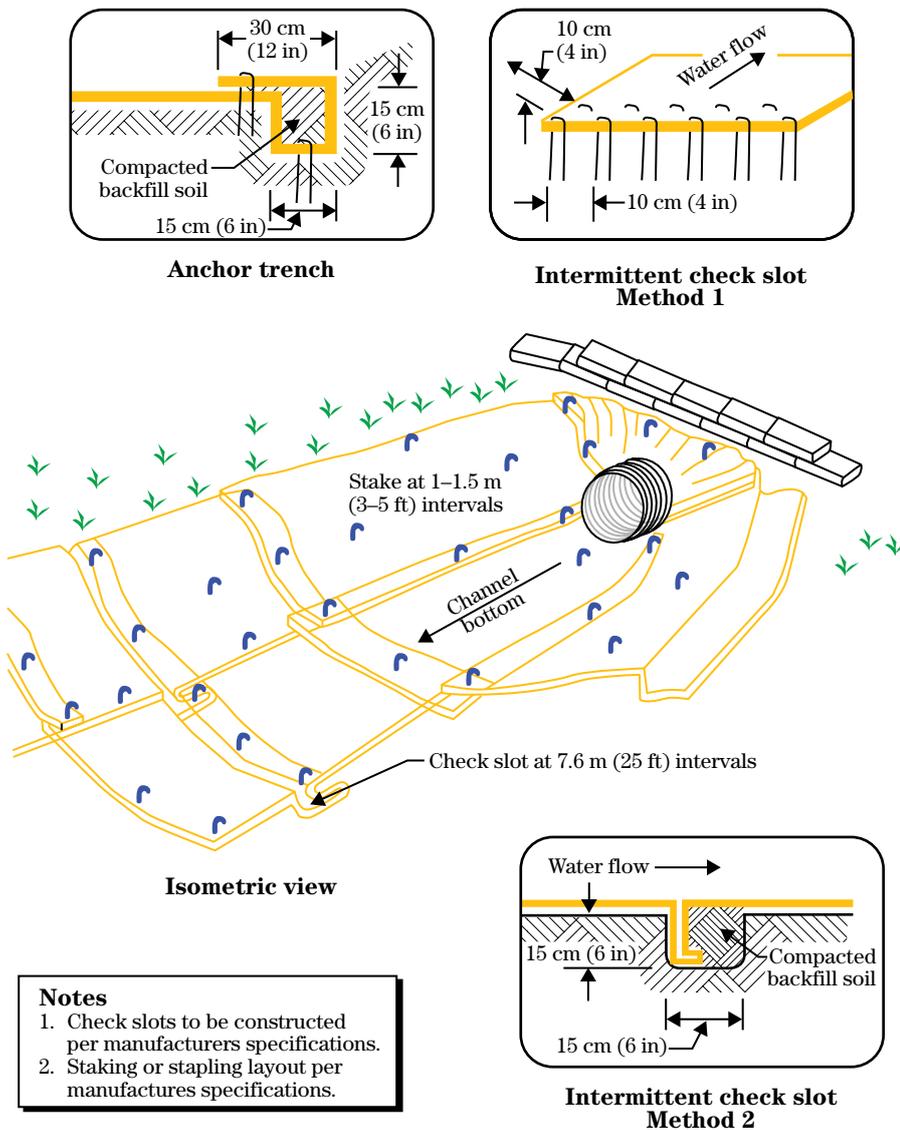
Figure CS15-7 Erosion control blankets channel installation

The authors determined that the blankets had been installed incorrectly because the application had been applied based on the principles of slope stabilization, not channel stabilization. Channel installation requires that blankets be oriented parallel to the flow and include anchor slots (fig. CS15-7). Prior to coir

blanket application, the slope was regraded, top soil was placed on terraces and compacted to 85 percent of optimum density, and mulch and seed were applied hydraulically to the slope. Longitudinal slots (horizontal) and check slots (vertical) were dug into the fill material on the middle and upper portions of the bank to serve as footings for anchoring the blankets and coir logs.

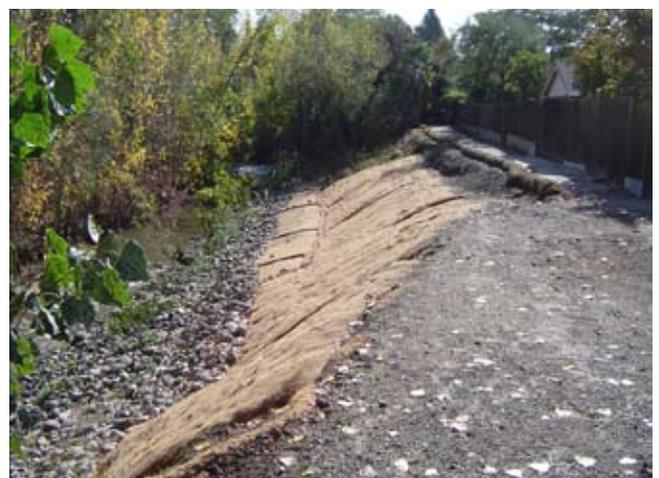
Figure CS15-9 Finished project
