## Case Study 3

## Little Elk River, Price County, Wisconsin

# Little Elk River, Price County, Wisconsin

*By Mary K. King, Area Engineer, U.S. Department of Agriculture, Natural Resources Conservation Service, Altoona, Wisconsin. Photographs courtesy of Price County Land Conservation Department*

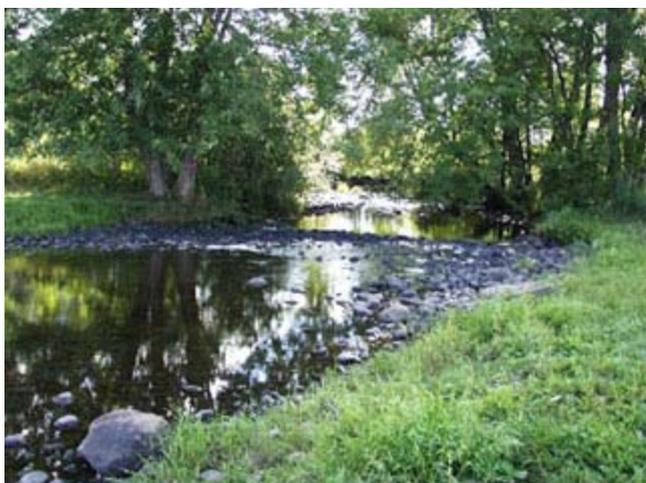
**Figure CS3–3** Little Elk River rock dam crossing

River in Price County, Wisconsin, was degraded by a rock dam crossing installed in the early 1990s, and uncontrolled cattle access led to loss of vegetation and widening of the stream (figs. CS3–3 and CS3–4). The crossing was located at the downstream end of the restoration project. Price County is located in the Wisconsin North Woods and supports 71 trout streams totaling 244 miles. Sixty miles are Class 1, 114 miles are Class 2, and 70 miles are Class 3. WDNR classifies trout streams as Class 1 if the high quality trout waters support natural reproduction to sustain populations of wild trout at or near carry capacity, Class 2 if there is some natural reproduction, and Class 3 when there is marginal trout habitat with no natural reproduction occurring. Classes 2 and 3 require annual stocking of trout.

The design concept was to restore the degraded stream to a similar cross section and stream classification type of a nearby undergraded section. First, in 2001, the rock dam was removed (fig. CS3-5) and replaced with a cattle crossing to meet Wisconsin NRCS Conservation Practice Standard No. 560, Access Road.

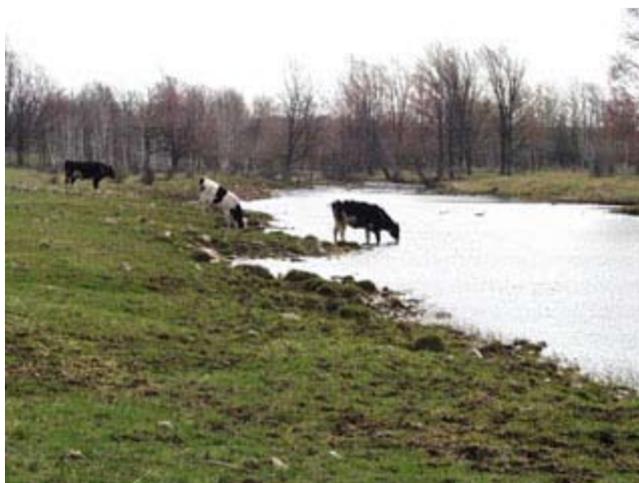
**Figure CS3–4** Uncontrolled cattle grazing

Uncontrolled cattle grazing has eliminated woody vegetation along 700 feet of the 1,400-foot-long site and damaged the remainder (fig. CS3–4). Continuous hoof traffic has broken down the undercut streambanks where trout could hide and eroded the banks, so that the stream width has tripled in places. In the degraded section, the length between pools and riffles, as well

as the drop over the riffles, has increased, compared to the more protected section upstream of the property.

The landowner initially contacted the NRCS to sign up for a riparian buffer in the continuous Cropland Reserve Program (CRP). The NRCS buffer program funded fencing along a 160-foot-wide corridor 1,400 feet long and tree planting for 1,050 feet.

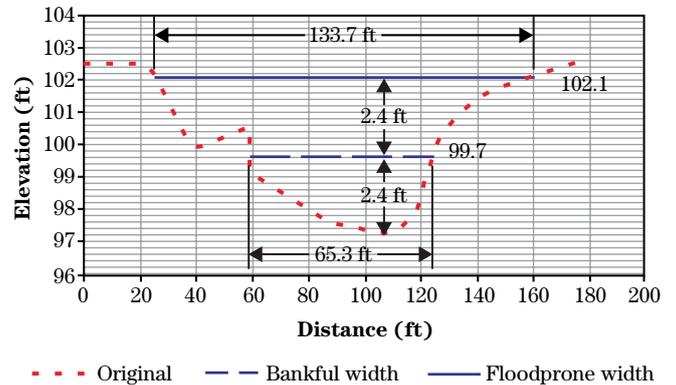
**Figure CS3-6** Cross section of disturbed site

The most critical information determined was the bankfull stage. Due to cattle traffic in the disturbed area, a typical bankfull elevation was not pronounced, so staining on rocks and elevations of woody vegetation were used to determine the bankfull elevation. The bankfull channel width was measured in the riffle segment of the selected reach. Cross sections were surveyed through a riffle area in the degraded site (fig. CS3-6) and upstream in an undisturbed area (fig. CS3-7). This information was used to determine the entrenchment ratio and width/depth ratio.

$$\text{entrenchment ratio}_d = 133.7 \text{ ft} \times 65.3 \text{ ft} = 2.0$$

$$\text{width/depth ratio}_d = 65.3 \text{ ft} \times 1.2 \text{ ft} = 54.4$$

Width/depth ratio is changing from a moderate toward high ratio.

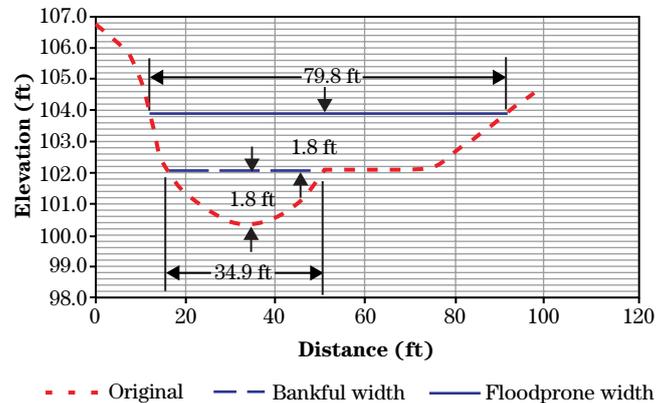
**Figure CS3-7** Cross section of undisturbed site upstream

$$\text{entrenchment ratio}_u = 79.8 \text{ ft} \times 34.9 \text{ ft} = 2.29$$

$$\text{width/depth ratio}_u = 34.9 \text{ ft} \times 0.9 \text{ ft} = 38.8$$

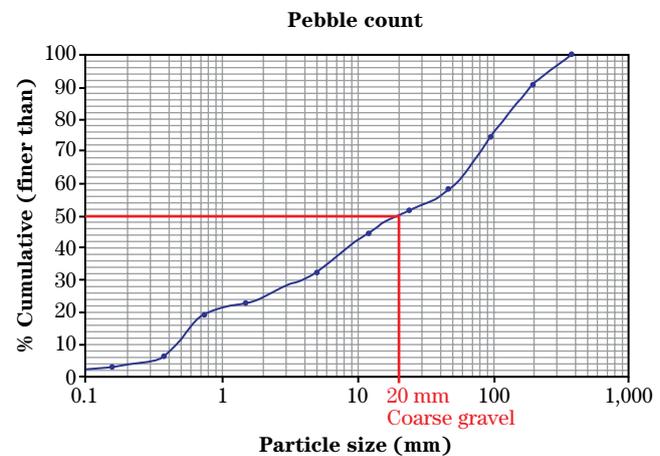
**Figure CS3-9** Channel material  $D_{50}$

Median particle size,  $D_{50}$ , from the pebble count was 20 millimeters, which is a coarse gravel and designates a "4" in the classification (fig. CS3-9).

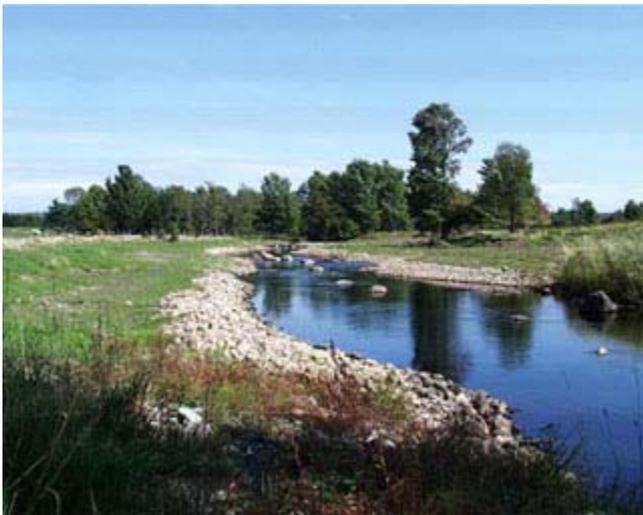
**Figure CS3-12** 1 month after construction

Figure CS3-12 shows the project 1 month after construction; figure CS3-13 shows a cross-sectional comparison.

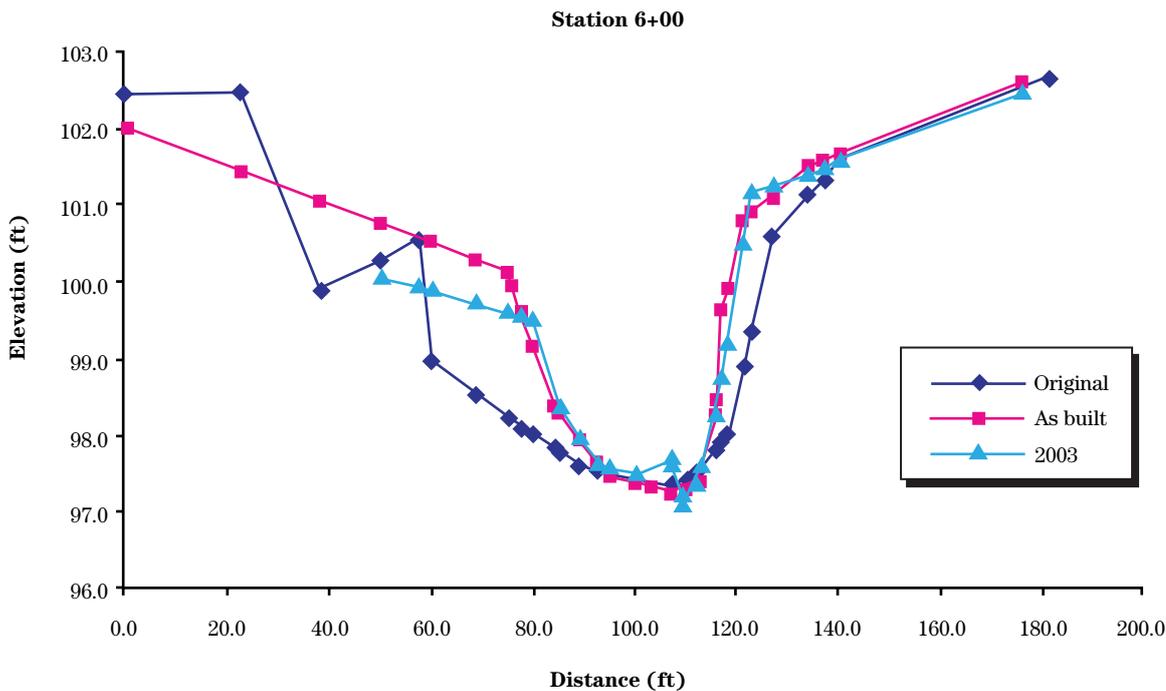
**Figure CS3-13** Cross-sectional comparison

placement in the riffles of the stream. Cross sections of the stream before construction, after construction, and the following spring were compared. The final cross sections show that the stream width of the degraded section was restored to class B4c to imitate the healthy section of stream.
