Case Study 3

Little Elk River, Price County, Wisconsin

Issued August 2007

By Mary K. King, Area Engineer, U.S. Department of Agriculture, Natural Resources Conservation Service, Altoona, Wisconsin. Photographs courtesy of Price County Land Conservation Department

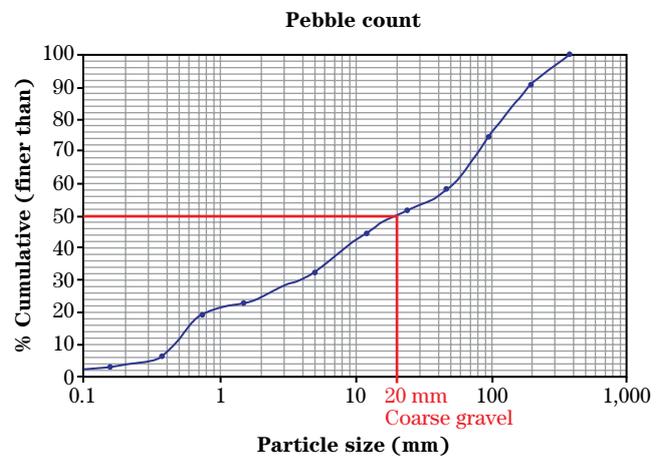
Figure CS3-9 Channel material D_{50}

Median particle size, D_{50} , from the pebble count was 20 millimeters, which is a coarse gravel and designates a "4" in the classification (fig. CS3-9).

The Little Elk River classified as a B4c stream according to the Rosgen method. The width/depth ratio was changing from a moderate to high ratio in the degraded section.

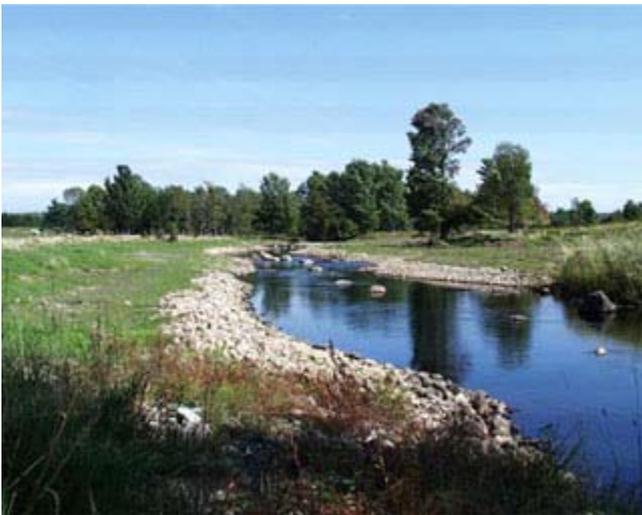
Figure CS3-12 1 month after construction

Figure CS3-12 shows the project 1 month after construction; figure CS3-13 shows a cross-sectional comparison.
