Advisory Note

Alica J. Ketchem, P.E.; U.S. Department of Agriculture, Natural Resources Conservation Service, Richmond, Virginia

Abstract

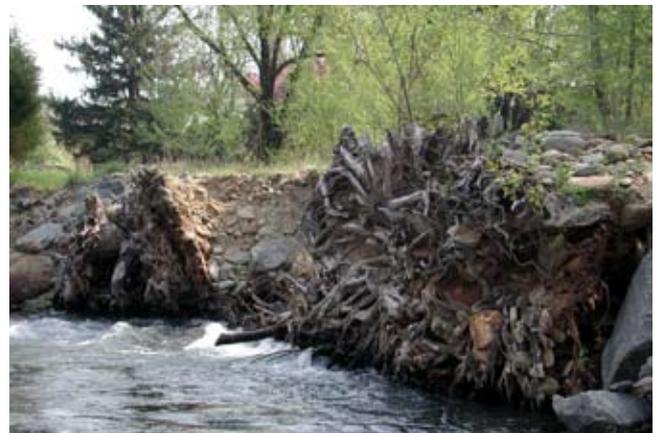
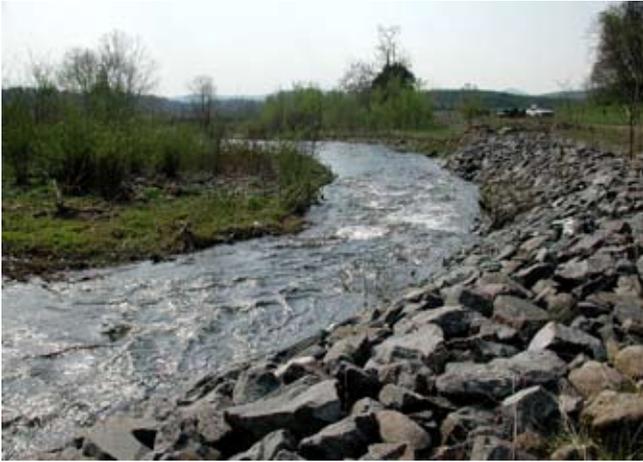
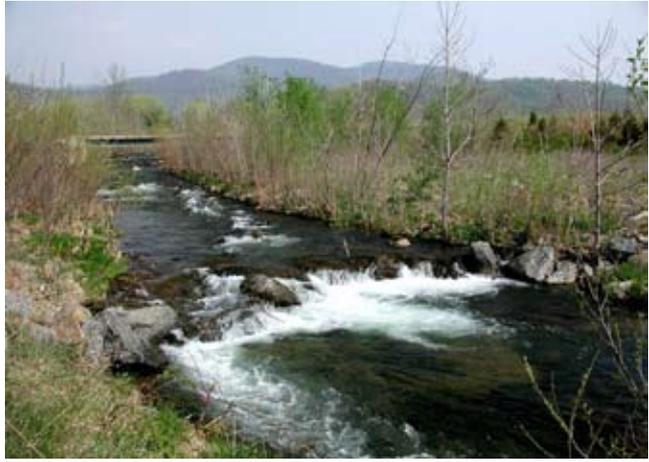
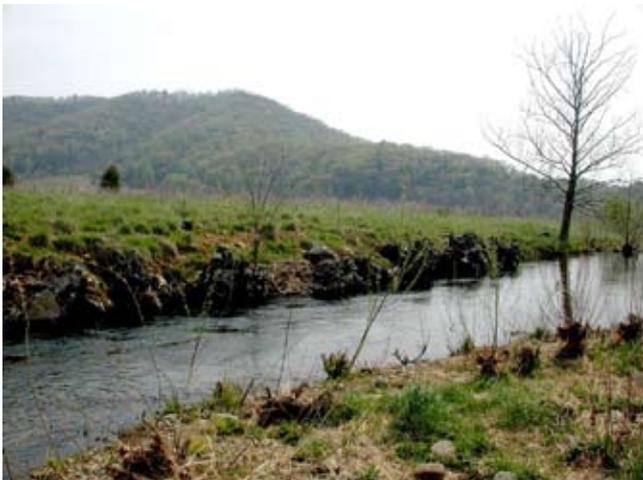
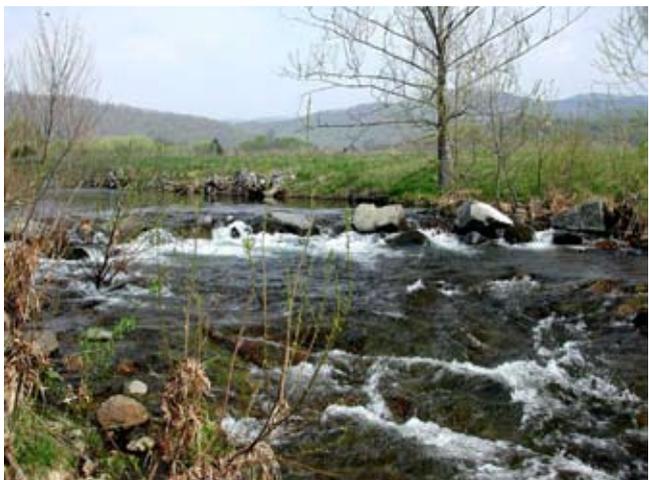
This site has been monitored visually for the past 7 years. Pictures taken annually showed little change from postconstruction in 1998 to April 2003 (figs. CS5-7 through CS5-11).

Figure CS5-7 Upper rootwads, April 2003

Figure CS5-8 Upper riprap, April 2003

Figure CS5-9 Weir #7, April 2003

Figure CS5-10 Lower rootwads, April 2003

Figure CS5-11 Weir #5, April 2003

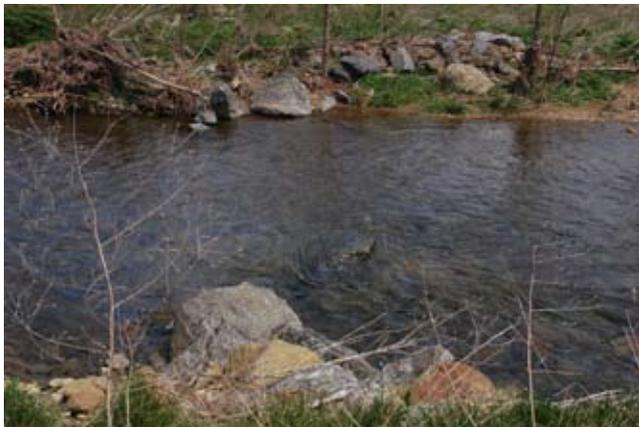
Figure CS5-12 Weir #7, April 2004, after Hurricane Isabel

After Hurricane Isabel (Sept. 2003), the section of the river immediately below the bridge filled in with about 3 feet of cobble material. Weir #7 was completely covered (fig. CS5-12).

Only the rocks on the edges can still be seen. The pool has shifted downstream 50 to 60 feet. The riffle has become longer with no intermediate pools in the curve between weir #7 and weir #6, and weir #6 is unchanged. However, the lower set of rootwads has been almost totally removed. The bank is raw and nearly vertical again (fig. CS5-13). The large pool remains, held in place by weir #5 (fig. CS5-14).

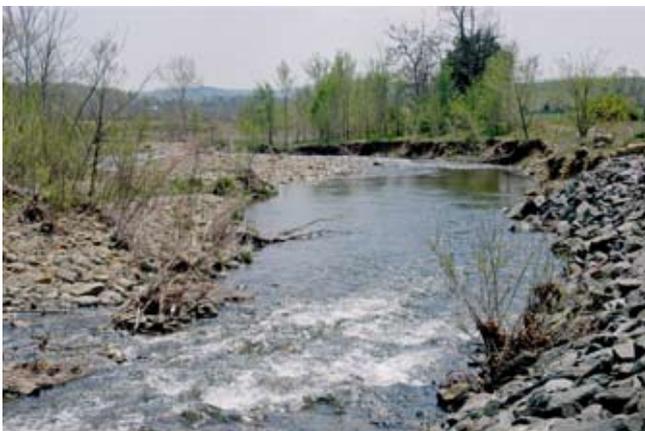
Figure CS5-15 Raw bank downstream of riprap

When the plan views were compared, they showed that most of the reach had only minor changes from 1997 (fig. CS5-1). The biggest change occurred below weir #8. Part of this probably occurred during construction, when the riprap was installed. However, the river has moved more to the right below the riprap, and the outside bank is vertical and unvegetated (fig.

CS5-15). A large, fairly steep riffle has formed below this point. The second area where major changes occurred is in the curve between weirs #7 and #6. The curve seems to have become sharper, and some meander development has occurred.
