*Alica J. Ketchem, P.E.; U.S. Department of Agriculture, Natural Resources Conservation Service, Richmond, Virginia*

In 1995 and 1996, major storm events caused severe damage to the Rose River in Madison County, Virginia. In 1998, 4,200 feet of the Rose River was restored to a more stable condition and strengthened using a variety of natural and ecologically friendly techniques. This effort included the installation of nine vortex rock weirs and two sets of rootwads. Five years after installation, during Hurricane Isabel, the Rose River flooded again. Although some of the weirs and rootwads were damaged by this flood, the majority of the site remained in a stable condition.

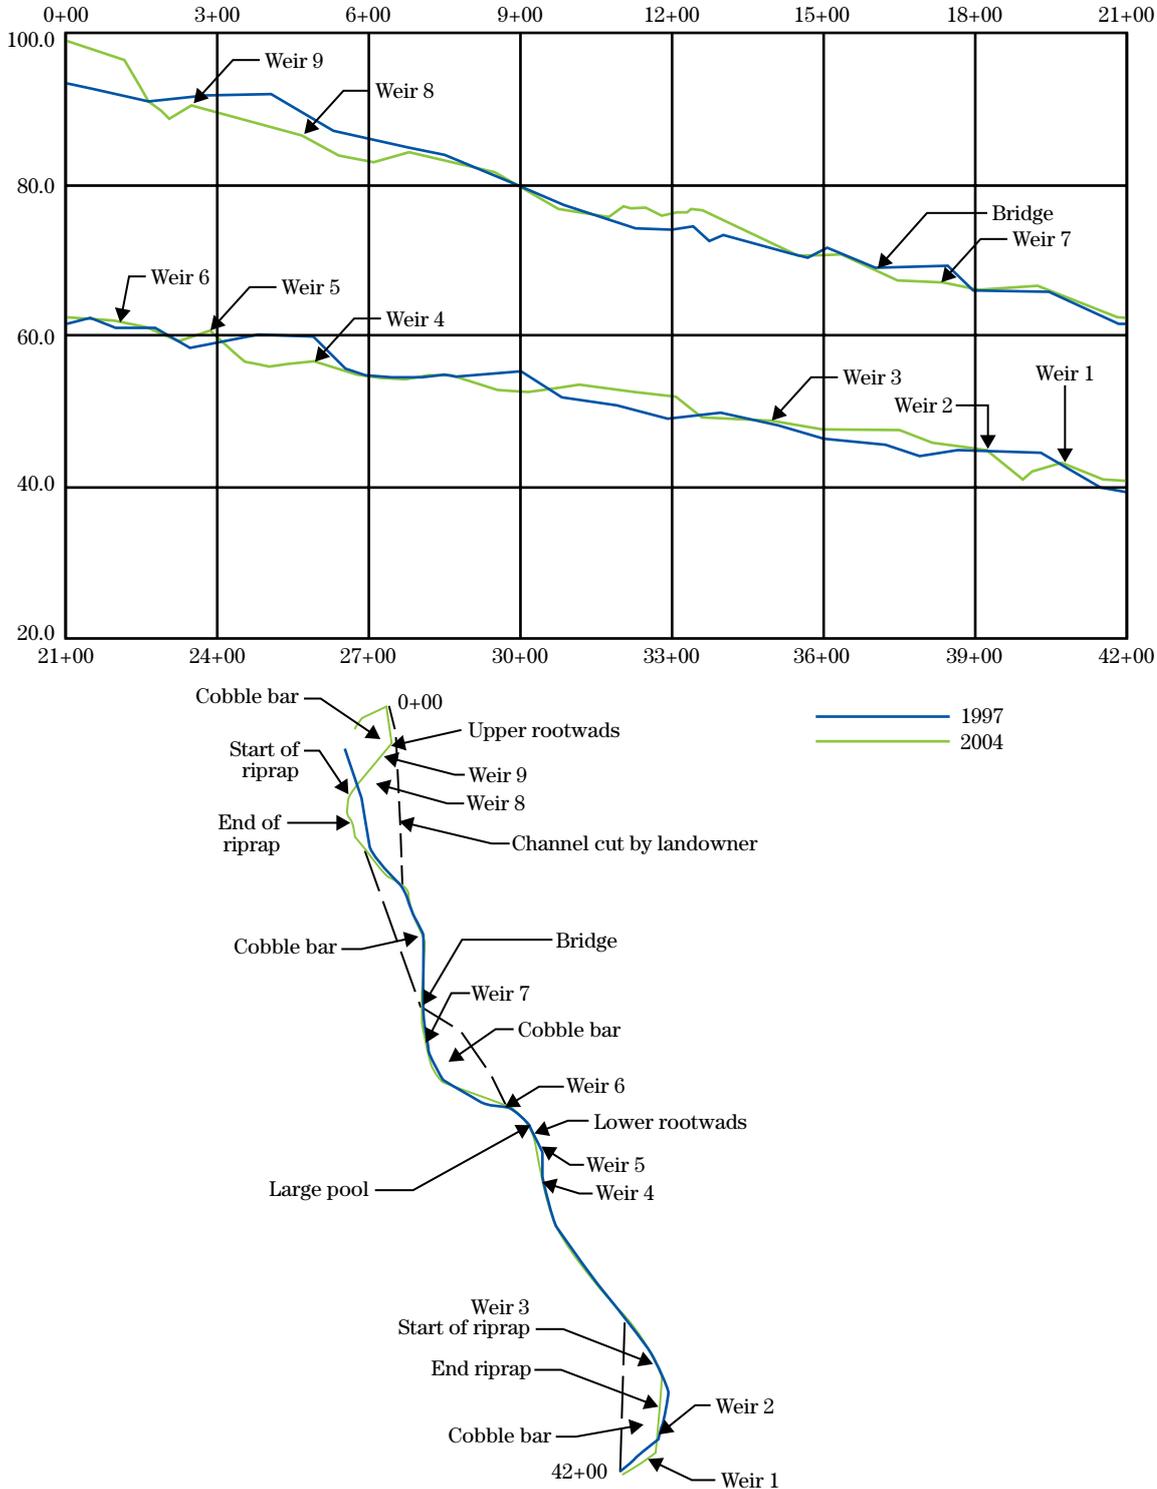
**Figure CS5-1** Rose River profile and plan view survey information (shown in ft, as surveyed) for 1997 and 2004

Figure CS5-1 shows complementary plan and profile survey information for Rose River for 1997 and 2004, after the severe storms.

The profile was again surveyed in April 2004 (fig. CS5-1). As could be expected, some sections were cut down, and some had filled in. The largest fill occurred at the beginning of the reach. The channel had filled in by about 7 feet in the section above the upper rootwads. It is unclear why this occurred. The profile also showed that weir #9 is providing grade control as planned. Where the river was turned back into its original channel, the profile shows the 2004 slope to be 3 to 4 feet lower than the 1997 profile. Some of this material was removed during construction. The riprap is stable and shows no signs of change. Below the riprap, the elevation of the channel bottom has not changed for about 400 linear feet. A deep pool has developed below the outlet of the gully cut by the landowner. The profile shows that the channel has filled in 2 to 3 feet for a distance of about 350 linear feet below

When the plan views were compared, they showed that most of the reach had only minor changes from 1997 (fig. CS5-1). The biggest change occurred below weir #8. Part of this probably occurred during construction, when the riprap was installed. However, the river has moved more to the right below the riprap, and the outside bank is vertical and unvegetated (fig.

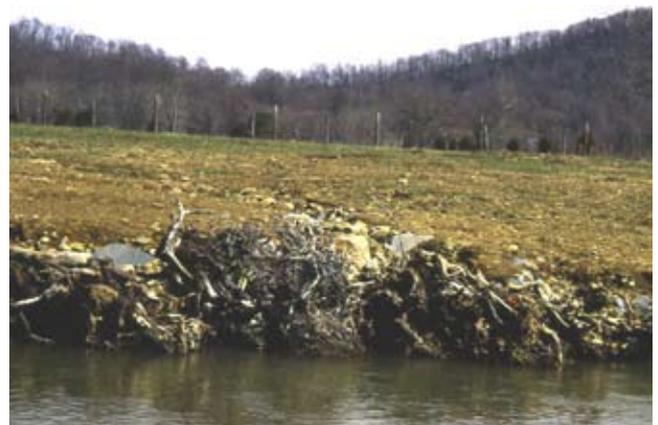
**Figure CS5-3** Lower rootwads, March 1998, immediately after construction

The next section that was of major concern was at the large pool. This pool was about 150 feet long and 3 to 4 feet deep at the outside of the curve. The outside bank was 5 to 6 feet high and undercut. Because of the excellent trout habitat provided by the deep water, the DGIF staff was interested in maintaining the pool at the existing depth and location. To do this, one weir (#6) was placed at the head of the pool and one at the foot, at the top of the riffle (#5) (fig. CS5-2). A third weir (#4) was placed at the bottom of this riffle. The vertical bank was graded to a stable slope, and rootwads were trenched in along the pool (fig. CS5-3). At

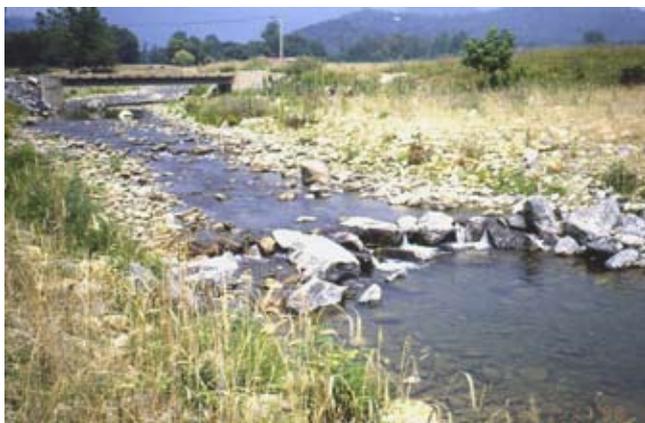
**Figure CS5-4** Weir #7, July 1998

Weir #7 was located between the bridge and the curve. The left end was embedded into the cobble bar, and the right end was anchored into natural ground (fig. CS5-4). The scour hole that developed below this weir

was several feet deep and formed excellent fish habitat.

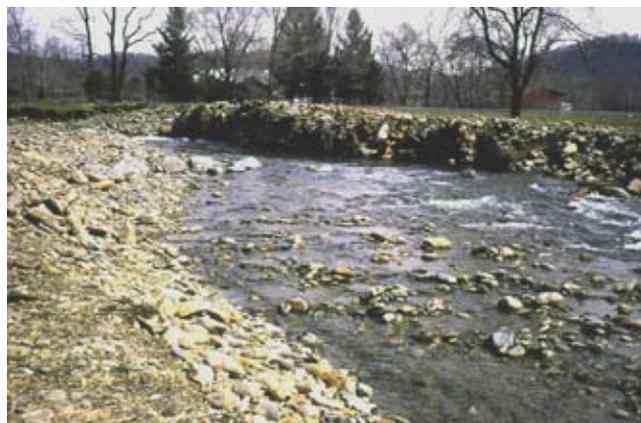
**Figure CS5-5** Upper rootwads after construction, July 1998

After the weirs were complete, the water was rerouted back into the original channel. The cut-through channel was blocked with large rootwads and cobble material from the large debris bar above the bridge (fig. CS5-5). The cobble material was trucked up the gully and dumped against the back of the rootwads. This made a very large plug of soil and rocks that would not be vulnerable to washing away if the river overtopped the rootwads. Fill was placed in the gully until the cobble bar material was removed to the bankfull elevation. The gully was then graded and shaped to a stable

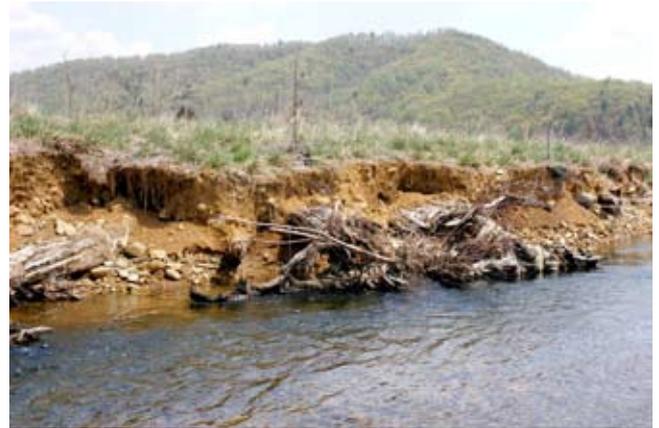
Only the rocks on the edges can still be seen. The pool has shifted downstream 50 to 60 feet. The riffle has become longer with no intermediate pools in the curve between weir #7 and weir #6, and weir #6 is unchanged. However, the lower set of rootwads has been almost totally removed. The bank is raw and nearly vertical again (fig. CS5-13). The large pool remains, held in place by weir #5 (fig. CS5-14).

**Figure CS5-13** Lower rootwads, April 2004, after Hurricane Isabel

The lower rootwads were trenched into the bank with 10 to 15 feet of the bole embedded. Some of the rootwads at the upper end of this group are still in place. At the lower end, some of the rootwads are missing entirely, while others appear to have been snapped off. One possible explanation is that the flood plain became more entrenched immediately above the rootwads. Starting at the bridge, the right bank was 6 to 8 feet higher than the left bank. The excess cobble had been removed from the left bank to increase the width of the flood plain. Just below weir #6, the left bank intersected the first terrace. This constriction would have increased the flow velocity against the left bank and the rootwads along it. The water elevation may have been above the top of the rootwads, contributing to the problem.

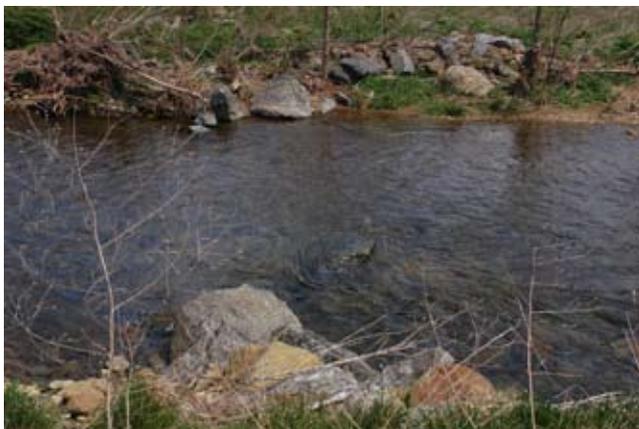
After Hurricane Isabel (Sept. 2003), the section of the river immediately below the bridge filled in with about 3 feet of cobble material. Weir #7 was completely covered (fig. CS5-12).

**Figure CS5-12** Weir #7, April 2004, after Hurricane Isabel

However, a few things could be done to enhance performance. Weirs #1, #2, #8, and #9 were installed “in the dry.” Of these, only weir #2 has retained its function of grade control and flow direction. Weirs #3, #4, #5, #6, and #7 were installed without diverting the water. Of these, only the rocks in weirs #5 and #6 have shifted from their installed position. It was much easier to place the weirs at the desired elevation when the water was flowing. It is also easier to put them in the right place on the profile. For example, weir #9 should have been placed further upstream. After the first flood event, the river cut down to meet the weir. By placing the weir higher up, less change would have occurred in the channel in that area. The other main advantage of working “in the wet” is that it is viewed as being less disruptive to the stream ecology. It takes a full day to build a weir, if the water is diverted from the site. It only takes about 2 hours, if the equipment is allowed to work in the stream.

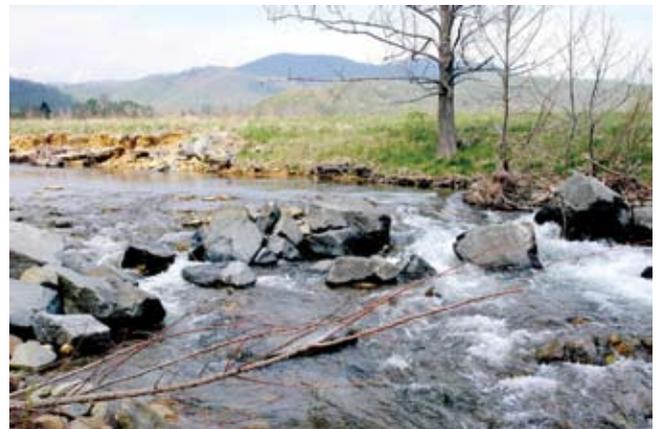
**Figure CS5-14** Weir #5 and lower rootwads, April 2004, after Hurricane Isabel

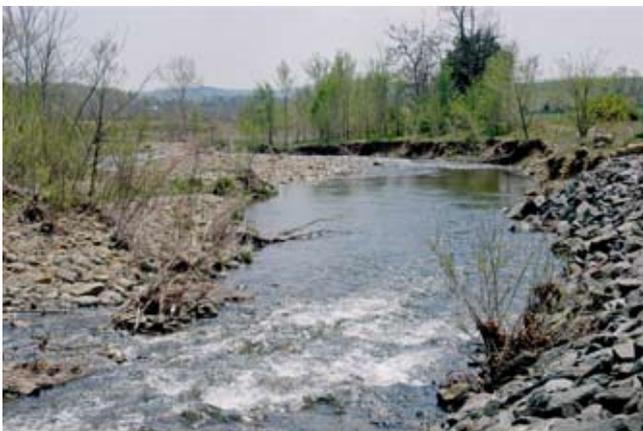
CS5-15). A large, fairly steep riffle has formed below this point. The second area where major changes occurred is in the curve between weirs #7 and #6. The curve seems to have become sharper, and some meander development has occurred.

**Figure CS5-15** Raw bank downstream of riprap

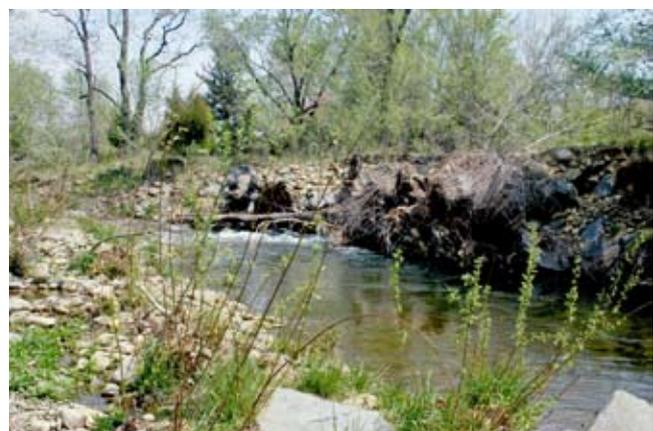
of this general observation. The upper rootwads were used as part of a gully plug to cut off the manmade channel. The material used behind this was primarily cobble with some purchased riprap. To date, there seems to be little or no deterioration in these rootwads (fig. CS5-16). One possible reason is that the flood plain elevation is at least 4 feet lower on the side across from the rootwads. Previous failures on other sites were because of overtopping. This has yet to occur on this site.

**Figure CS5-16** Upper rootwads, April 2004, after Hurricane Isabel
