## Case Study 13

## Owl Creek Farms, North Branch of the Kokosing River, Knox County, Ohio

Issued August 2007

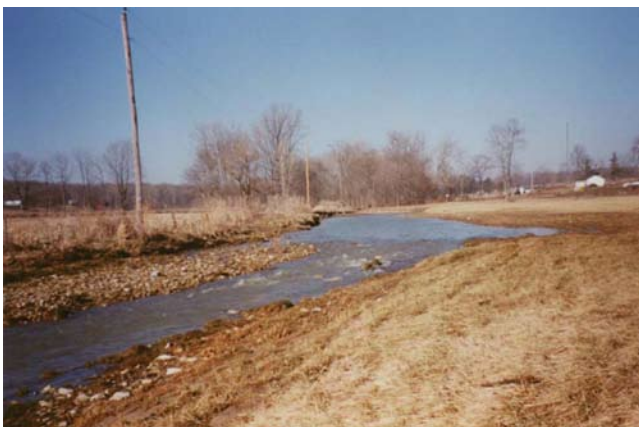
**Figure CS13-1** Owl Creek—before

The drainage area above the site is about 10 square miles, and the substrate is predominantly gravel. The stream slope is relatively low (0.4%). The original bank condition was fair to poor, with erosion concentrated on the outside meander bends. Little vegetation was present along the banks (<10-ft corridor width). The bankfull channel width at riffles was 20 to 25 feet, and the mean bankfull depth at riffles was about 2 feet.

No channel reconstruction was undertaken for mitigation. Existing postchannelization alignment was stabilized in place, and vortex rock weirs and plantings were added. No in-depth hydraulic analyses were conducted. Weir locations were determined in the field.

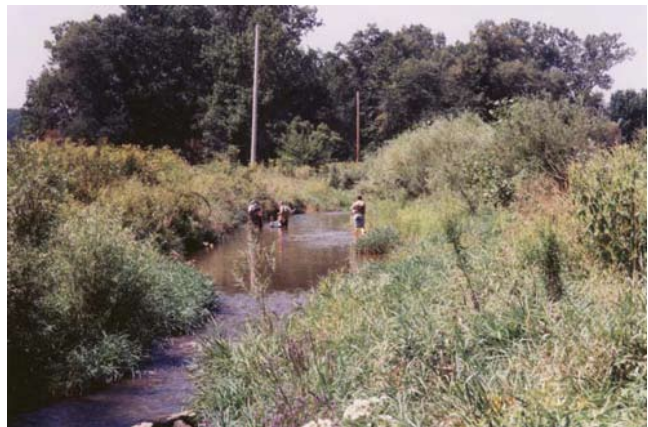
**Figure CS13-2** Owl Creek—after

In the third year of monitoring, the project is meeting or exceeding stated goals for fish and macroinvertebrate community quality, habitat quality, and vegetation survival. The vortex rock weirs, bank stabilization measures, live willow plantings, and mowing and grazing restrictions all have performed better than expected. The least successful feature of this project was the survival of riparian tree seedlings. The tree seedlings should have been better protected from competition, or not planted at all, to allow natural succession to occur.

The vortex rock weirs performed better than anticipated in creating scour pools and attracting fish and macroinvertebrates. Of key importance was the skillful installation of anchor rocks that were well keyed into the bank. The property owner was a skilled equipment operator. The live willow stakings were very successful in stabilizing banks, improving cover, and even providing some shading benefits in the first growing season. Simply ceasing mowing and precluding grazing next to the stream are effective aquatic habi-
