Case Study 1

Chalk Creek, Summit County, Utah

Issued August 2007

By Shane Green, Area Range/Riparian Specialist, U.S. Department of Agriculture, Natural Resources Conservation Service, Utah

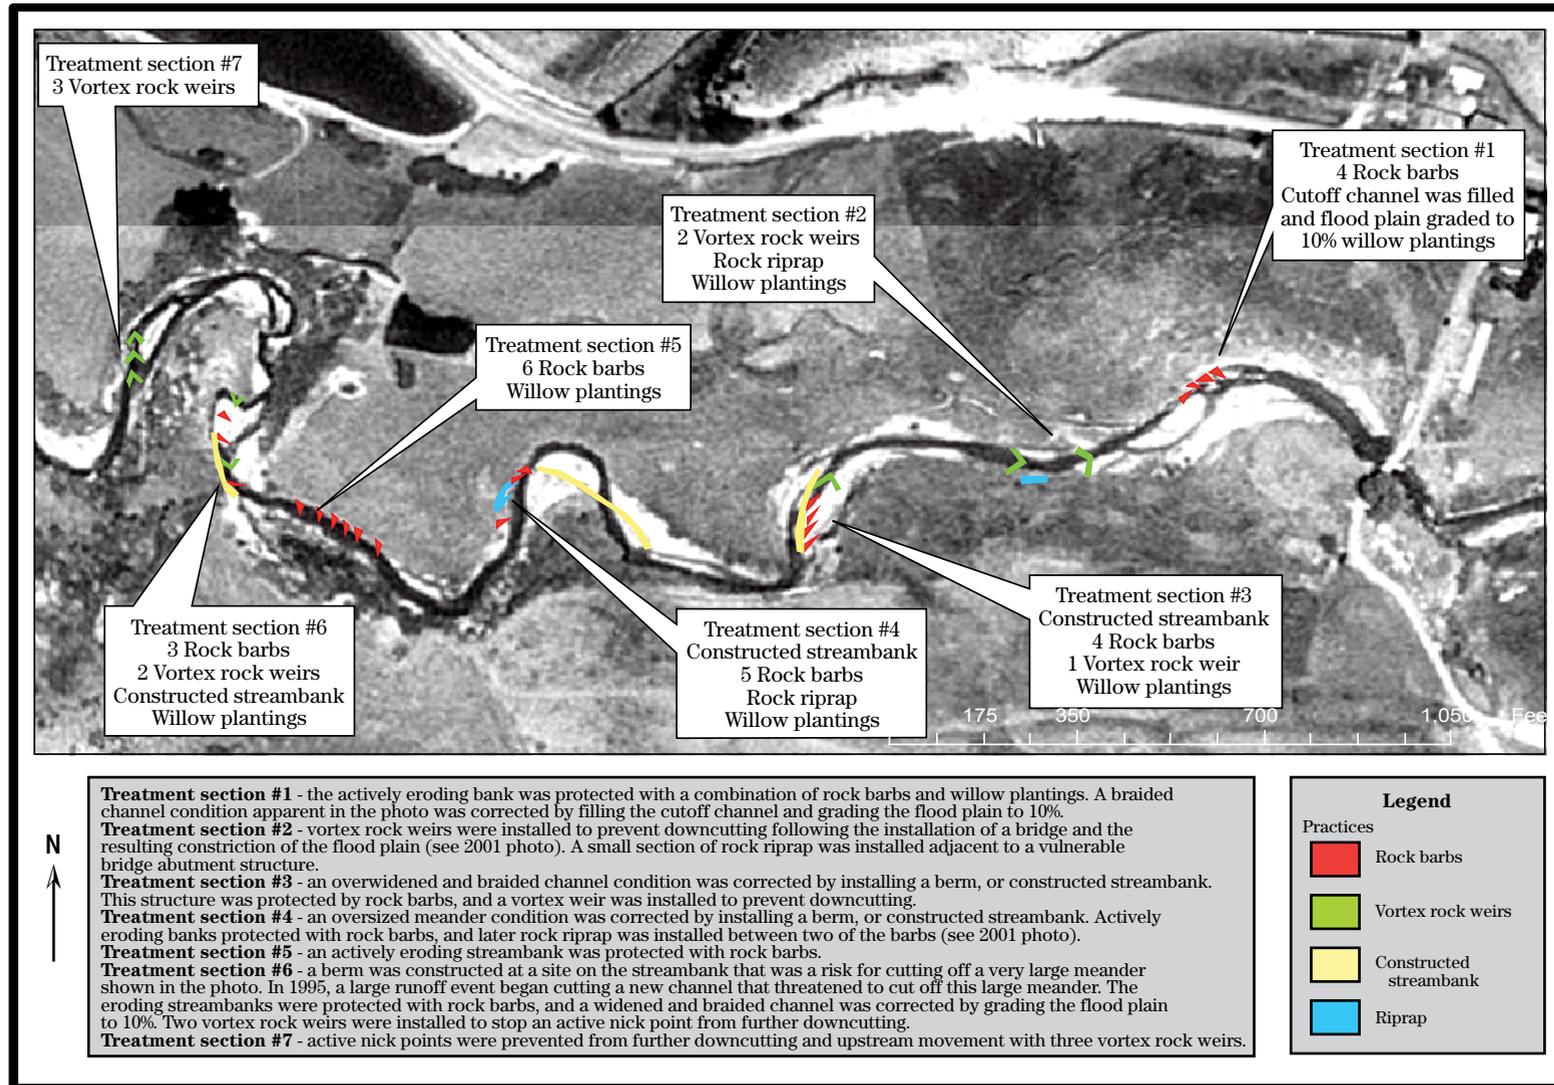
Figure CS1-3 Chalk Creek example project, pretreatment view, 1989

In this case study, the landowner had recently acquired the property and was concerned about the amount of irrigated pastureland he was losing annually to bank erosion adjacent to Chalk Creek. In one instance, the stream channel encroached approximately 30 feet into the pasture during a single snowmelt runoff (fig. CS1-3, treatment section #4). Resource inventory revealed that past practices had removed woody riparian vegetation from many of the banks. Also, some apparent nick points or overfalls in the channel indicated active downcutting. Evidence of past channel dredging was apparent on a few reaches. At one location, a new bridge constricted the flow in the channel.

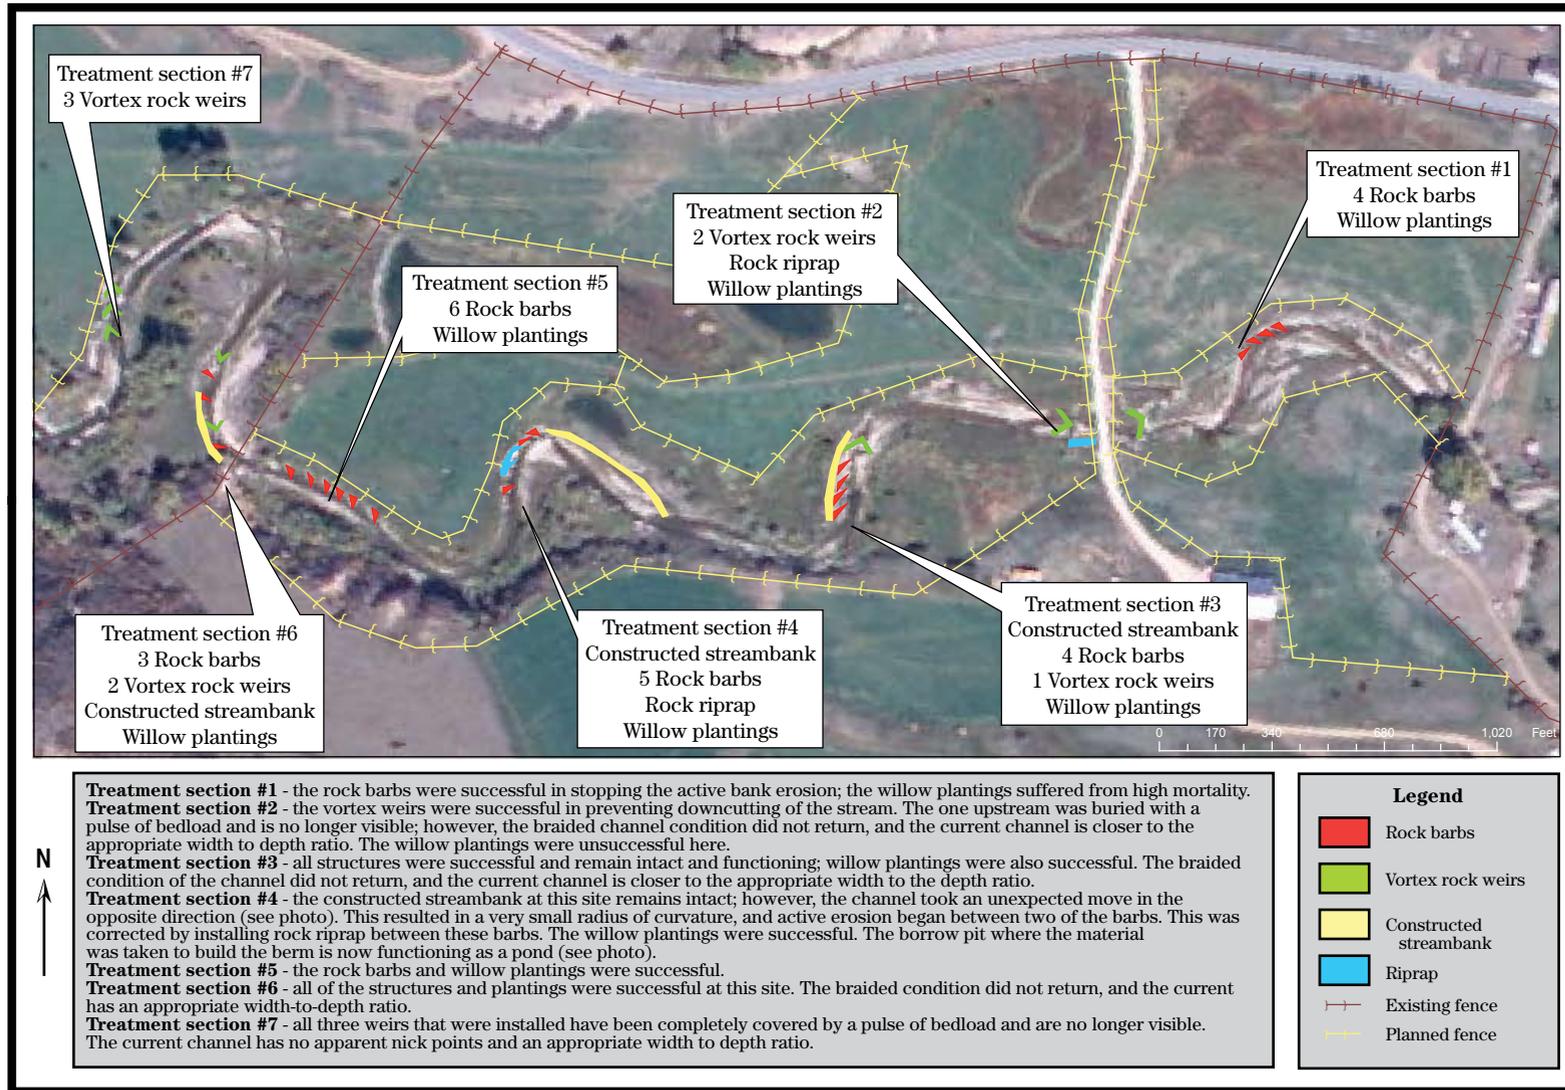
Figure CS1-5 Chalk Creek Example Project, posttreatment view, 2001

The landowner is pleased with the results of this project (figs. CS1–5 through CS1–7). The eminent threat of the stream changing course and cutting off a large meander at treatment section #6 has been alleviated. A few of the installed practices were not successful, however. Most notable was the failure of the barbs to stop bank erosion in treatment section #4. The stream was anticipated to follow the contour of the installed berm, but it started to curve away from the berm in subsequent years (fig. CS1–5). This caused a very tight radius of curvature on the bend where the erosion occurred between the barbs. A more careful analysis of the oversized meander and design of the placement of the berm may have prevented this. Bank erosion has ceased and woody riparian vegetation is recovering

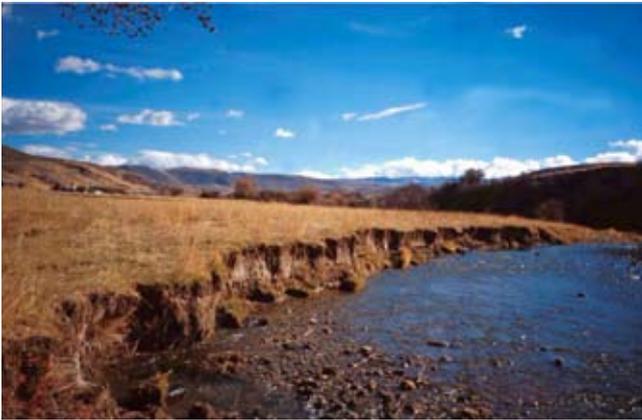
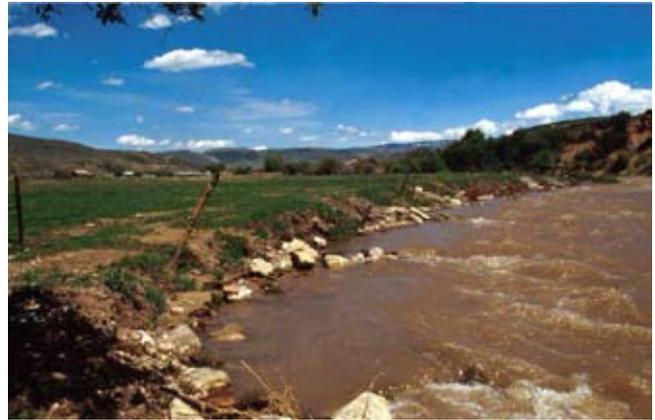
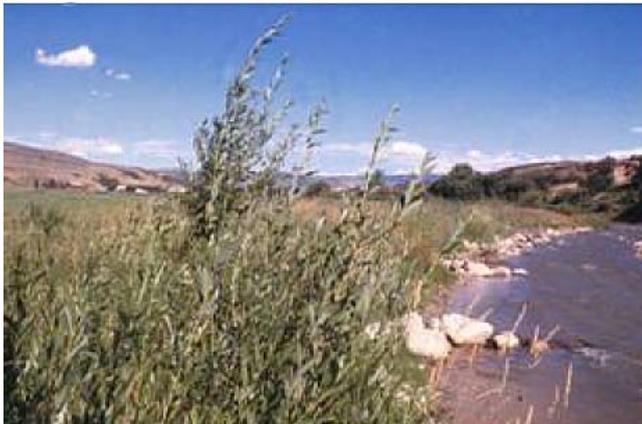
Figure CS1-6 Treatment section #4 (view looking upstream)

(CS1-6c). Note the function of the rock barbs as the current is focused away from the bank downstream of each barb.

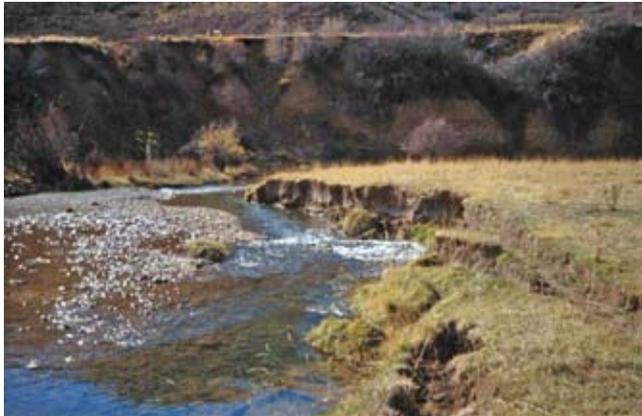
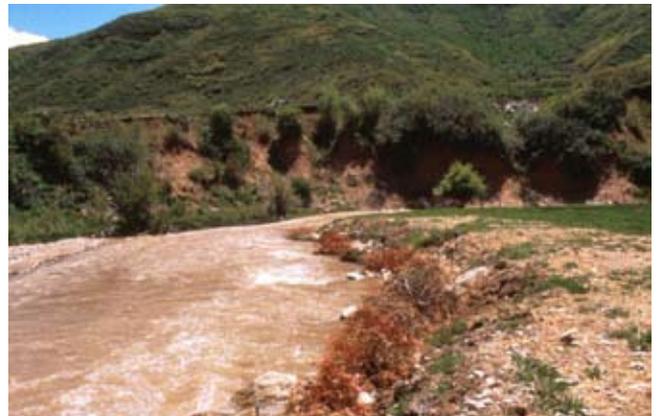
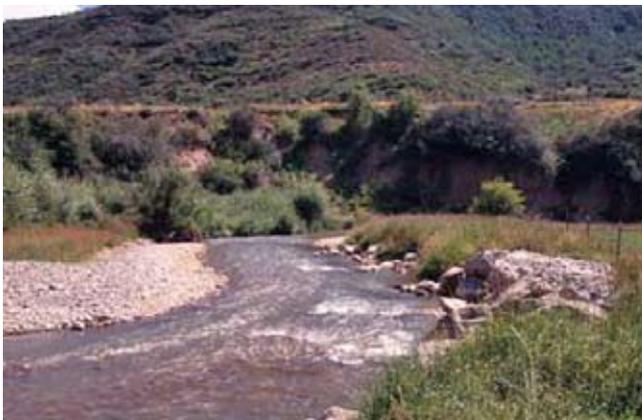
Figure CS1-7 Treatment section #3 (view looking downstream)

Figure CS1-7 shows treatment section #3 before, immediately following, and after treatment. Bank erosion has ceased and woody riparian vegetation is recovering. By 1998, the conifer revetments and rock barbs were necessary to provide protection for the evacu-

ated material used to construct the new streambank. Note the improved width/depth ratio of the channel and removal of the braided condition.
