Case Study 10

Newaukum River, Lewis County, Washington

Issued August 2007

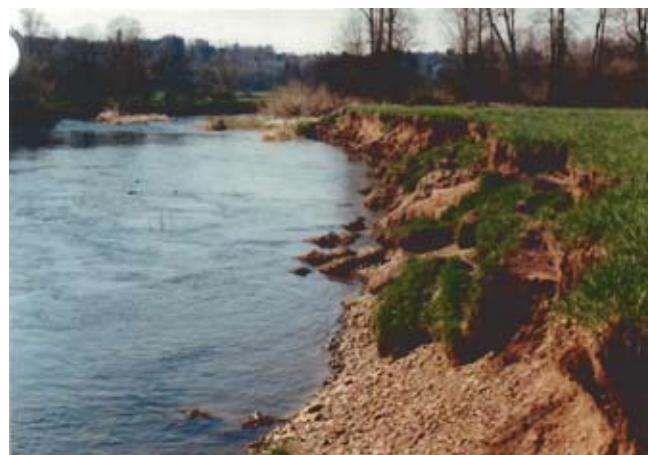
Figure CS10–1 Typical conditions that existed at the project sites prior to design treatments

- high banks on the outside of a curved reach with seasonal erosion at toe, resulting in periodic upper bank sloughing

Bank soils varied from fine sandy silts with clay to fine sand with lenses of sand and gravel. The banks were devoid of woody vegetation. Raw slopes generally had herbaceous cover by late spring.

The ratios of radius of curve to channel width varied from <2 to 20, a nearly straight reach. The oversteepened bank slopes, combined with saturated soils, resulted in active bank sloughing during and following winter and spring high water events. These sites were not fenced prior to the project and were subject to livestock grazing.

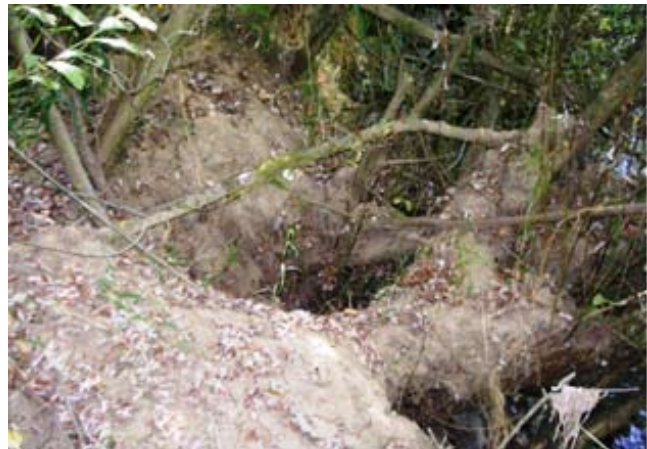
(b) Willow development above toe rock. There appears to be some loss of fine soils at the interface.

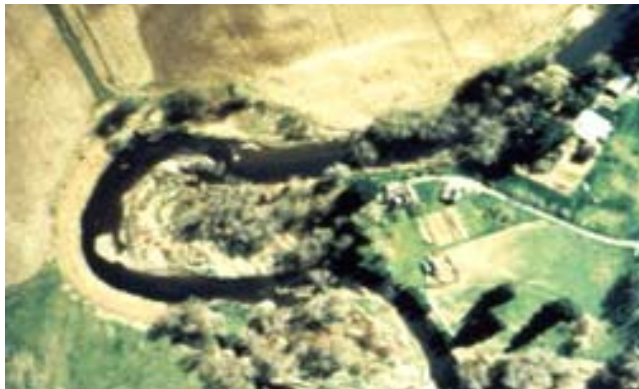
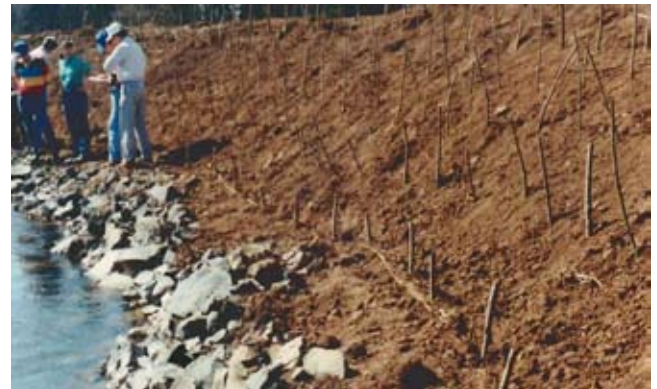
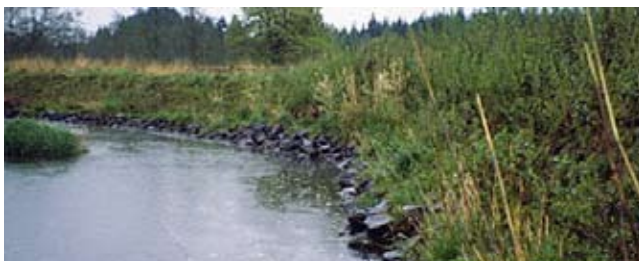
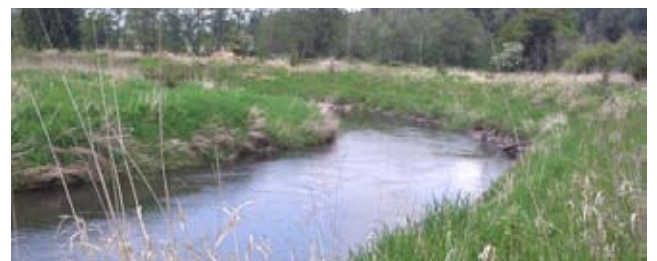
Figure CS10-5 Teitzel site

The Teitzel site, with the lowest R:W ratio, was initially treated with narrow (approximately 12-in-wide) rock and brush (RB) structures at 8- to 10-foot intervals. These failed in the first season during an over-bank flood event. Following the flood, the bank was reshaped and treatments applied as indicated in table CS10-4. The live stakes produced an extensive stand of woody bank cover the first year after repair. This was followed by an extremely dry year and infestation of the willow borer, which killed off 80 to 90 percent of the willows. Natural recovery was further decimated by beaver activity in subsequent years. Currently, the bank is stable with heavy grass cover, but no woody vegetation (fig. CS10-5).

Sometimes, even with proper maintenance, establishment of vegetative treatments can be difficult. The Teitzel site was also restaked after the willow borer infestation, but did not recover. Beaver activity and southern exposure at this site exacerbated the situation. In the fall of 2005, the banks were well grassed, but with no woody cover. It appears from table CS10-4 that soils and perhaps soil fertility have played a role at this site. Those sites with Chehalis silt loam soil series and south or east facing slopes did not fair well for establishment of woody vegetation.

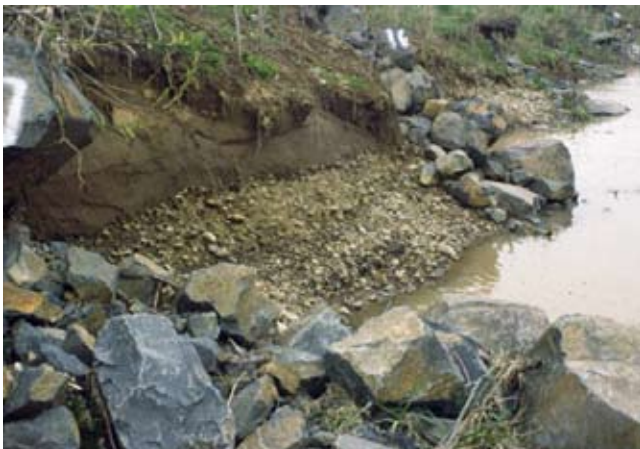
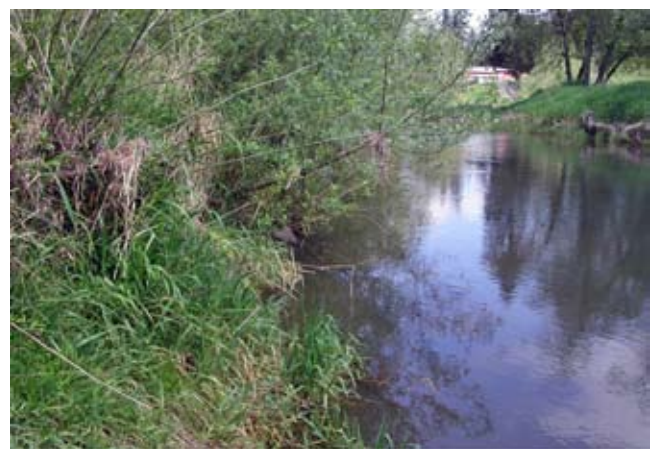
Figure CS10-6 Fitzgerald site, photos taken from similar view points. Initial erosion at toe adjacent to RB; structures filled with sediment as vegetation developed

The Fitzgerald site is a near linear reach (highest R:W ratio), at the opposite end of the spectrum for curve radius. In the first years of monitoring, the RB structures appeared to be on the verge of failure with

considerable erosion and scour of loose bank material (sand-gravel lenses) adjacent to the structures. As the willows in the RB structures developed, the roughness element is believed to have slowed the near-bank velocity and allowed for sediment deposition. Currently, the thalweg has moved away from the toe, and significant sediment deposition has occurred along this reach. Woody vegetation is dense at the RB structures and between structures as evident in figure CS10-6.

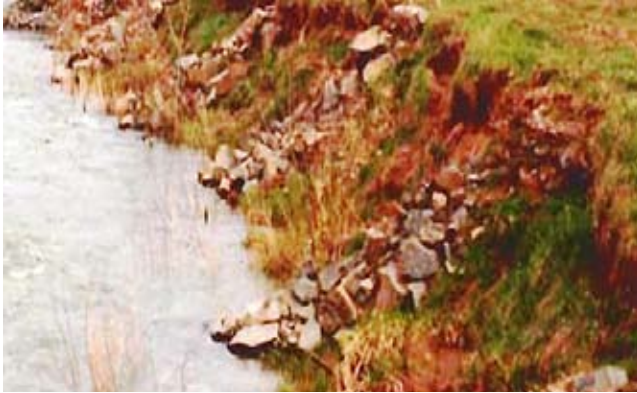
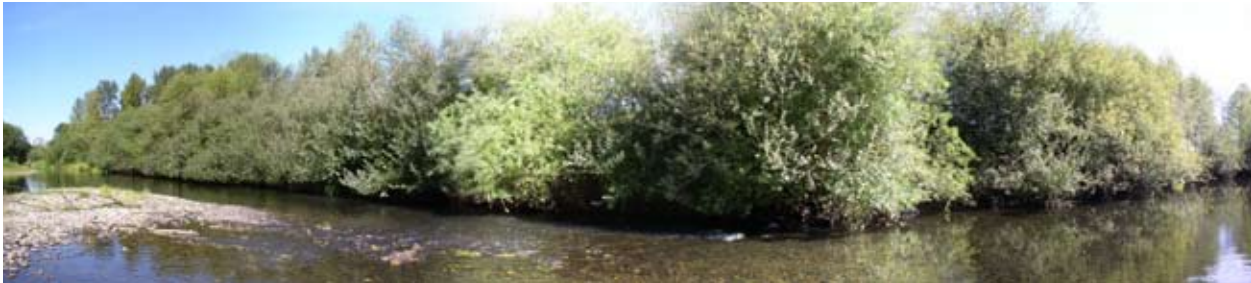
Figure CS10-7 Nygard site

The Nygard site has a moderate R:W ratio and perhaps is the more consistent of all the sites in steady progress towards stability. It, too, has experienced the flood events and dry seasons, but lower losses (50%) from infestation of the willow borer and not significantly affected by beaver activity. The treatment at this site combines toe rock with the RB structures in the upper curved portion of the reach. Very little bank shaping was done at this site, other than what occurred during excavation of the rock and brush trenches. The steep bank slope was still evident during the site visit in 2005. As figure CS10-7 shows, the water level was above the toe rock. The RBs continue downstream through a shallower bend without toe rock. The thalweg remains at the toe of the bank in the upper curved reach. The willows are dense and extend out over the stream providing heavy shading over the thalweg.

It is almost a certainty that the Nygard and Teitzel sites would have failed without toe rock. Visual inspections in the fall of 2005 indicated that the thalweg continued to flow along the toe of bank. Even at low flow, the water depth along the toe was estimated at 4 to 5 feet. Without the rock toe protection, the bank would likely undercut during seasonal high water events with upper bank sloughing as flow subsides. The upper bank sloughing would be slowed because of dense vegetation, but slope failures would likely occur.
