Case Study 11

Streambank Stabilization in the Red River Basin, North Dakota

Issued August 2007

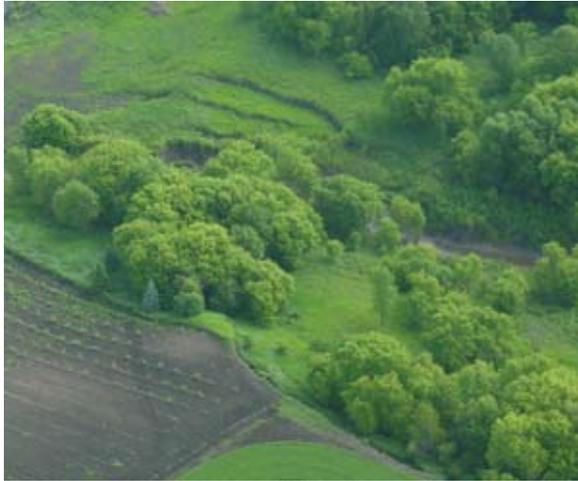
Figure CS11-3 Types of slope failures

These clay soils cause significant geotechnical problems, especially where they are unconfined. Because of the low-gradient and underfit nature of rivers in the valley, sinuosities are very high (>1.5), creating meanders with a very low radius of curvature. In tight meanders, higher velocity flows are forced against the outside of the channel, eroding the slope toe and steepening the bank. This natural process leads to frequent slope failures along the Red River and its tributaries. The two most common types of slope failure are rotational slumps and flow slumps (fig. CS11-3), with creep and earth flows occurring to a lesser extent.

(a) Rotational failure near Reynolds, ND

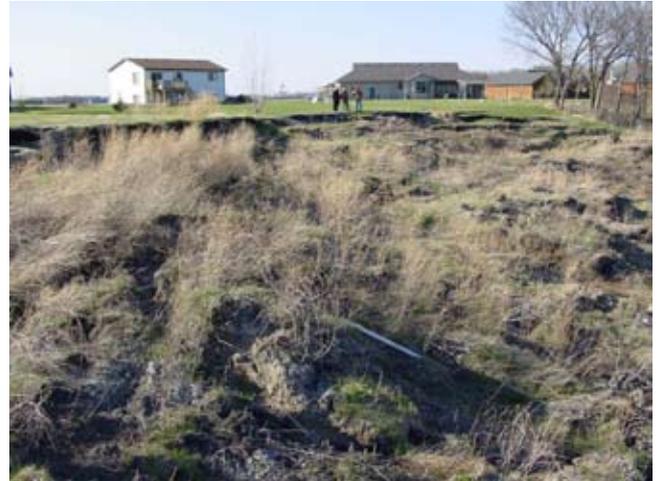
(b) Flow slump failure near Wild Rice, ND

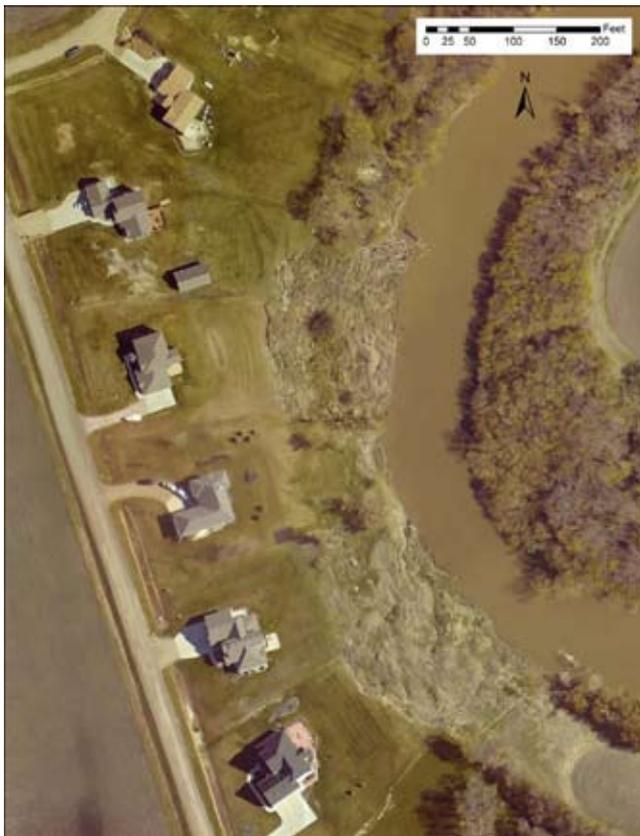
Enhanced soil moisture, a critical factor of slope stability, is frequently the result of development. Removal of the moisture-loving native plants and trees, installation of lawn sprinkler systems, and septic drain fields may double or triple the amount of moisture these soils typically receive annually. Local hydrology is altered as homeowners seek to move water away from their houses and, logically, toward the river. However, water from gutters, sumps, and yard drains only helps to saturate the already wet slopes (fig. CS11-4 (UND Energy and Environmental Research Center)).

Figure CS11-4 Slump flows caused by septic drain fields near Fargo, ND

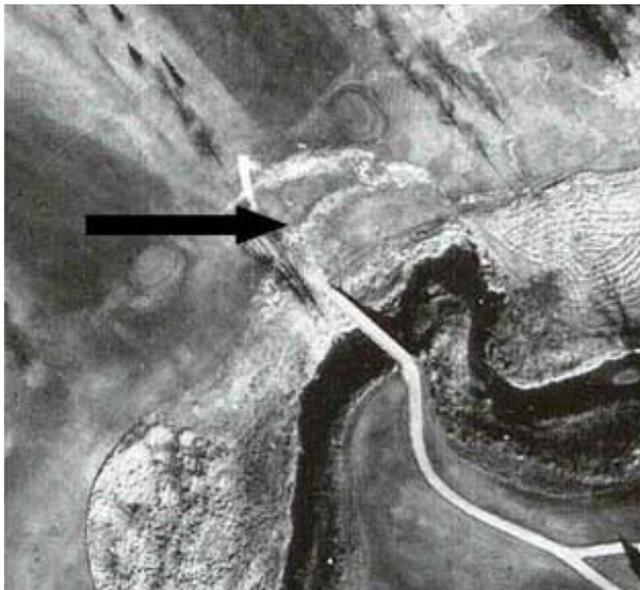
Evidence of the slumping that had damaged the golf cart bridge was visible in aerial photographs as early as 1997 (fig. CS11-6). As the 330-foot-long rotational failure settled toward Cole Creek, it unearthed the wooden bridge pilings, narrowed the creek channel, and raised the channel bottom (fig. CS11-7).

Figure CS11-6 1997 aerial photo of Grand Forks Country Club slump, marked by arrow

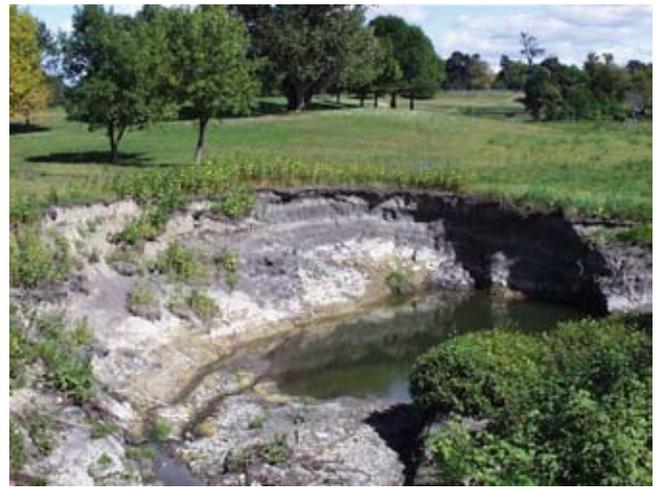
The narrowing of the channel at this point increased flow velocities, causing accelerated bank and channel scouring downstream (fig. CS11-8). A survey of the slump area showed the channel banks to be as steep as 2H:1V or greater and the slope grade to average

Figure CS11-8 Looking downstream on Cole Creek at the scour erosion caused by the narrowed channel

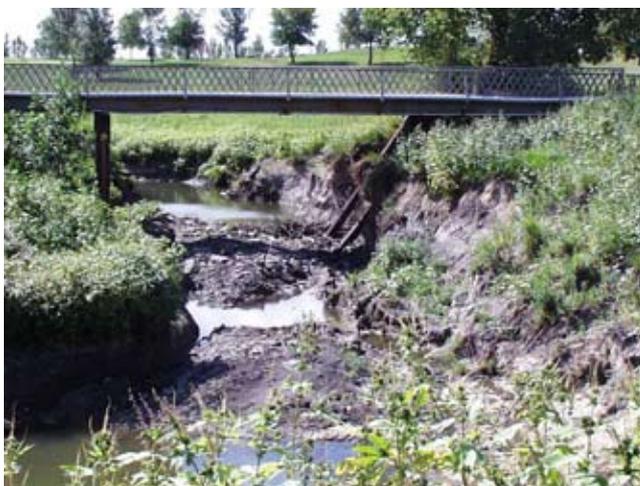
Figure CS11-7 Looking upstream on Cole Creek at the GFCC Cart Bridge (old)

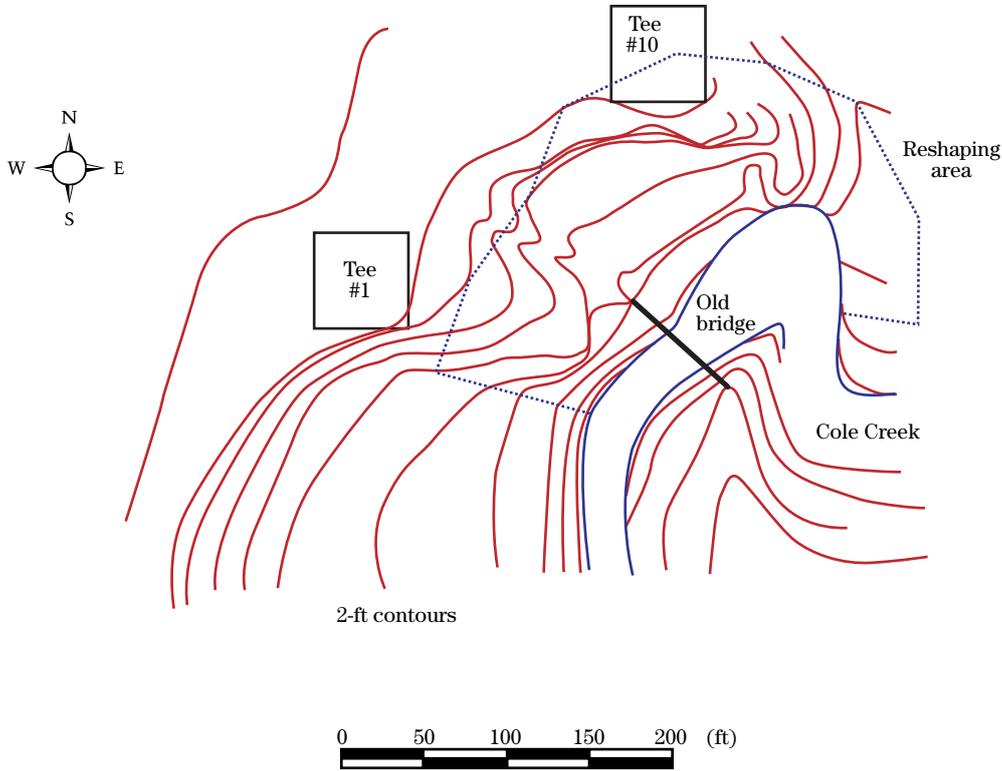
5H:1V (fig. CS11-9). A geotechnical report produced for the design for the new golf cart bridge suggested that the rotational failure could be 100 feet wide and 45 feet deep (CPS 2000).

Figure CS11-9 Topographic map of the slope failure prior to restoration

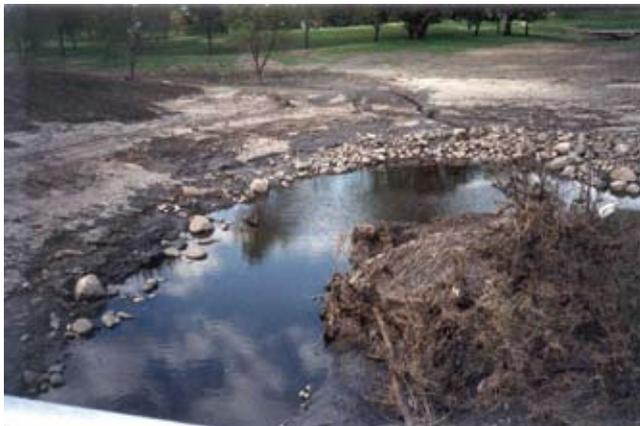
Figure CS11–12 Downstream view of Cole Creek, May 2002, prior to planting

In March of 2001, the slope reshaping and rock and rootwad installation had been completed during the construction of the new golf cart bridge (fig. CS11–12). The plant materials were installed in June and by

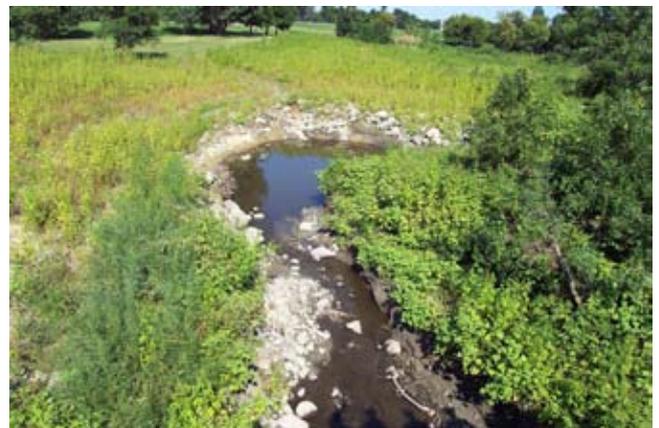
August were growing vigorously (fig. CS11–13). Total cost for the work was \$33,400, with the excavation accounting for over half of the expense. With the exception of the native grasses being replaced with Kentucky bluegrass and irrigation continuing as before, the stabilization appeared to be holding.

Figure CS11–13 Downstream view of Cole Creek, August 2002, after planting

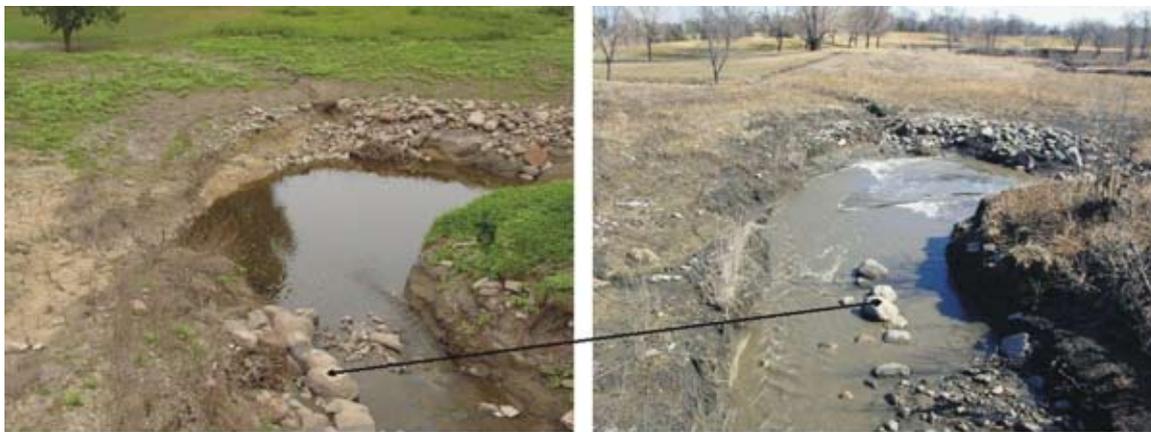
Figure CS11-14 Views of Cole Creek looking downstream from the new cart bridge

had been washed away or slipped into the channel (fig. CS11-14). Portions of the fascine and entire rootwads had been pulled from the bank. Without toe protection and sufficient counter-balancing weight, the saturated slope began to move, rotating 2 feet and narrowing the channel by 4 feet. The force of the rotation had even bent the bridge piers that were set 80 feet into the clay.

(a) Arrows indicate the same rocks in the stream

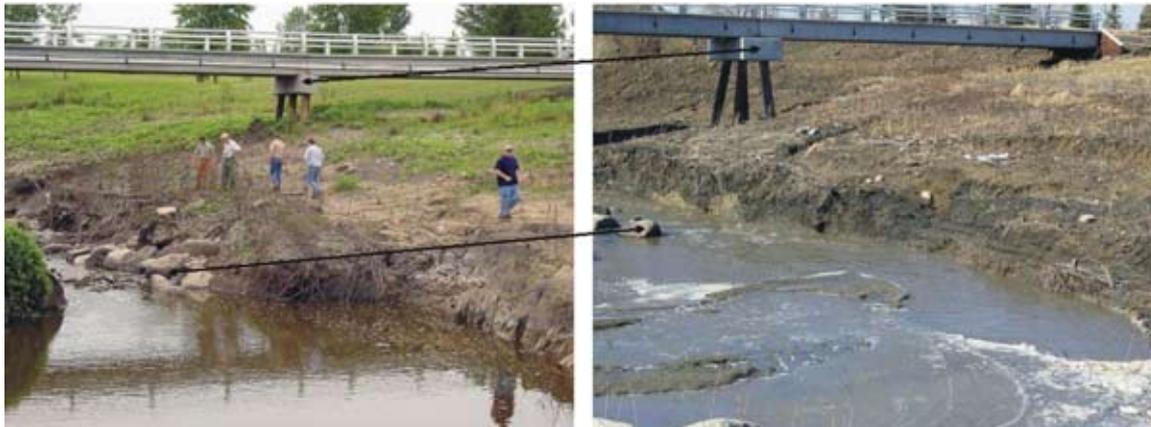
(b) Views of Cole Creek looking back upstream towards the bridge

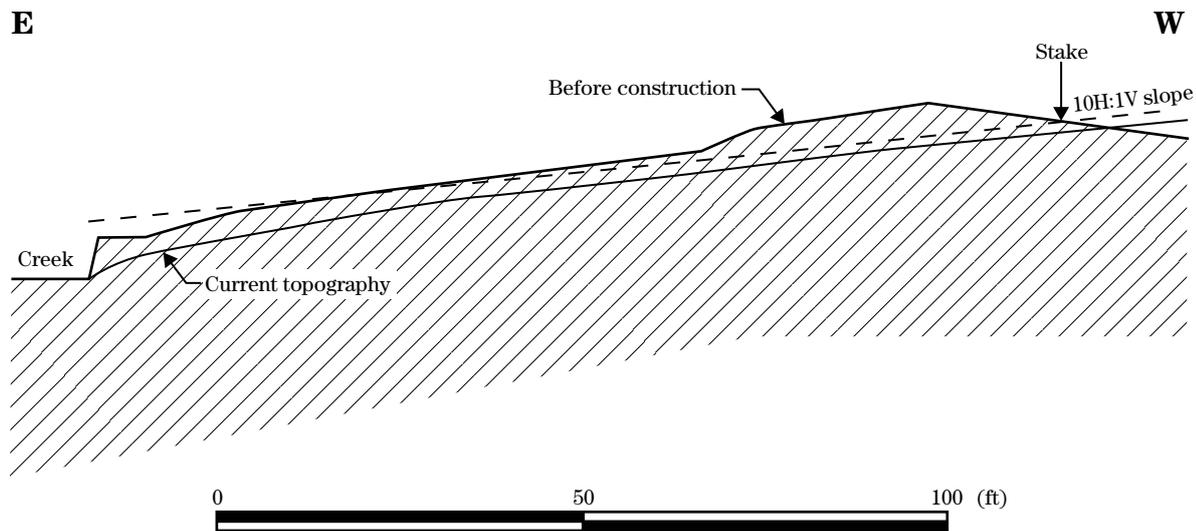
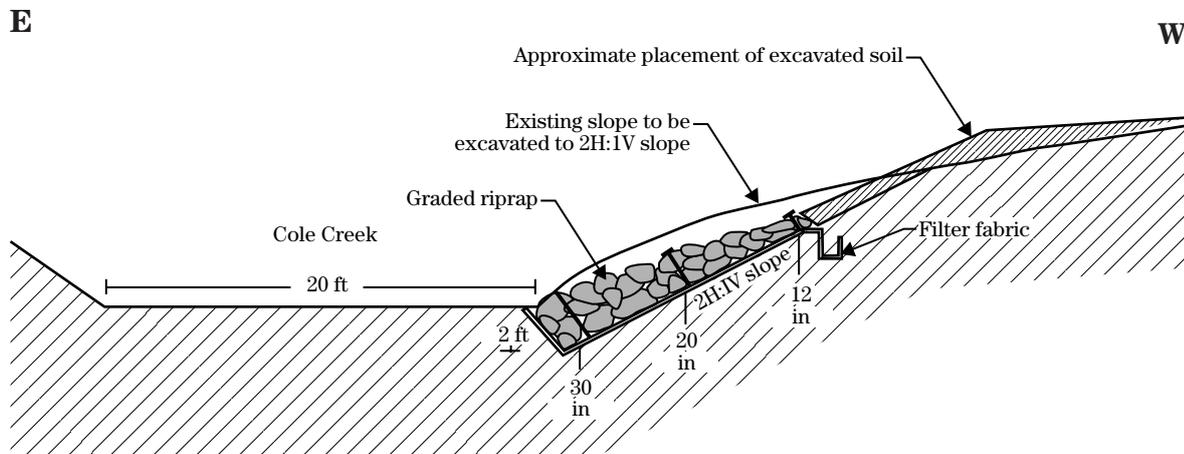
Figure CS11-15 Cross section of the slope showing the slope grade before construction and during repairs. The planned 10H:1V grade is shown for reference. Note that fill from the excavation will be placed directly above the rock.

that the slope be graded to at least 8H:1V and possibly 10H:1V, based on stable grades observed up and down-stream of the site. It was also recommended that 325 cubic yards of rock riprap be placed over geotextile along the entire reach (fig. CS11-15). The rock was to have a D_{50} of 10 inches and would be keyed into the toe, extending 12 to 15 feet up the slope. The wedge of rock would protect the toe to bankfull events and above and add counter-balancing weight.

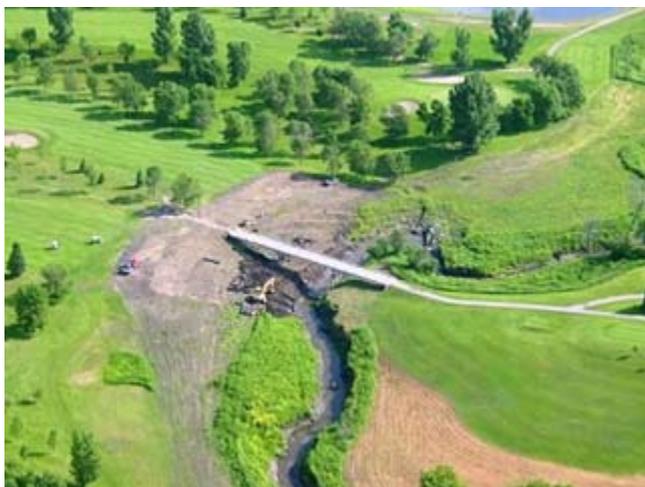
Figure CS11-16 Aerial view of slope grading and earthwork to place rock toe

Construction began in early June 2003 and was completed within 10 days (figs. CS11-16 through CS11-18). A nearly 10H:1V grade was achieved by removing material from the top of the slope, as well as placing fill above the rock toe. Total cost for the repairs was nearly \$26,000, bringing the grand total for the site to \$59,400. Table CS11-1 shows a breakdown of the

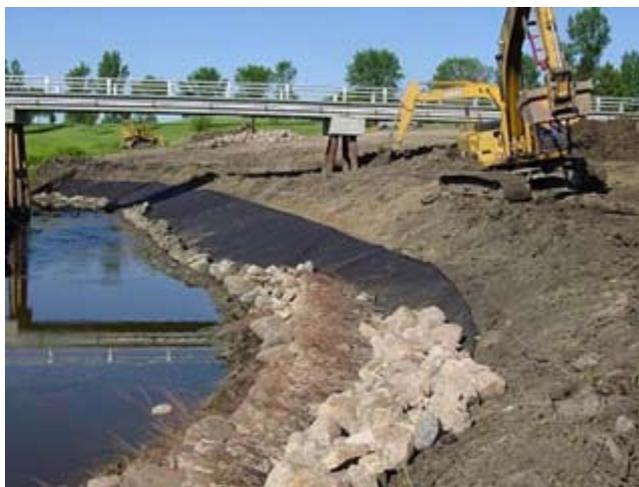
Figure CS11-17 Rock toe being placed over geotextile. A layer of live willow branches is visible within the rock toe.

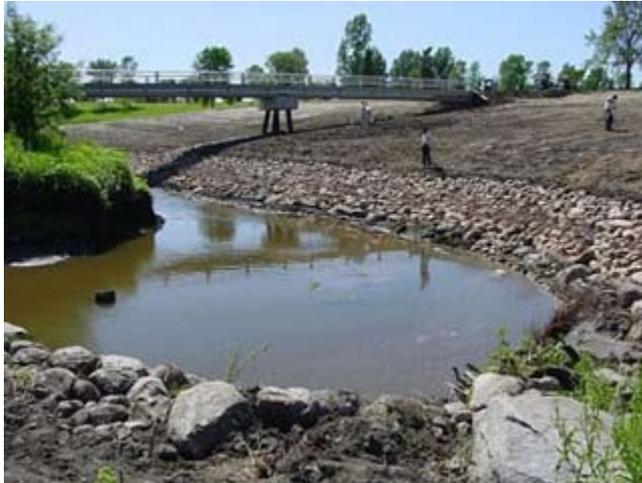
Figure CS11-18 Completed stabilization

(a) Looking upstream toward the cart bridge

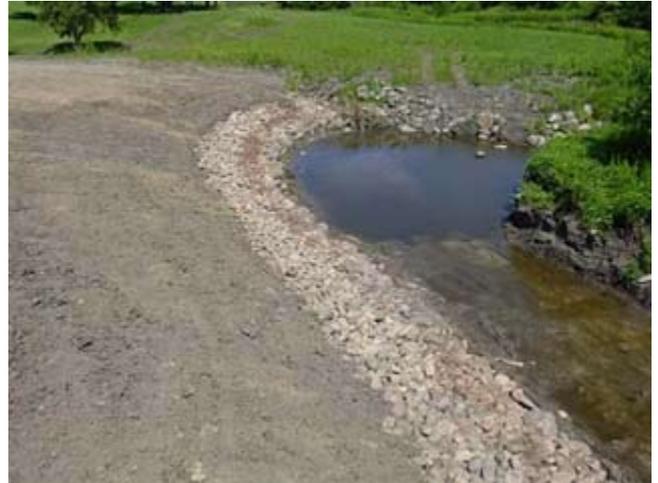
(b) Looking downstream from the cart bridge

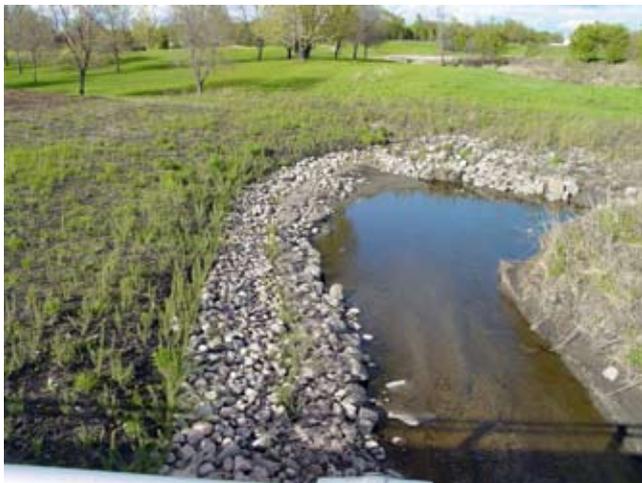
Figure CS11-19 Slope stabilization and soil bioengineering project in May of 2004

Repairs to the site appear to be functioning well; the vegetation is flourishing, channel erosion is limited, and the rotational slope failure is stable (fig. CS11-19).

(a) Looking downstream into the meander

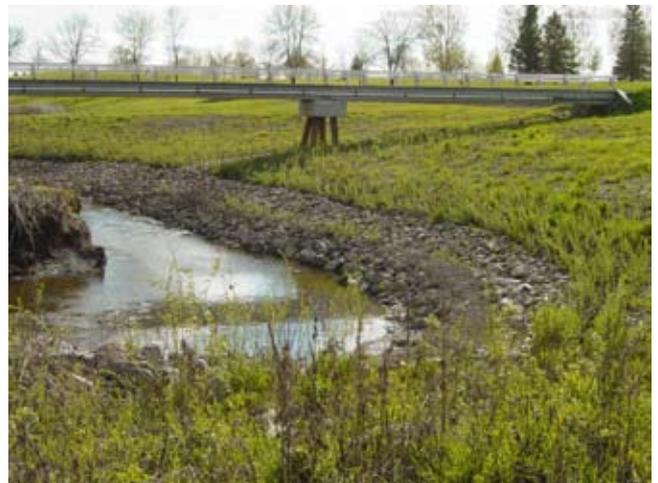
(b) Looking upstream toward the new golf cart bridge
