Case Study 11

Streambank Stabilization in the Red River Basin, North Dakota

Issued August 2007

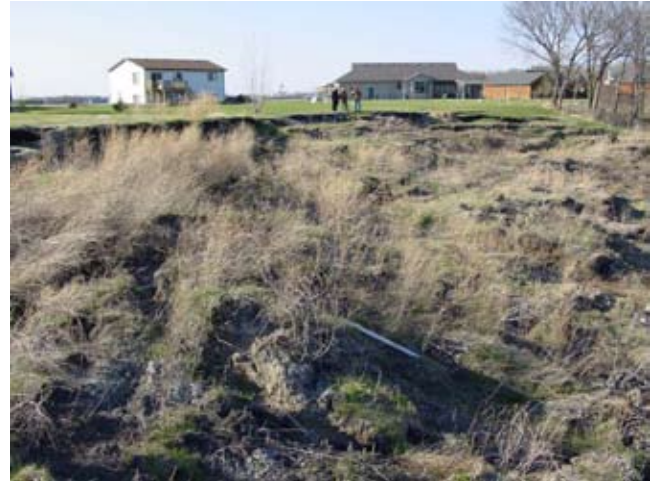
These clay soils cause significant geotechnical problems, especially where they are unconfined. Because of the low-gradient and underfit nature of rivers in the valley, sinuosities are very high (>1.5), creating meanders with a very low radius of curvature. In tight meanders, higher velocity flows are forced against the outside of the channel, eroding the slope toe and steepening the bank. This natural process leads to frequent slope failures along the Red River and its tributaries. The two most common types of slope failure are rotational slumps and flow slumps (fig. CS11-3), with creep and earth flows occurring to a lesser extent.

(b) Flow slump failure near Wild Rice, ND

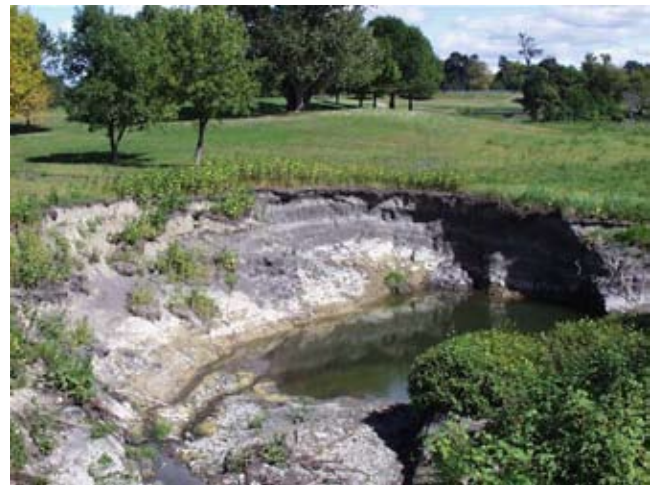
The narrowing of the channel at this point increased flow velocities, causing accelerated bank and channel scouring downstream (fig. CS11-8). A survey of the slump area showed the channel banks to be as steep as 2H:1V or greater and the slope grade to average

Figure CS11-8 Looking downstream on Cole Creek at the scour erosion caused by the narrowed channel

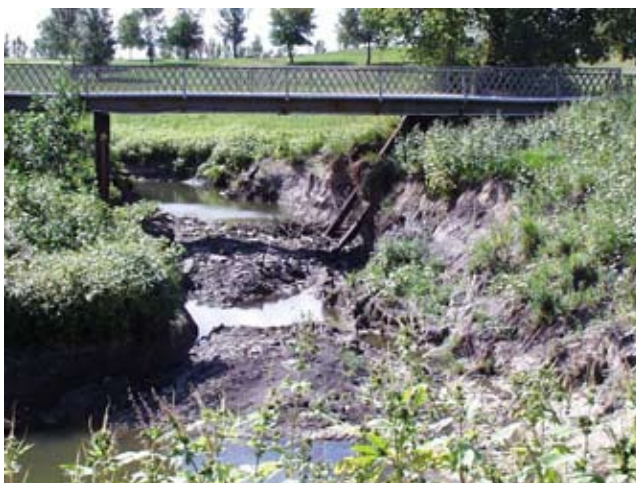
Evidence of the slumping that had damaged the golf cart bridge was visible in aerial photographs as early as 1997 (fig. CS11-6). As the 330-foot-long rotational failure settled toward Cole Creek, it unearthed the wooden bridge pilings, narrowed the creek channel, and raised the channel bottom (fig. CS11-7).

Figure CS11-7 Looking upstream on Cole Creek at the GFCC Cart Bridge (old)

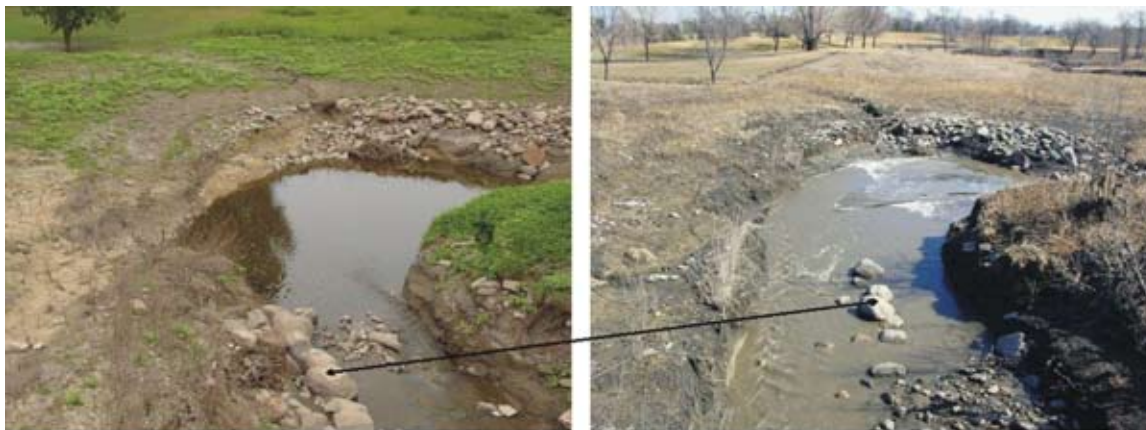
had been washed away or slipped into the channel (fig. CS11-14). Portions of the fascine and entire rootwads had been pulled from the bank. Without toe protection and sufficient counter-balancing weight, the saturated slope began to move, rotating 2 feet and narrowing the channel by 4 feet. The force of the rotation had even bent the bridge piers that were set 80 feet into the clay.

Figure CS11-14 Views of Cole Creek looking downstream from the new cart bridge

(a) Arrows indicate the same rocks in the stream

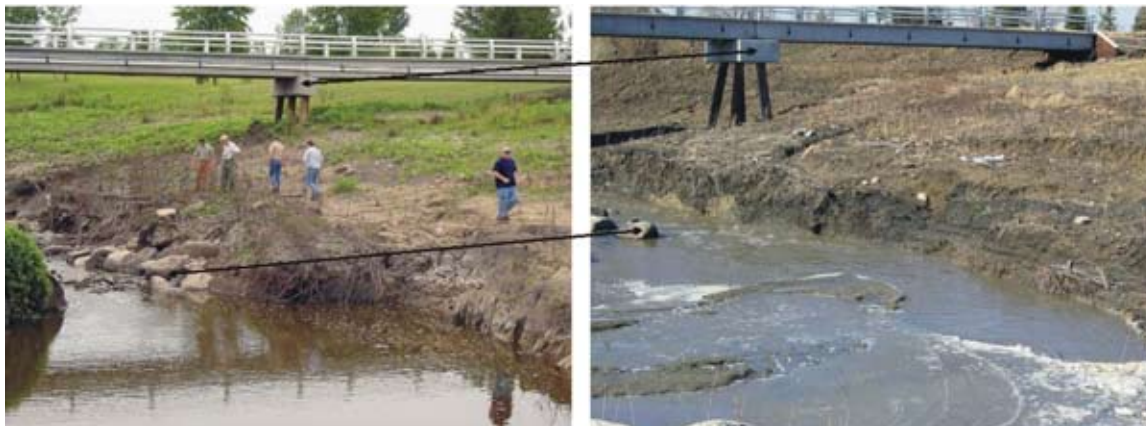
(b) Views of Cole Creek looking back upstream towards the bridge

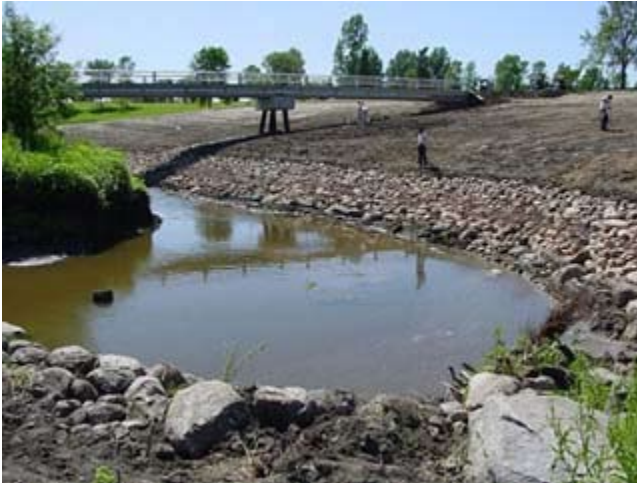
Figure CS11-18 Completed stabilization

(a) Looking upstream toward the cart bridge

Construction began in early June 2003 and was completed within 10 days (figs. CS11-16 through CS11-18). A nearly 10H:1V grade was achieved by removing material from the top of the slope, as well as placing fill above the rock toe. Total cost for the repairs was nearly \$26,000, bringing the grand total for the site to \$59,400. Table CS11-1 shows a breakdown of the

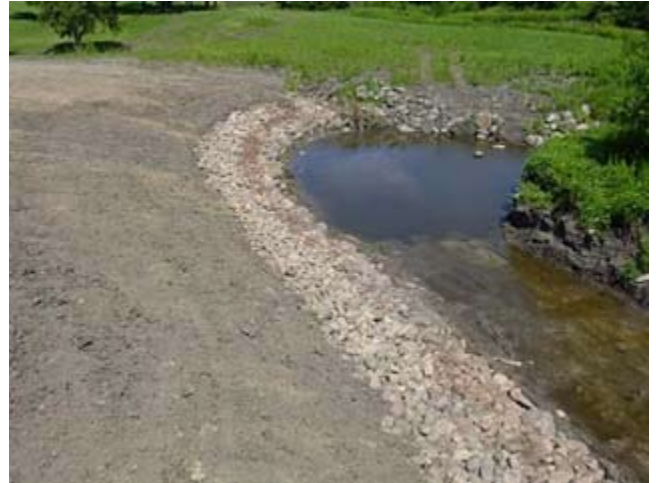
(b) Looking downstream from the cart bridge

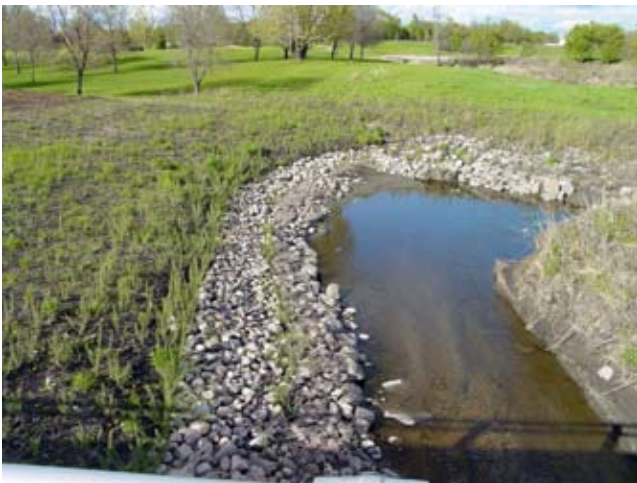
Repairs to the site appear to be functioning well; the vegetation is flourishing, channel erosion is limited, and the rotational slope failure is stable (fig. CS11-19).

Figure CS11-19 Slope stabilization and soil bioengineering project in May of 2004

(a) Looking downstream into the meander

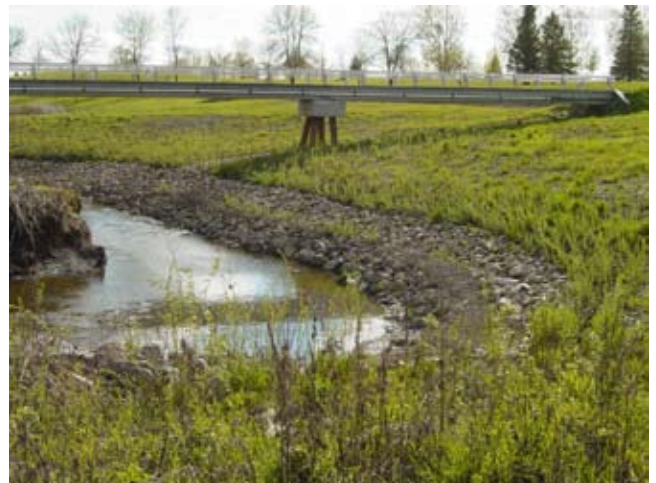
(b) Looking upstream toward the new golf cart bridge
