## Case Study 13

## Owl Creek Farms, North Branch of the Kokosing River, Knox County, Ohio

Issued August 2007

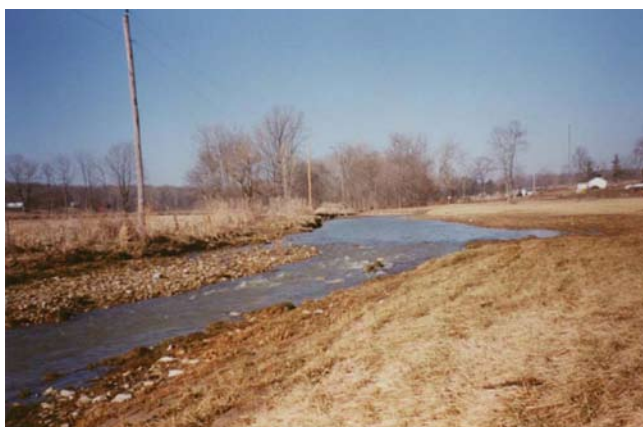
**Figure CS13-1** Owl Creek—before

The drainage area above the site is about 10 square miles, and the substrate is predominantly gravel. The stream slope is relatively low (0.4%). The original bank condition was fair to poor, with erosion concentrated on the outside meander bends. Little vegetation was present along the banks (<10-ft corridor width). The bankfull channel width at riffles was 20 to 25 feet, and the mean bankfull depth at riffles was about 2 feet.

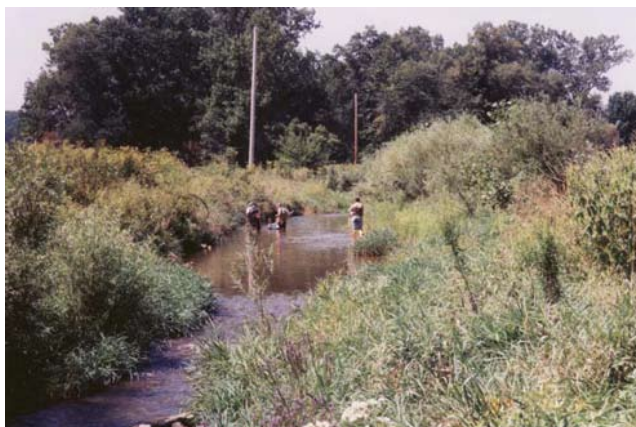
**Figure CS13-2** Owl Creek—after

In the third year of monitoring, the project is meeting or exceeding stated goals for fish and macroinvertebrate community quality, habitat quality, and vegetation survival. The vortex rock weirs, bank stabilization measures, live willow plantings, and mowing and grazing restrictions all have performed better than expected. The least successful feature of this project was the survival of riparian tree seedlings. The tree seedlings should have been better protected from competition, or not planted at all, to allow natural succession to occur.

The vortex rock weirs performed better than anticipated in creating scour pools and attracting fish and macroinvertebrates. Of key importance was the skillful installation of anchor rocks that were well keyed into the bank. The property owner was a skilled equipment operator. The live willow stakings were very successful in stabilizing banks, improving cover, and even providing some shading benefits in the first growing season. Simply ceasing mowing and precluding grazing next to the stream are effective aquatic habi-

No channel reconstruction was undertaken for mitigation. Existing postchannelization alignment was stabilized in place, and vortex rock weirs and plantings were added. No in-depth hydraulic analyses were conducted. Weir locations were determined in the field.
