Case Study 14

**Streambank Stabilization in the
Merrimack River Basin,
New Hampshire**

Issued August 2007

By Ghislan Brunet, Maccaferri, Bioengineering and Ecological Systems, Maryland

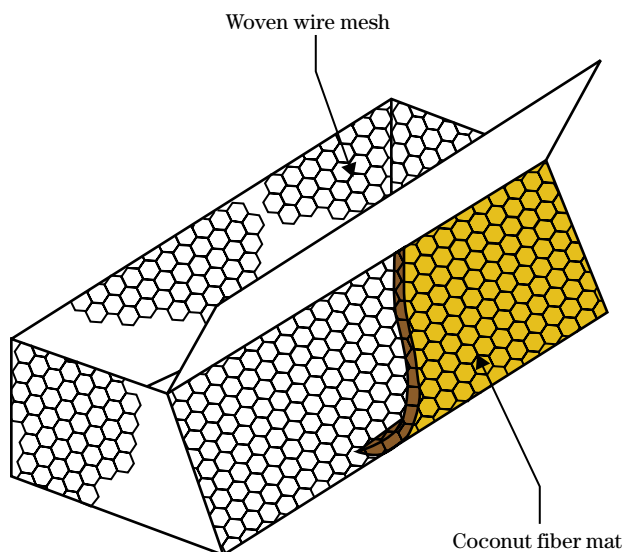
Figure CS14-4 Green Gabion[®] schematic

The selection of appropriate materials was very important to the environmental aspects of this project so that the final installation would be integrated into the surrounding environment. Two new types of products were selected that offer strength, resistance, and natural integration. Green Gabion[®] (fig. CS14-4) is a trapezoidal-type of gabion with an inclination angle of 60°, lined with 900 grams per square meter (26.5 oz/yd²) coconut mat in the facing. The unit is 2 meters (6.5 ft) long, 1 meter (3.25 ft) wide, and 0.5 meter (19 in) high. Envirolog[®] is a cylindrical type of gabion lined with 900 grams per square meter (26.5 oz/yd²) coconut mat. Both types of product used in this project are made of PVC-coated woven wire mesh. To ensure durability of the structure, all wire is galvanized and PVC-coated before being transformed in mesh. The flexibility and strength of the double-twisted mesh are very important. The flexibility of the mesh allows the units to adapt to the profile of the bank even after any subsequent settlement.

To retain the topsoil in the units for vegetation, a thick layer of coconut mat is lined inside the wire mesh basket (figs. CS14-4 and CS14-5).

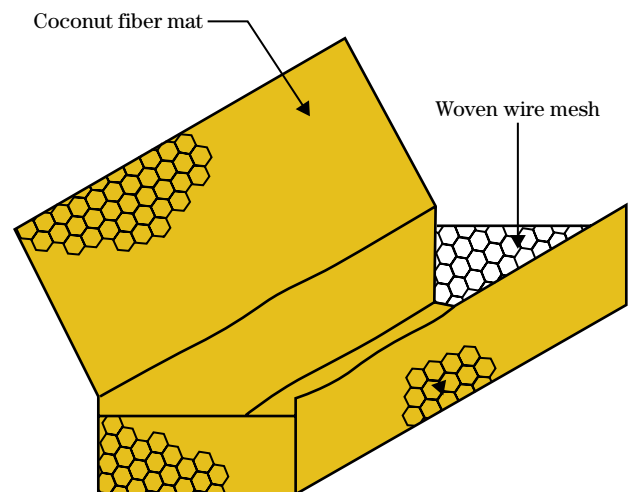
Figure CS14-5 Coconut fiber was used to line gabion baskets to retain soil for vegetation growth.

The coconut mat, with a durability of 3 to 5 years before its biodegradation, helps to maintain the topsoil's moisture for the vegetation.

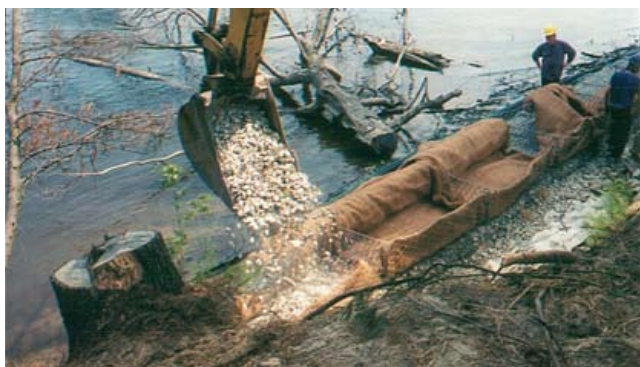
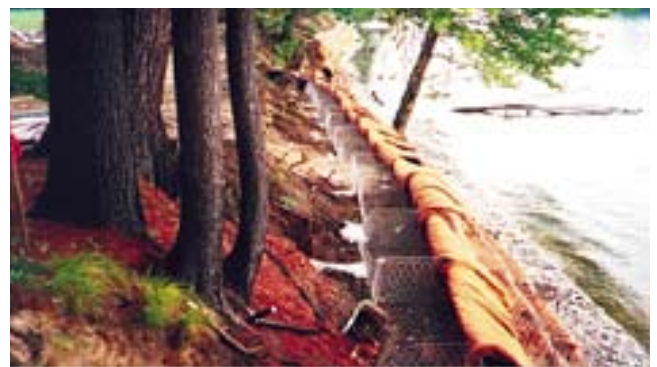
Figure CS14-8 Installed gabion baskets lined with coconut fiber mat and filled with stone and topsoil

After being placed and secured together, the units were filled with stone and topsoil (fig. CS14-8). The lower sections, which are more exposed to the wave action, first were filled with stone followed by topsoil to fill the voids. Filled in this way, the bottom units were getting a higher percentage of stone to prevent loss of topsoil with time. The upper section was filled with stone and topsoil already mixed together before being placed in the units.

In general, the project work was done as per the specification for the assembly and installation of the units. Because of the limited budget, a full-time inspector on the project was not possible. Some small problems could have been prevented with an inspector on the site, considering that the contractor did not have a lot of experience with gabions. In particular, there was a problem with the size of the stone being too small in the Reno[®] Mattresses used for toe protection. Some stones have already come out of the mattress after 1 year. These mattresses should be opened and refilled with proper sized stone.
