**Case Study 14**

**Streambank Stabilization in the  
Merrimack River Basin,  
New Hampshire**

*By Ghislan Brunet, Maccaferri, Bioengineering and Ecological Systems, Maryland*

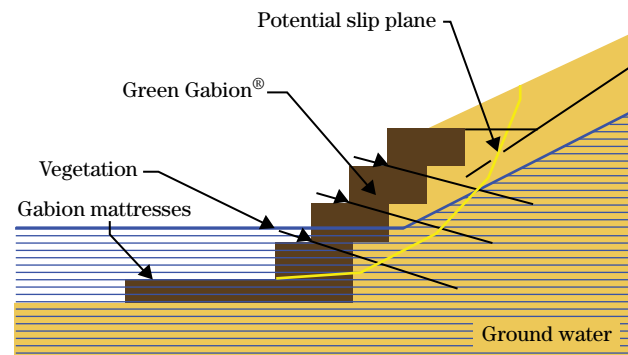
The slope stability analysis, done immediately after installation, resulted in a safety factor of 1.55 for global stability and 4.02 for internal stability (fig. CS14-1). The impact of the vegetation on slope stability was determined based on measured shear resistance of willow roots. The shear resistance of a 3-year-old willow can have an ultimate shear stress of 9.1 kilonewtons per square meter ( $\text{kN/m}^2$ ) ( $191 \text{ lb/ft}^2$ ) (Goldsmith 1996). The reinforcing root length was considered to be 2 meters (6 ft) deep. To represent the root reinforcement in the structure, the density of the vegetation was considered at 30 centimeters (1 ft) spacing between each plant for each row of units.

The analysis of the impact of vegetation on slope stability was performed using the shear resistance of a willow after 3 years of growth. A reduction factor of 3 was applied to the ultimate strength to represent the uncertainties of the growing vegetation. A shear resistance of 3.0 kilonewtons per square meter ( $63 \text{ lb/ft}^2$ ) was used in the calculation. With the contribution of the vegetation, the internal stability of the structure (fig. CS14-1) gave a safety factor of 4.55 and a global safety factor of 1.55. The internal stability of the slope may increase 10 percent after the establishment of the vegetation. This last analysis was considered as information only and not for the design stability analysis. The global stability was not affected because the potential slip plane did not pass through the vegetation.

**Figure CS14-1** Slope stability analysis of design

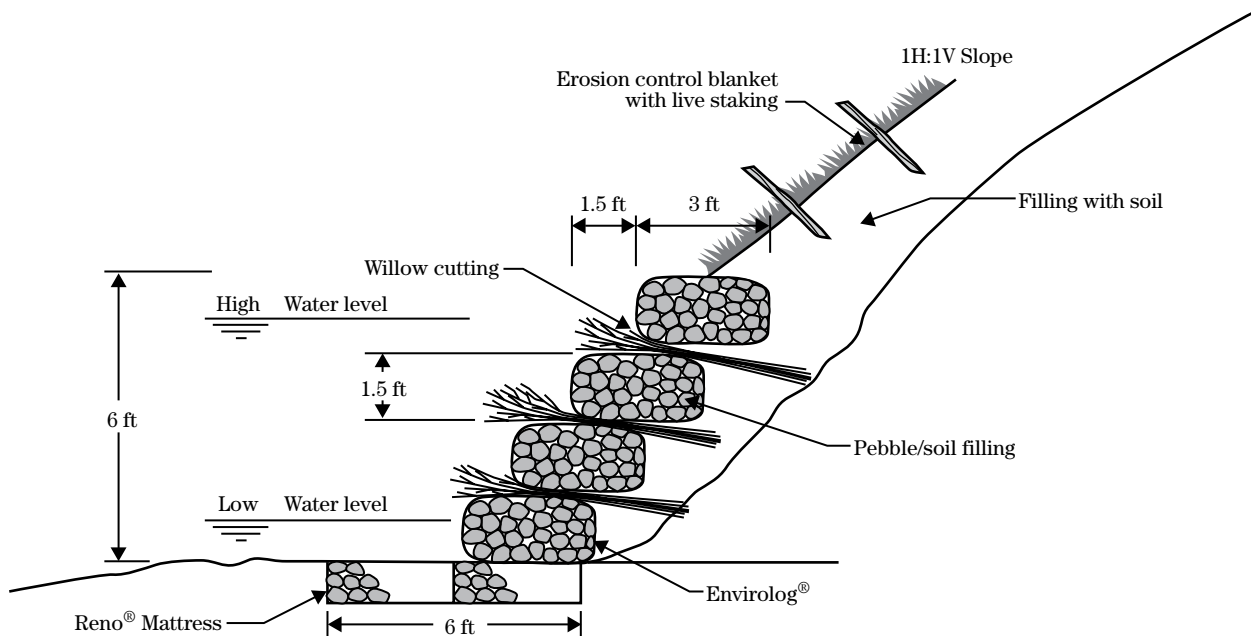
To prevent any potential scour under the structure, a Reno<sup>®</sup> Mattress of 30 centimeters (12 in) by 1.9 meters (6 ft) was installed at the base of the units, with an extension of 1 meter (3 ft) streamward to stop any erosion (figs. CS14-2 and CS14-3).

**Figure CS14-2** Reno<sup>®</sup> Mattress, gabions, and vegetation form a stable streambank design

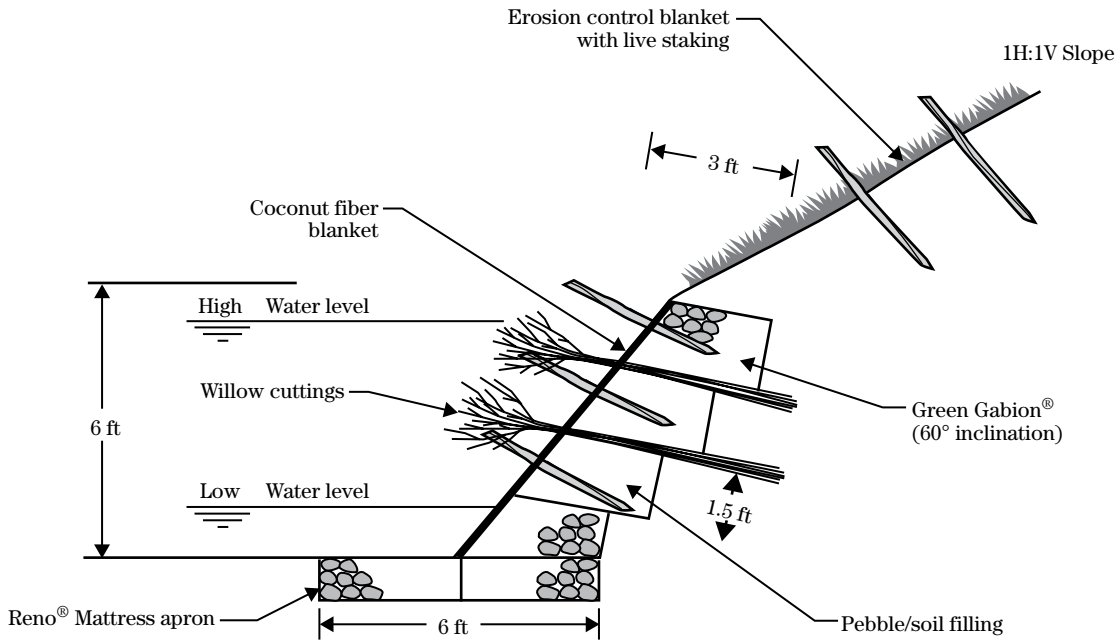
**Figure CS14-3** Reno<sup>®</sup> Mattress used with vegetation to create a stable slope

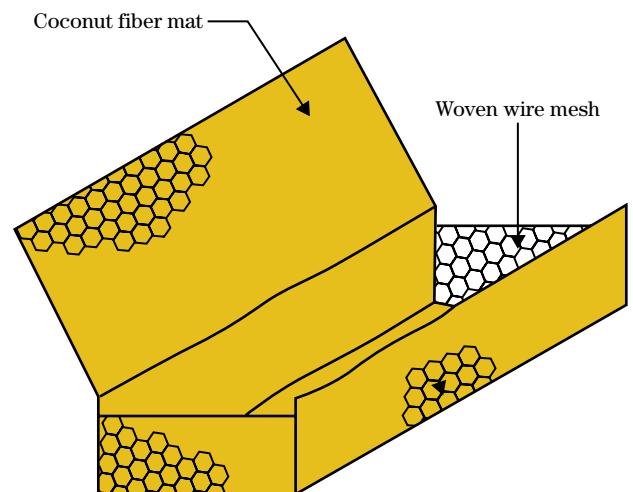
To retain the topsoil in the units for vegetation, a thick layer of coconut mat is lined inside the wire mesh basket (figs. CS14-4 and CS14-5).

**Figure CS14-5** Coconut fiber was used to line gabion baskets to retain soil for vegetation growth.

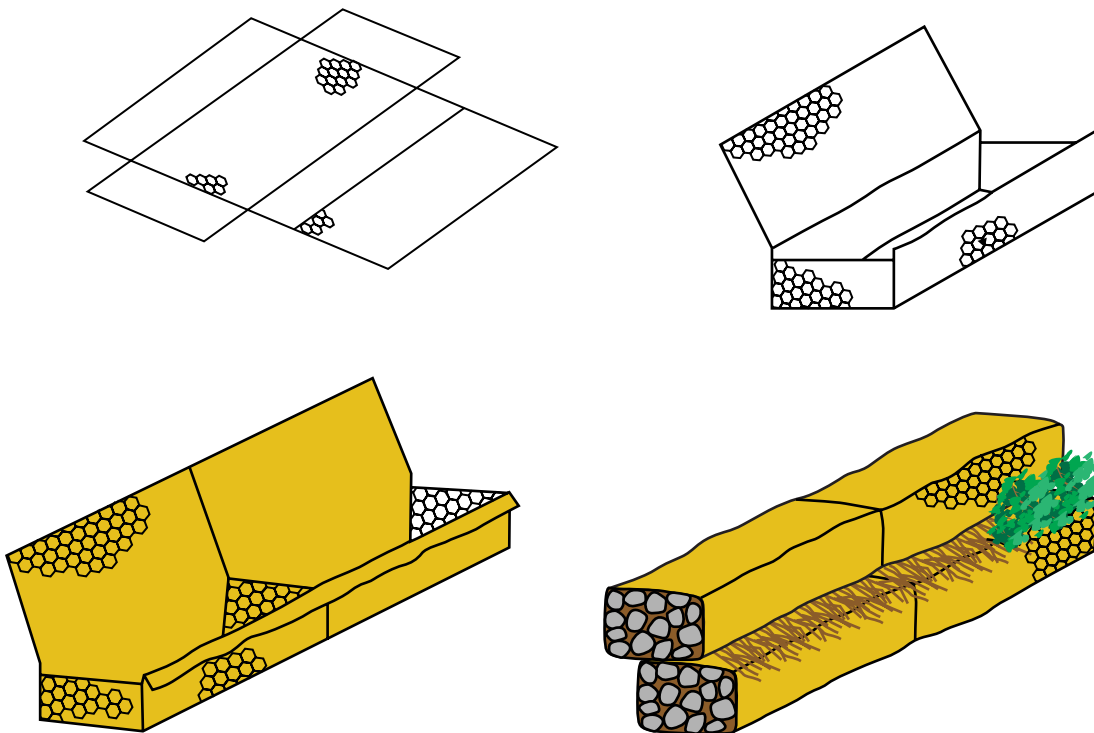
The units were preassembled as a box and lined with the coconut mat before being placed on the site (figs. CS14-6 and CS14-7).

**Figure CS14-6** Green Gabions® preassembled with coir fiber mat

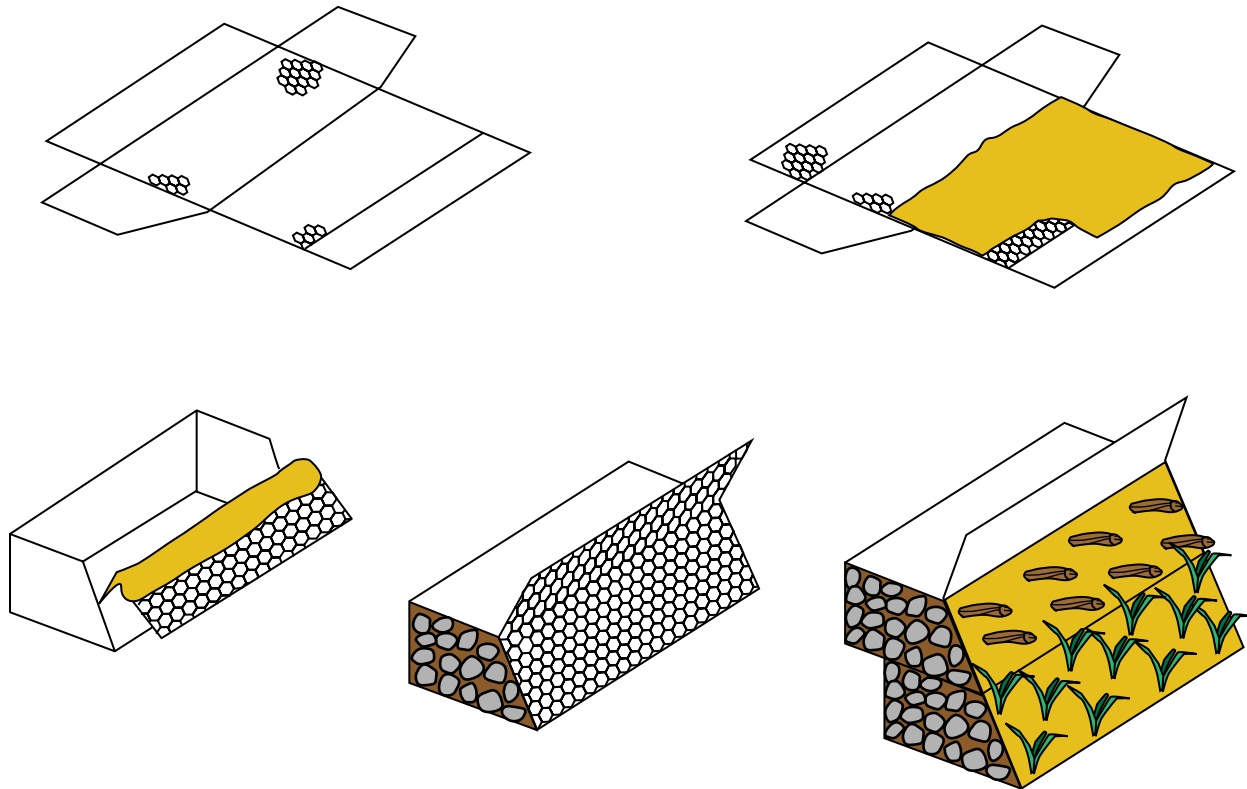
**Figure CS14-7** Green Gabions® preassembled with coir fiber mat

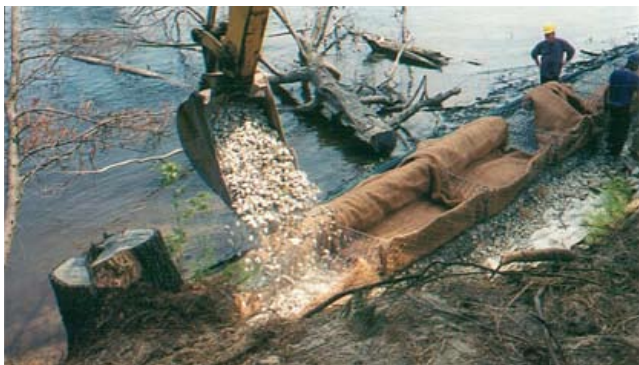
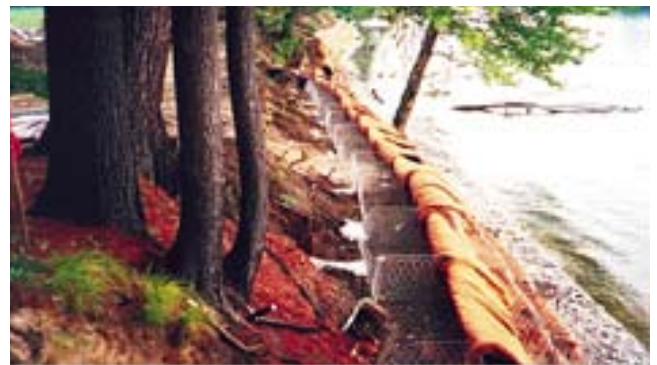
After being placed and secured together, the units were filled with stone and topsoil (fig. CS14-8). The lower sections, which are more exposed to the wave action, first were filled with stone followed by topsoil to fill the voids. Filled in this way, the bottom units were getting a higher percentage of stone to prevent loss of topsoil with time. The upper section was filled with stone and topsoil already mixed together before being placed in the units.

**Figure CS14-8** Installed gabion baskets lined with coconut fiber mat and filled with stone and topsoil

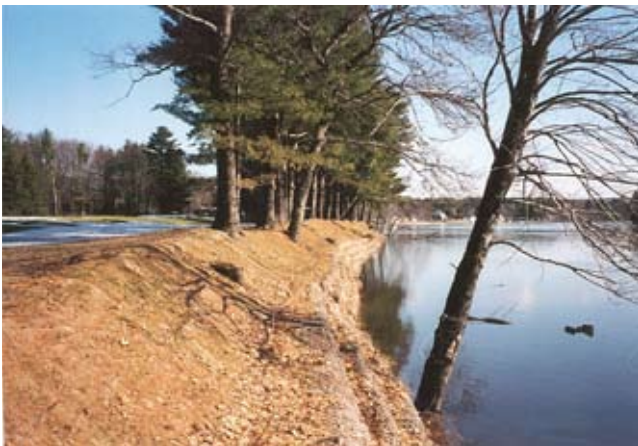
where the plants were too small or not properly placed during the installation have some problems with establishment in the structure. Figures CS14-9 and CS14-10 show the progression of the growth of vegetation. Figure CS14-9 was taken in the spring, and figure CS14-10 in the midsummer of the first growing season. The modified gabions used on this project combined with thick coconut blanket can resist erosion for 3 to 5 years before seeing any degradation of the coconut blanket. Live staking was recommended by the designer to enhance vegetation where it was missing.

**Figure CS14-9** Project in spring after initial installation

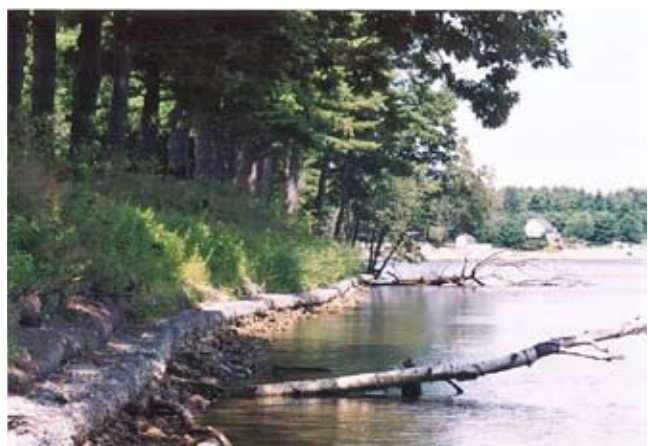
**Figure CS14-10** Completed project in midsummer after installation
