Case Study 15

**Streambank Stabilization in the
Guadalupe River Basin,
Santa Clara County, California**

Streambank Stabilization in the Guadalupe River Basin, Santa Clara County, California

*By John McCullah, Watershed Geologist,
CPESC, and Kaila Dettman, Watershed Hydrologist
of Salix Applied Earthcare*

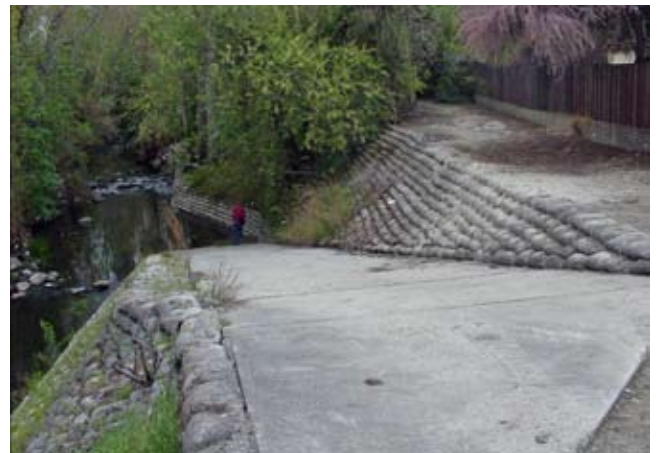
The original restoration work involved removing the damaged concrete access ramp and the sack concrete wall (fig. CS15-1) and replacing the structures with more habitat-friendly treatments. Restoration of the streambank included complete removal of the access ramp. Biotechnical techniques were installed on

Figure CS15-1 Damaged access ramp and wall

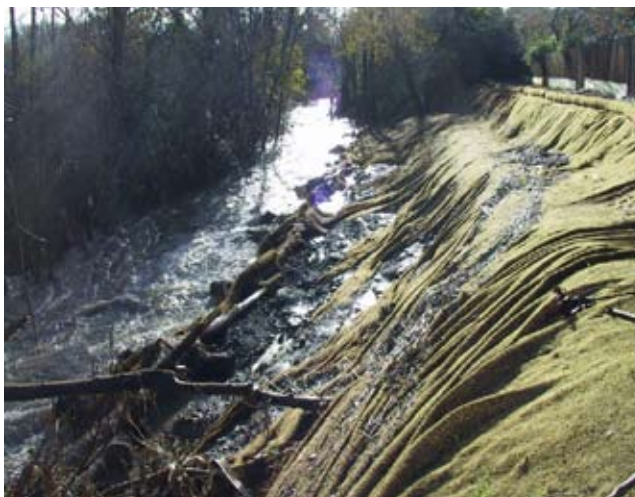
During December 2002, the first winter following project completion, a significant storm event occurred with a 5-year return frequency. The coir netting was severely damaged, and the underlying fill on the toe and midslope of the streambank was undercut and washed away (fig. CS15-3). The logs at the toe of the slope remained in place, yet extensive scour occurred around the structures (fig. CS15-4).

Hydraulic analysis indicated that the river reached velocities of 6 feet per second, developed shear forces of approximately 1 pound per square foot, and was at least 17 feet deep during the storm. The question was whether the failure was due to shear forces too great for the geotextile material or due to improper installation.

Figure CS15-3 Damaged streambank following a 5-year frequency event in December 2002

The authors determined that the blankets had been installed incorrectly because the application had been applied based on the principles of slope stabilization, not channel stabilization. Channel installation requires that blankets be oriented parallel to the flow and include anchor slots (fig. CS15-7). Prior to coir

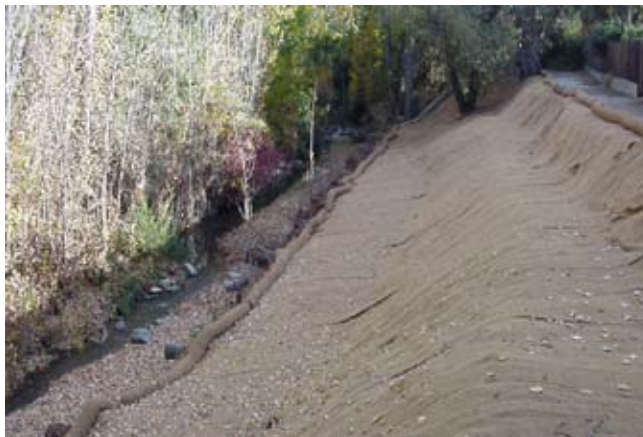
Installation proceeded as planned in fall of 2002 (fig. CS15-2). Log structures were keyed into the toe of the slope to provide anchoring and stability. Blankets made from coir netting (900 g/m^2) were laid out vertically along the slope (or perpendicular to the flow, which was consistent with manufacturer recommendations for slope protection), with coir rolls installed on the top and toe edges of the blanket layer. The blanket was then stapled along the length of each section.

Figure CS15-2 Finished original project in fall of 2002

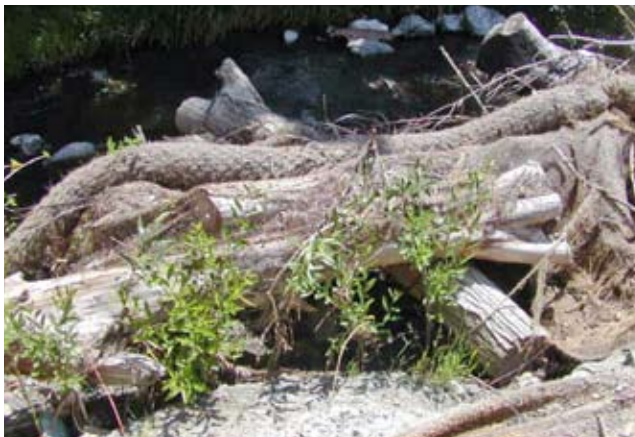
Figure CS15-4 Evidence of scour and exposure of the log structures

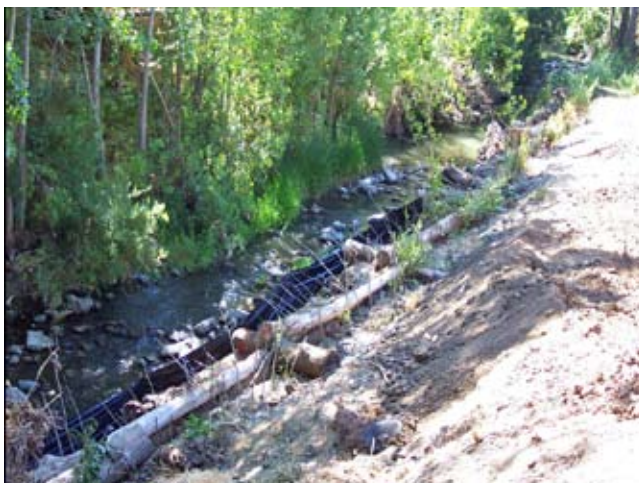
Figure CS15-5 Live siltation installation

Live siltation is a technique in which willow cuttings are arranged in bunches to provide roughness and encourage sediment deposition. Willow cuttings were

staked into the soil and rock above and within the log structures at the toe of the bank (fig. CS15-5). Deep, voided areas from the previous erosion allowed the stakes to be planted without digging. Willows are capable of withstanding periodic inundation and high velocity flows, and the roots help anchor the toe, while surface vegetation provides shading and habitat.

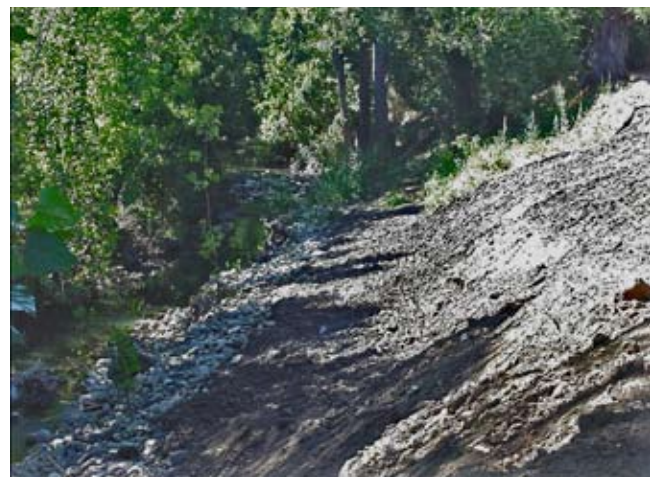
Figure CS15-6 Cobble placement following the live siltation installation

The use of stone was prohibited due to new policies that allowed only “green” solutions within the watershed. The recommendation that cobble be installed was met with resistance; however, regulatory personnel were reassured that cobble would provide natural habitat and aesthetic value while improving channel integrity. Following the installation of the willows, cobble was placed on the toe of the slope to armor the bank and provide initial support for the willows during establishment (fig. CS15-6). Rounded cobble was used and fit in with the appearance of the river while providing the stability needed at the toe of the bank.

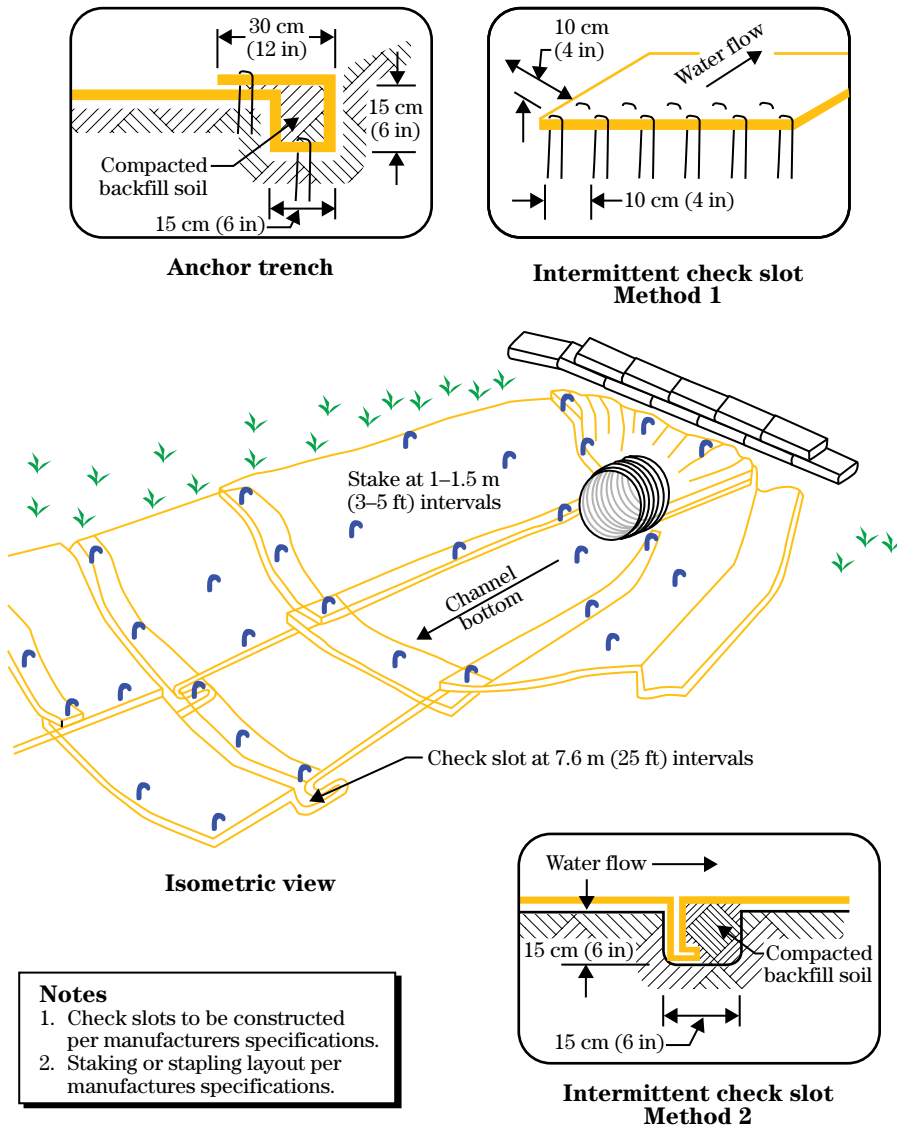
Figure CS15-7 Erosion control blankets channel installation

blanket application, the slope was regraded, top soil was placed on terraces and compacted to 85 percent of optimum density, and mulch and seed were applied hydraulically to the slope. Longitudinal slots (horizontal) and check slots (vertical) were dug into the fill material on the middle and upper portions of the bank to serve as footings for anchoring the blankets and coir logs.

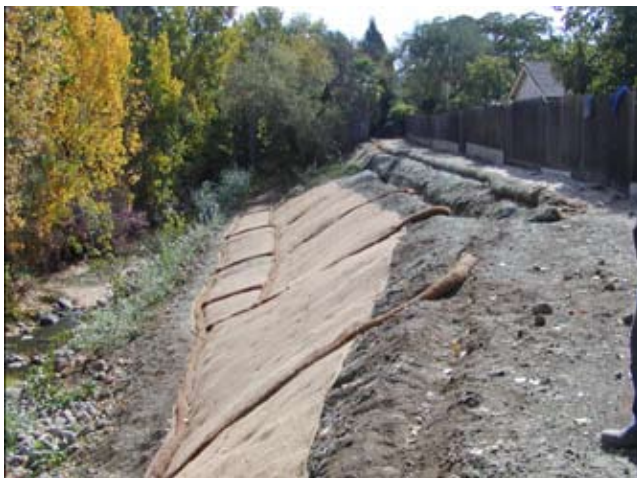
Figure CS15-8 Slope preparation and blanket installation

Materials included 55 coir logs at 6 inches in diameter and 10 feet in length, 7 rolls of GEOCOIR[®]/DeKoWe[®] 900 geotextile blanket, and one 100 #3 rebar J-hook staples (with 18-in legs and 6-in hooks). The coir blankets were rated to withstand velocities of 10 feet per second by the manufacturer. The blankets were installed loosely to allow all fibers to make contact with the soil surface and were laid horizontally along the slope (parallel to the river) to reduce the potential for undermining and dislodging by high flows. The coir logs were installed over the blankets in the previously dug trenches and anchored with the hooked staples on both sides of the coir log. The edges of the blankets were incorporated into small trenches and backfilled to secure the material to the slope (fig. CS15-8). Additional cobble was brought in and incorporated on the toe of the slope following blanket installation, and the project was completed (fig. CS15-9). Container plants were installed later with DriWater[™] packets to provide necessary moisture during the establishment period.

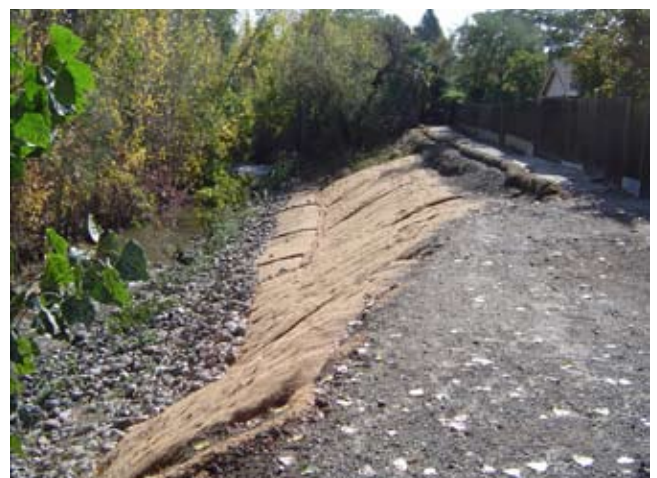
Figure CS15-9 Finished project

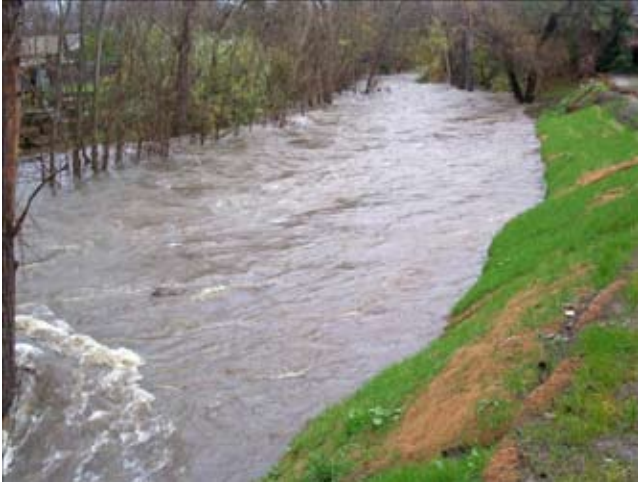
During the winters of 2003 and 2004, the slope remained stable, and the blankets, cobble, and willows stayed in place. Photographs taken during storm

events demonstrated the inundation experienced by the slope during high flows (fig. CS15-10). Following a storm in January 2004, the flow line reached high elevations on the slope and indicated that the restoration work had been successful (fig. CS15-11).

Figure CS15-10 Inundation of the restored slope

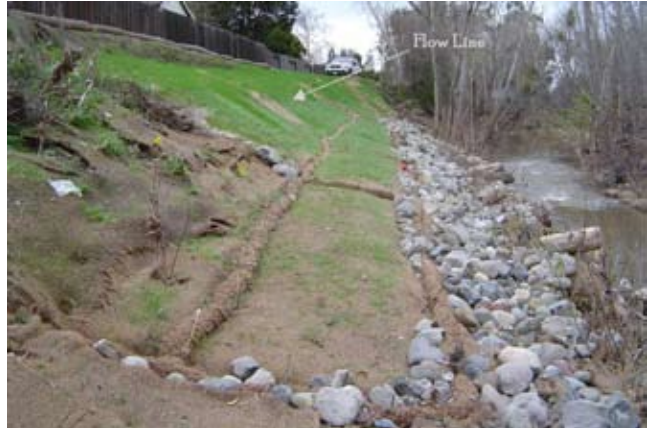
Figure CS15-11 Flow line after a storm in January 2004

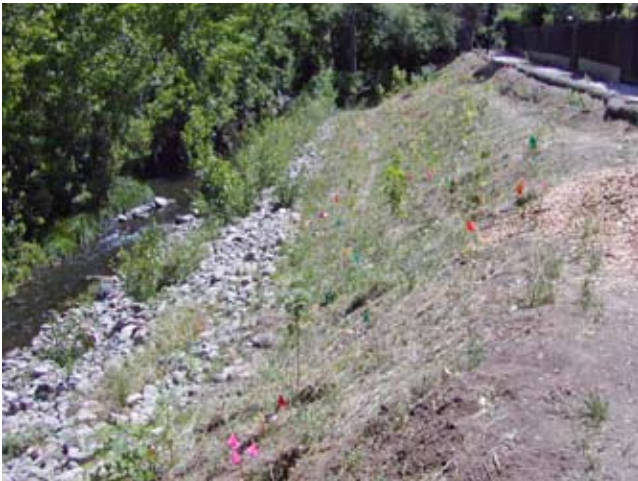
The restoration work performed in 2003 was extremely successful in stabilizing the slope. In April 2004, the bank was becoming vegetated (fig. CS15-12), and the willows were successfully established at the toe (fig. CS15-13). For future projects, plantings should be performed with minimal disturbance to the geotextile blanket (holes cut for the vegetation were quite large and could provide a potential point of undermining). The project emphasized the importance of installing geotextile blankets parallel to the flow of water within channels where inundation will occur. Combining techniques such as cobble revetment, live staking, pole planting, live siltation, hydroseeding, and coir blankets provided the stability, habitat, and aesthetic value needed for the site.

Figure CS15-12 Revegetated slope 1 year later

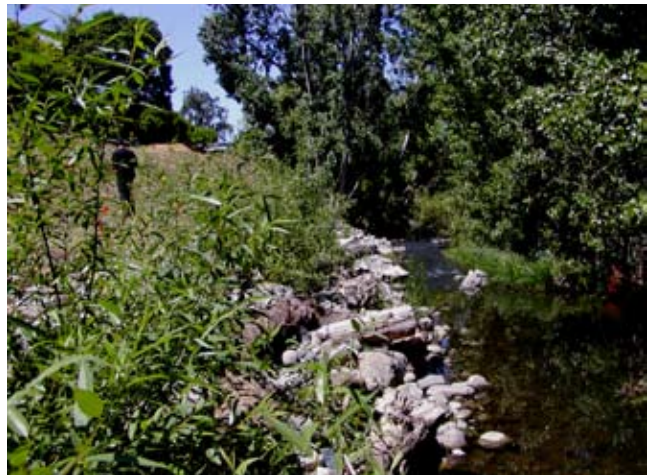
Figure CS15-13 Willow establishment at the toe
