Cover photo: Treated section of Coffee Creek in Edmond, Oklahoma

Case Study 16

Coffee Creek, Edmond, Oklahoma

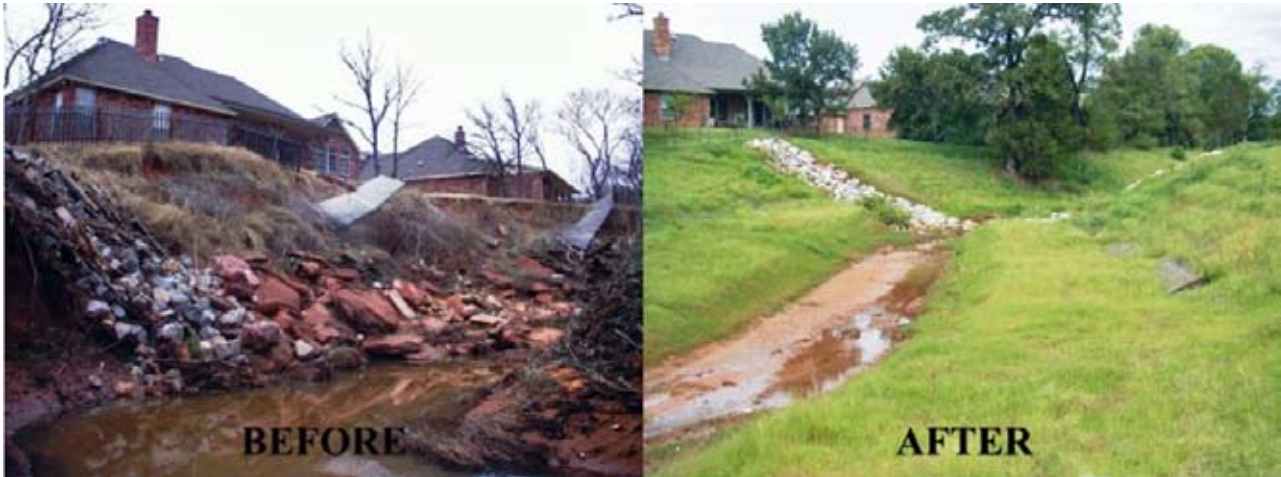
Figure CS16-9 Eroding channel prior to construction, and after project implementation; house and property lines imposed restrictions on the design

Project construction began in October 2002 and was substantially complete in August 2003. The project has been subjected to several significant postconstruction runoff events including an event that inundated the flood plain bench. Vegetation has begun to establish, and the channel is stable. As expected, the low-flow channel has begun to change shape and alignment. In a few locations, the low-flow channel has migrated to, and exposed, the buried riprap toe. The excessive erosion and scour, lateral migration, and general widening of the channel have ceased. The channel banks are stable, and the infrastructure has been protected. The project will continue to be monitored to help assess and document long-term performance of the design elements. Figures CS16–9 through CS16–11 show a comparison of preconstruction photos and photos taken after construction was substantially complete.

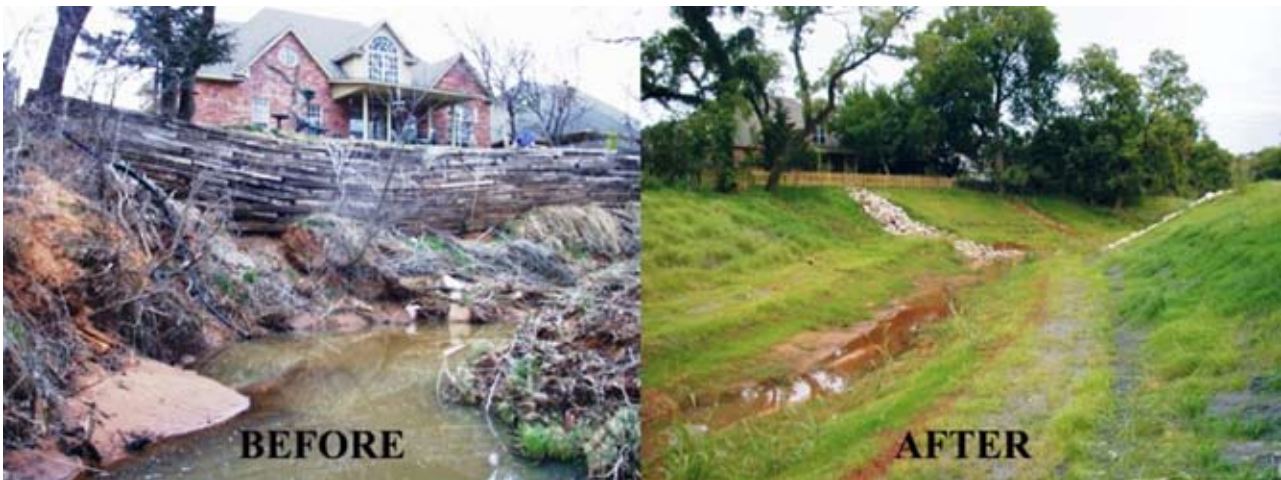
Figure CS16-10 Eroding channel prior to construction, and after project implementation; house and property lines imposed restrictions on the design
