## Case Study 16

## Coffee Creek, Edmond, Oklahoma

*Robert P. Armstrong, P.E., Senior Project Manager, Huitt-Zollars, Inc., Dallas, Texas; William D. Armstrong, P.E., RPLS, Senior Director of Development and Marketing, BWR Corporation Inc., Bartlesville, Oklahoma; Mark L. Johnston, P.E., Project Manager, BWR Corporation Inc., Oklahoma City, Oklahoma; Nancy L. Kennedy, Flood Plain Administrator, City of Edmond, Oklahoma*

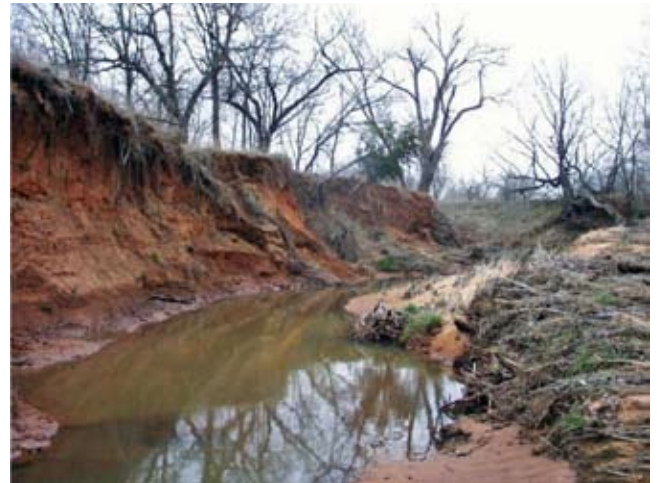
Coffee Creek is a deeply incised channel with a width/depth ratio of less than 5H:1V. The entrenchment ratio for this reach of Coffee Creek, the ratio of flood plain width to channel width, is approximately 2H:1V. Coffee Creek is a highly meandering stream and has undergone active lateral migration leading to a high degree of instability (figs. CS16-3, CS16-4, and CS16-5.) The channel cross section is highly irregular. Near vertical banks have developed in several locations. Previous attempts to prevent lateral migration through the use of riprap and retaining walls have been unsuccessful.

**Figure CS16-4** Streambank erosion prior to the project

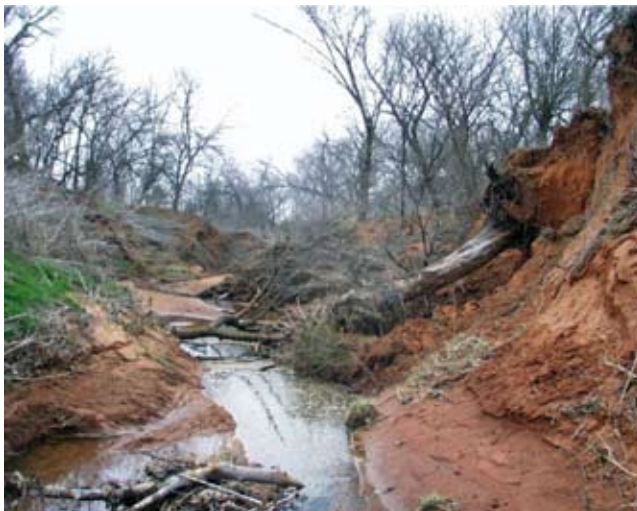
The soils throughout most of the project reach are highly erodible. Bank slopes are comprised typically of sandy clay and sandy loam. Bed material is mainly a sandy loam. A few areas of the bed are comprised of fat clay (highly plastic) with low erodibility. The ordinary high water depth is approximately 2 to 3 feet. Vegetation above the ordinary high water mark and within the channel is not well established due to the high degree of lateral instability. Limited riparian habitat exists outside of the main channel.

**Figure CS16-3** Streambank erosion prior to the project

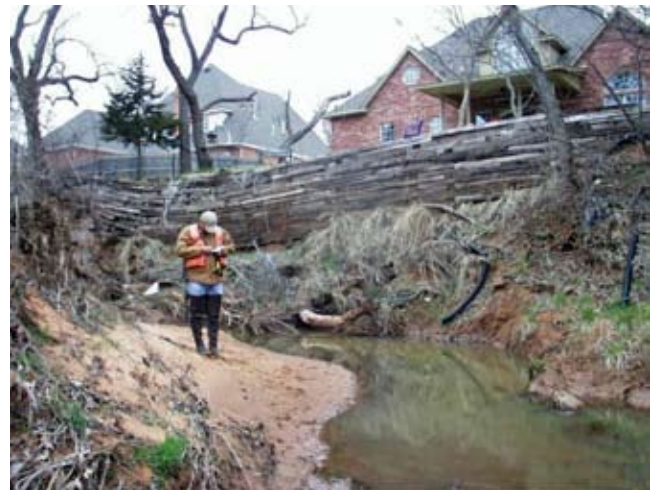
**Figure CS16-5** Proximity to infrastructure imposed restrictions on design approaches

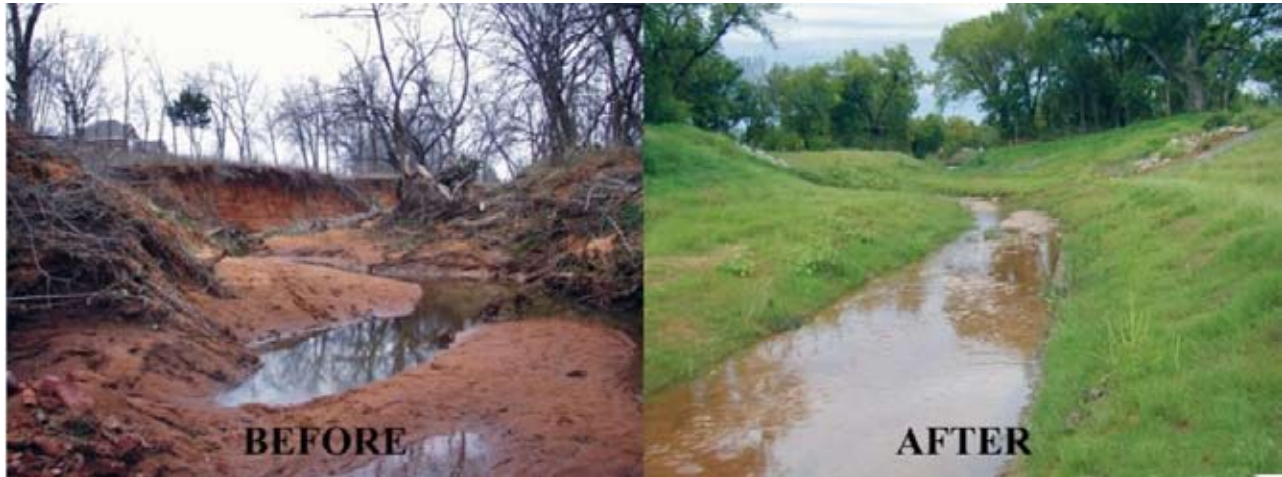
**Figure CS16-11** Eroding channel prior to construction and after project implementation
