*By Sean Welch, state hydraulic engineer, U.S.
Department of Agriculture, Natural Resources
Conservation Service, Portland, Oregon*

Introduction

The Wiley Creek Streambank Protection Project in Linn County, Oregon, was designed in 2003 and 2004 by the U.S. Department of Agriculture (USDA) Natural Resources Conservation Service (NRCS), Oregon State Office. The project goals included the protection of two structures located 5 feet from the edge of a 23-foot-high vertical bank, bank stabilization, and fisheries habitat improvement.

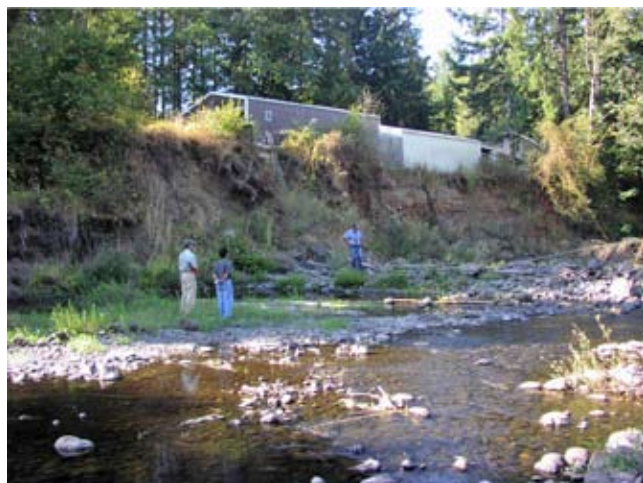
Figure CS18-1 Preproject riverbank along Wiley Creek, December 2003. Note location of buildings at the top of bank.

bank with two structures approximately 5 feet from the top edge of the bank (fig. CS18–1). Anecdotal information from the landowner and analysis of historical photographs indicated that the river's left bank had eroded more than 40 feet since the rain-on-snow flood event of 1996 (fig. CS18–3).

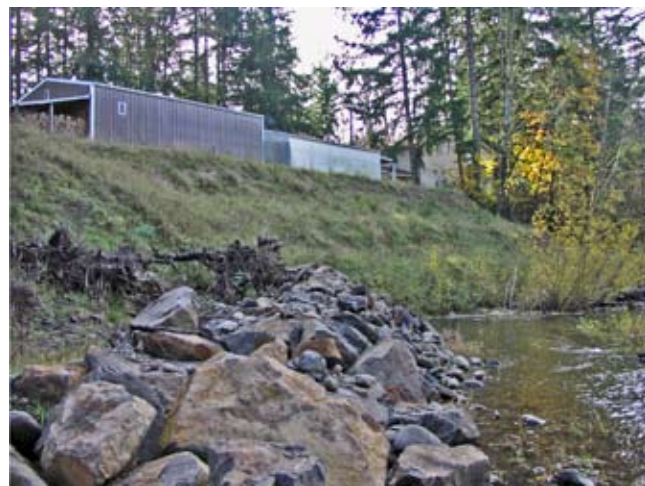
Figure CS18-2 Completed reinforced earth embankment, stream barb, and bank vegetation 1 year following construction

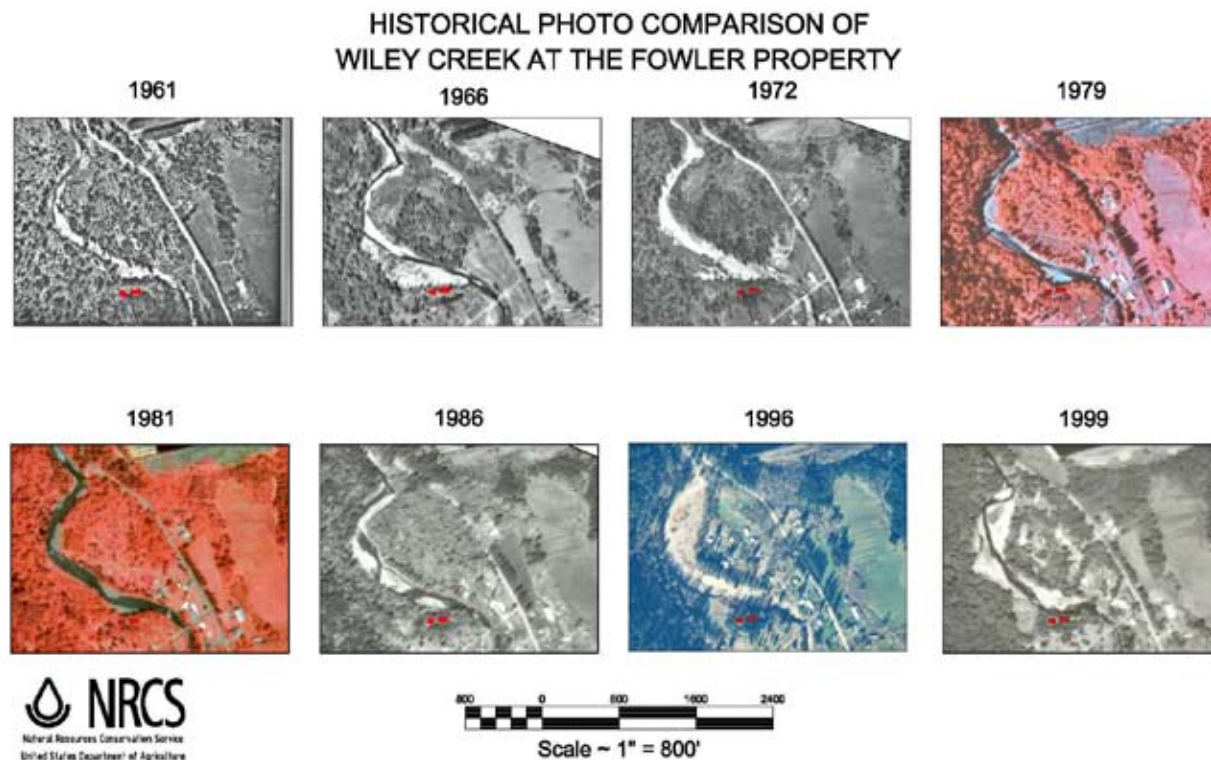
Figure CS18–3 Historical aerial photographs of Wiley Creek along the project reach showing morphologic changes over time

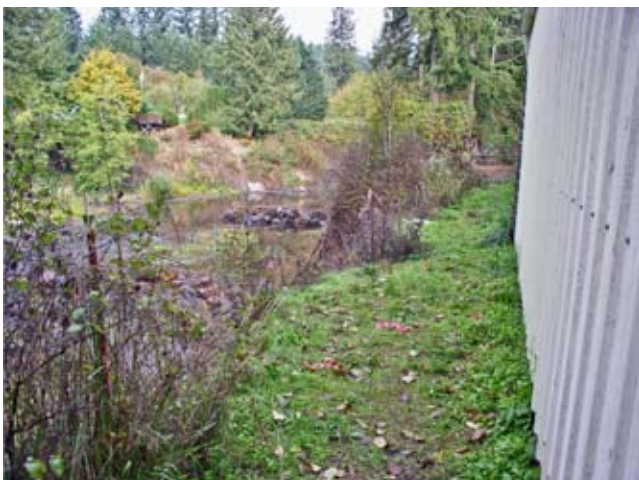
During the initial site reconnaissance, the bank condition was evaluated for both hydraulic and geotechnical stability. The bank had eroded to a near vertical condition and was well beyond the stable angle of repose (fig. CS18–9). Bank stratigraphy consisted of poorly consolidated alluvium (fig. CS18–10). The buildings at the top of bank were an additional destabilizing factor as point loads. The dominant bank failure mechanism was hydraulic stress undercutting the bank with subsequent tension-block failure of the overburden. Rapid drawdown of the saturated soils and positive pore water pressure within the bank also contributed to instability.

Figure CS18–9 Looking upstream at the project bank. Less than 5 feet of bank remained from the building to the edge.

The combination of hydraulic stress, low strength of the earth materials, and loading condition at the top of the bank required a design that would provide free-draining support to the bank, while resisting hydraulic stresses. Preliminary alternatives were identified that included an out-sloped embankment with a rock-reinforced toe or a structural fill section using cellular confinement or reinforced earth.

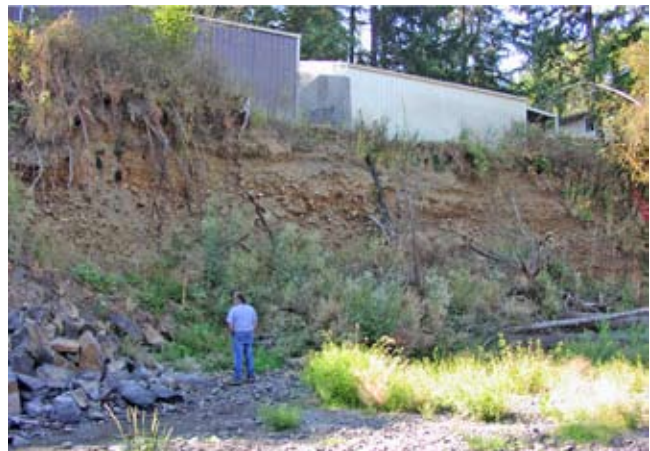
Figure CS18–10 Instream view of project bank. Note vertical condition and poorly consolidated sandy-silt alluvium bank material.

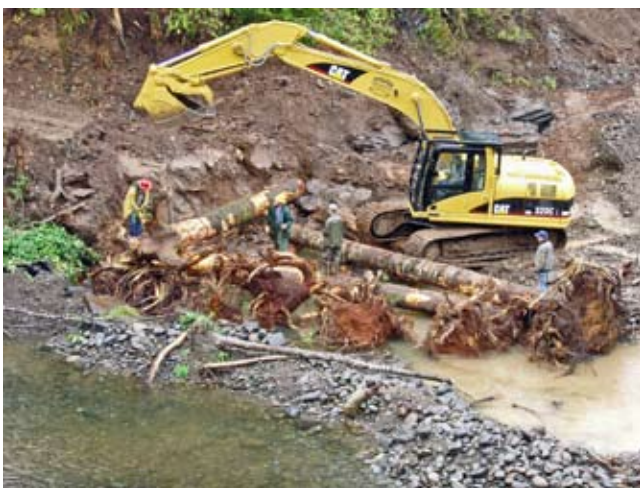
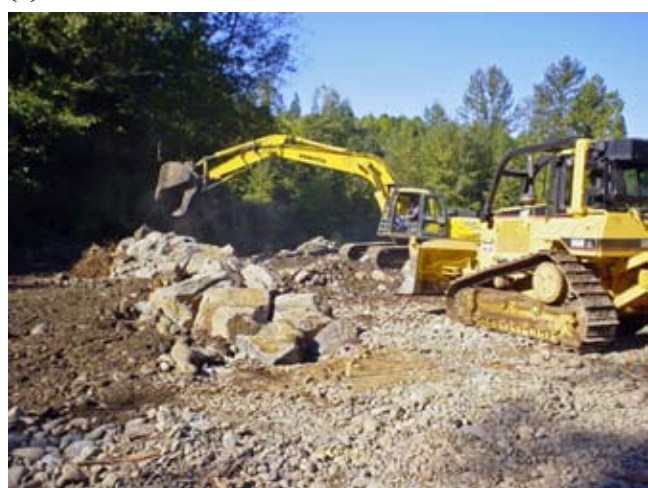
Figure CS18–14 (a) Construction of the upstream ELJ. A temporary cofferdam was placed to dewater the construction area; (b) construction of one of the project stream barbs. Photo is taken looking up the axis of the barb structure.

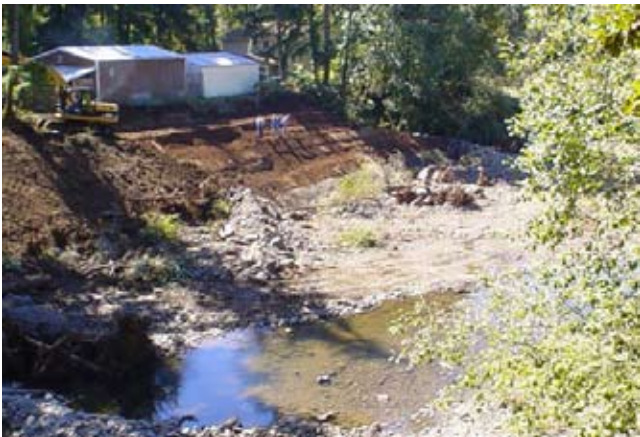
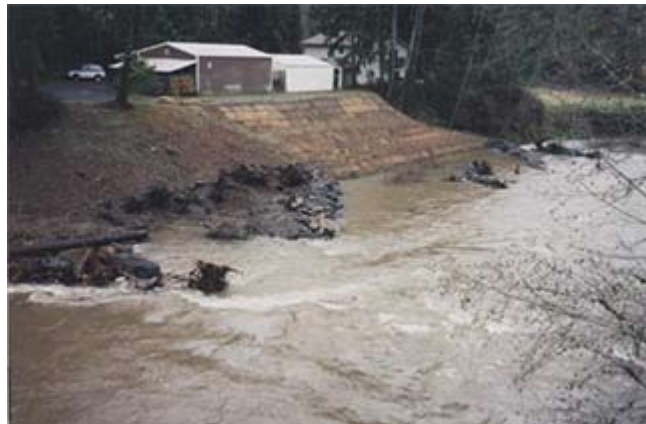
Figure CS18–22

(a) Project nearing completion. All primary project components are complete except for embankment vegetation. (b) November 2004 flooding approximately 2 months after the completion of construction. Note high velocities deflected at the upstream log jam (on left of photo) and the subcritical, low-shear stress flow condition in the near bank region along the embankment toe.

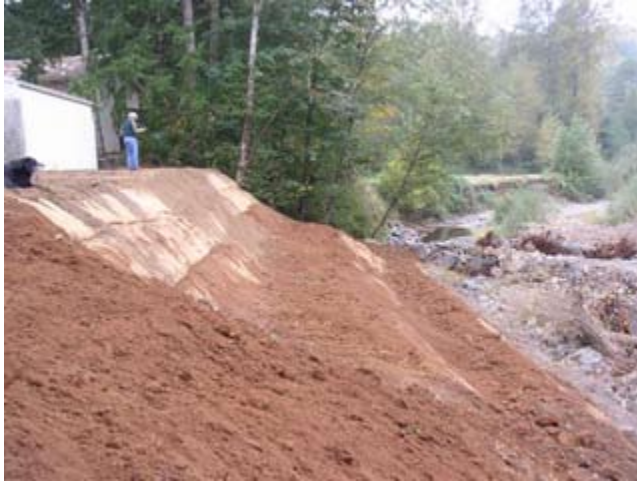
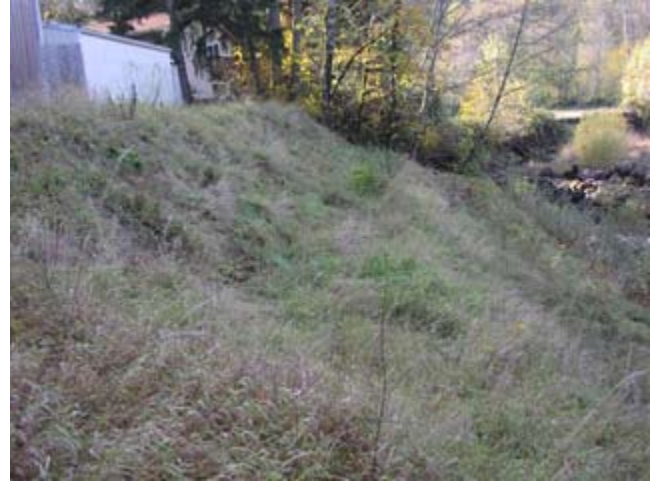
Figure CS18–23 (a) Looking downstream along the embankment immediately after construction and before planting of vegetation (August 2004); (b) Same view of project in December 2005 showing vegetation establishment. Note location of buildings in both photos.

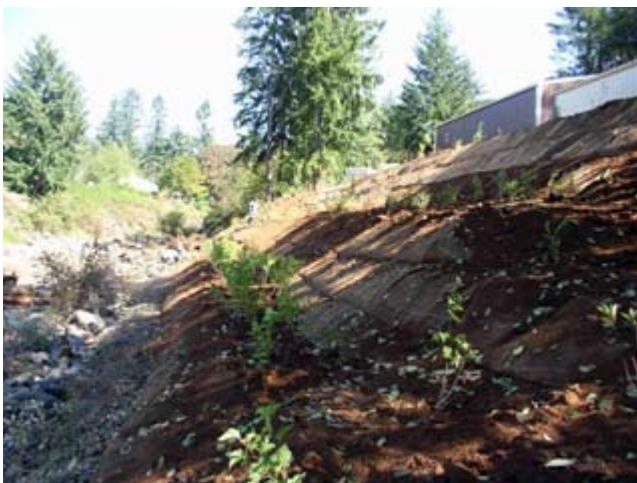
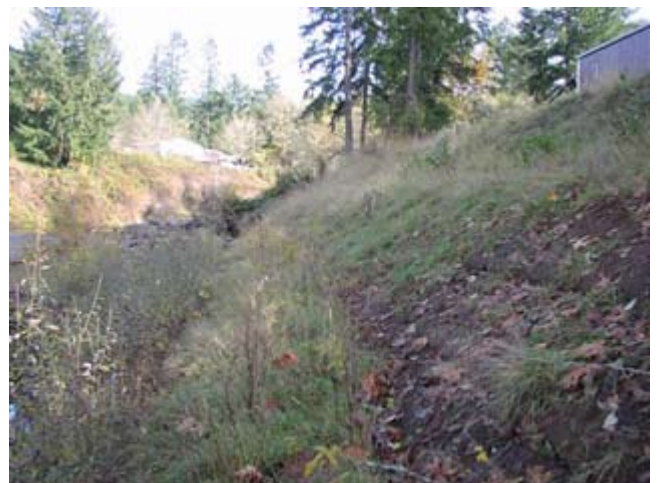
Figure CS18–24 (a) Looking upstream along the embankment immediately following placement of vegetation (August 2004); (b) Same view of project in December 2005 showing establishment of vegetation with vigorous willow growth along the embankment toe. Note location of buildings in both photos.

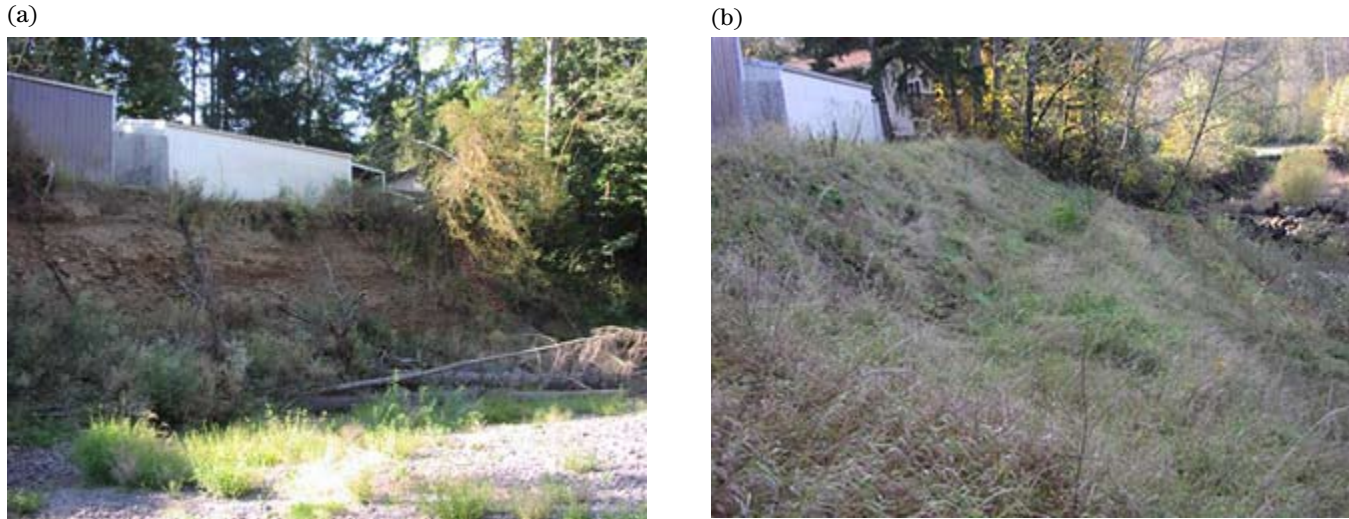
Figure CS18–25 (a) Preproject bank condition (June 2004); (b) Bank condition 1 year after project completion
