**Case Study 3**

**Little Elk River, Price County,  
Wisconsin**

# Little Elk River, Price County, Wisconsin

*By Mary K. King, Area Engineer, U.S. Department of Agriculture, Natural Resources Conservation Service, Altoona, Wisconsin. Photographs courtesy of Price County Land Conservation Department*

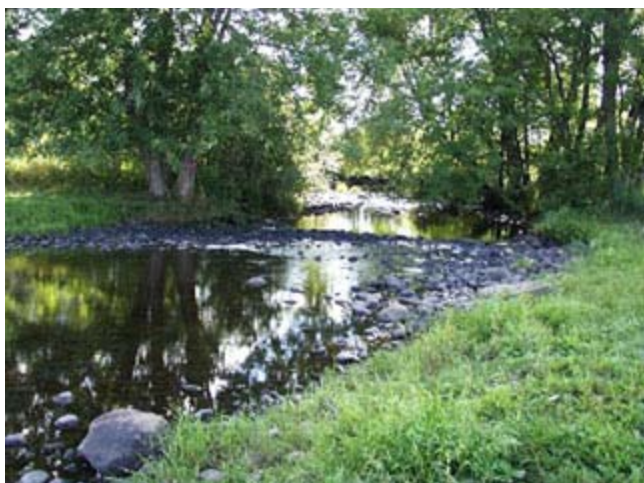
**Figure CS3–3** Little Elk River rock dam crossing

River in Price County, Wisconsin, was degraded by a rock dam crossing installed in the early 1990s, and uncontrolled cattle access led to loss of vegetation and widening of the stream (figs. CS3–3 and CS3–4). The crossing was located at the downstream end of the restoration project. Price County is located in the Wisconsin North Woods and supports 71 trout streams totaling 244 miles. Sixty miles are Class 1, 114 miles are Class 2, and 70 miles are Class 3. WDNR classifies trout streams as Class 1 if the high quality trout waters support natural reproduction to sustain populations of wild trout at or near carry capacity, Class 2 if there is some natural reproduction, and Class 3 when there is marginal trout habitat with no natural reproduction occurring. Classes 2 and 3 require annual stocking of trout.

The design concept was to restore the degraded stream to a similar cross section and stream classification type of a nearby undergraded section. First, in 2001, the rock dam was removed (fig. CS3-5) and replaced with a cattle crossing to meet Wisconsin NRCS Conservation Practice Standard No. 560, Access Road.

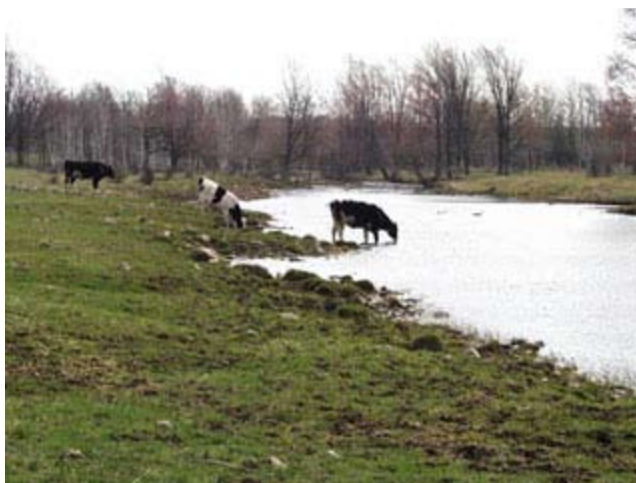
**Figure CS3–4** Uncontrolled cattle grazing

Uncontrolled cattle grazing has eliminated woody vegetation along 700 feet of the 1,400-foot-long site and damaged the remainder (fig. CS3–4). Continuous hoof traffic has broken down the undercut streambanks where trout could hide and eroded the banks, so that the stream width has tripled in places. In the degraded section, the length between pools and riffles, as well

as the drop over the riffles, has increased, compared to the more protected section upstream of the property.

The landowner initially contacted the NRCS to sign up for a riparian buffer in the continuous Cropland Reserve Program (CRP). The NRCS buffer program funded fencing along a 160-foot-wide corridor 1,400 feet long and tree planting for 1,050 feet.

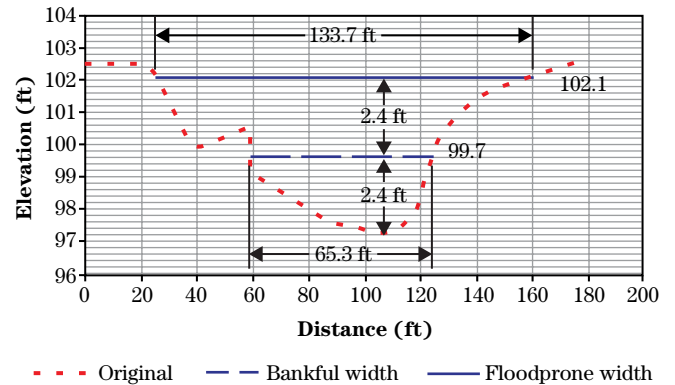
**Figure CS3-6** Cross section of disturbed site

The most critical information determined was the bankfull stage. Due to cattle traffic in the disturbed area, a typical bankfull elevation was not pronounced, so staining on rocks and elevations of woody vegetation were used to determine the bankfull elevation. The bankfull channel width was measured in the riffle segment of the selected reach. Cross sections were surveyed through a riffle area in the degraded site (fig. CS3-6) and upstream in an undisturbed area (fig. CS3-7). This information was used to determine the entrenchment ratio and width/depth ratio.

$$\text{entrenchment ratio}_d = 133.7 \text{ ft} \times 65.3 \text{ ft} = 2.0$$

$$\text{width/depth ratio}_d = 65.3 \text{ ft} \times 1.2 \text{ ft} = 54.4$$

Width/depth ratio is changing from a moderate toward high ratio.

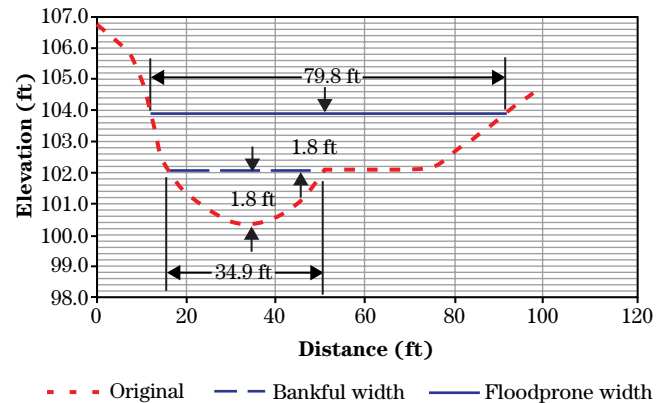
**Figure CS3-7** Cross section of undisturbed site upstream

$$\text{entrenchment ratio}_u = 79.8 \text{ ft} \times 34.9 \text{ ft} = 2.29$$

$$\text{width/depth ratio}_u = 34.9 \text{ ft} \times 0.9 \text{ ft} = 38.8$$

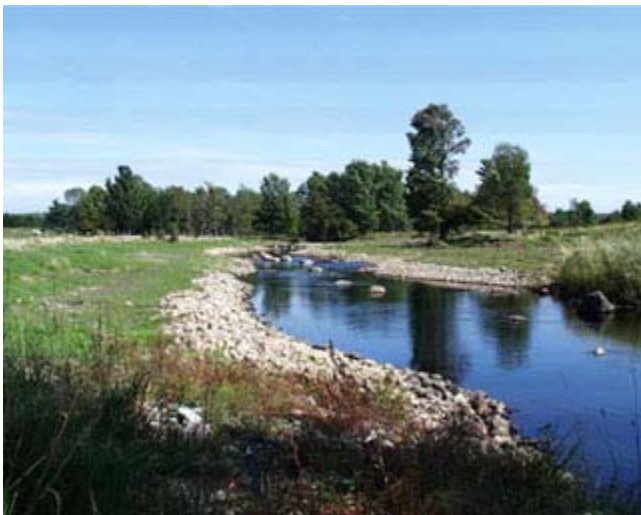
**Figure CS3-12** 1 month after construction

Figure CS3-12 shows the project 1 month after construction; figure CS3-13 shows a cross-sectional comparison.

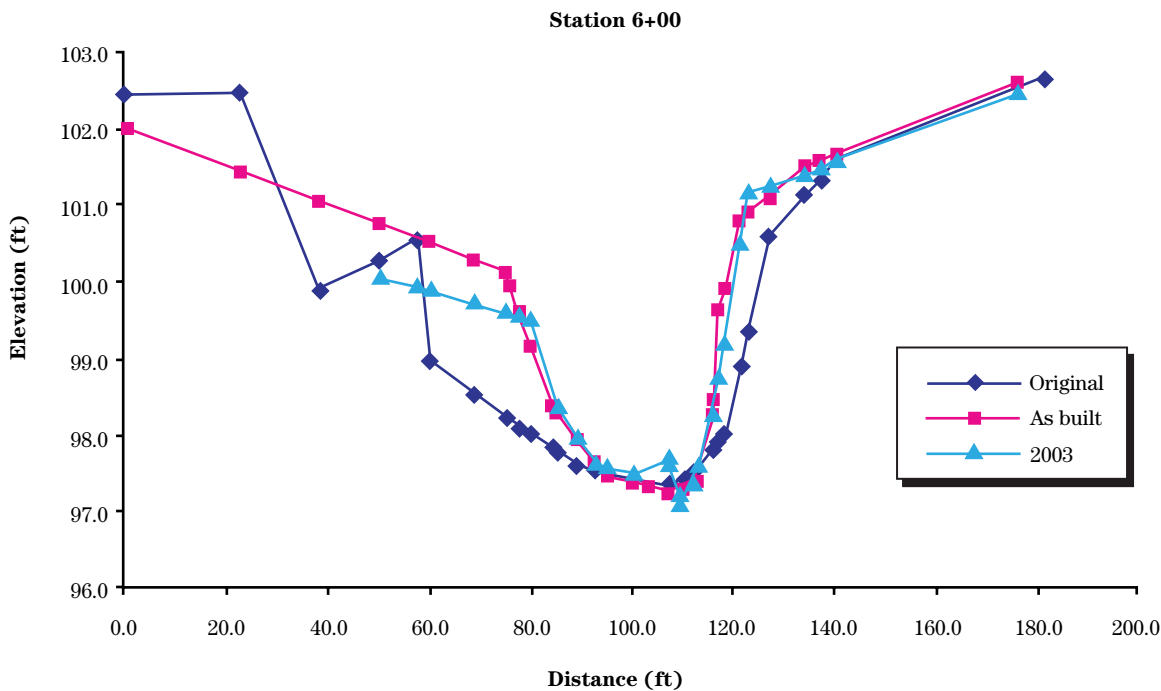
**Figure CS3-13** Cross-sectional comparison

placement in the riffles of the stream. Cross sections of the stream before construction, after construction, and the following spring were compared. The final cross sections show that the stream width of the degraded section was restored to class B4c to imitate the healthy section of stream.
