Alica J. Ketchem, P.E.; U.S. Department of Agriculture, Natural Resources Conservation Service, Richmond, Virginia

In 1995 and 1996, major storm events caused severe damage to the Rose River in Madison County, Virginia. In 1998, 4,200 feet of the Rose River was restored to a more stable condition and strengthened using a variety of natural and ecologically friendly techniques. This effort included the installation of nine vortex rock weirs and two sets of rootwads. Five years after installation, during Hurricane Isabel, the Rose River flooded again. Although some of the weirs and rootwads were damaged by this flood, the majority of the site remained in a stable condition.

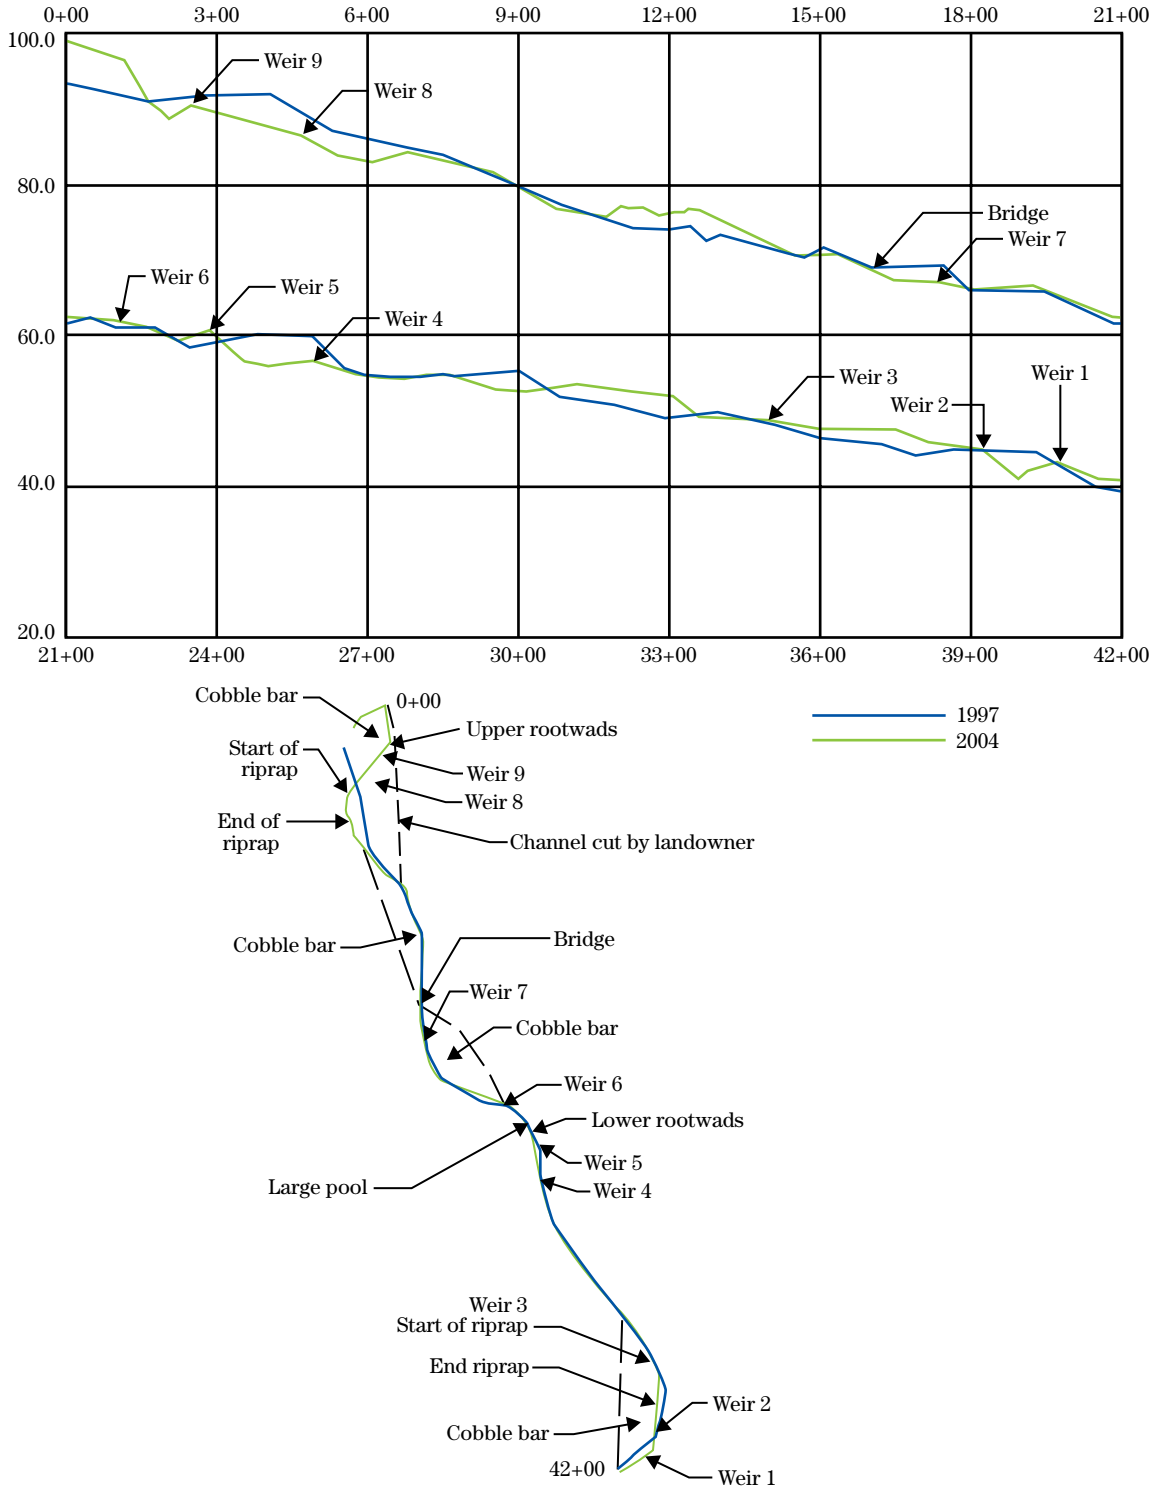
Figure CS5-1 Rose River profile and plan view survey information (shown in ft, as surveyed) for 1997 and 2004

The profile was again surveyed in April 2004 (fig. CS5-1). As could be expected, some sections were cut down, and some had filled in. The largest fill occurred at the beginning of the reach. The channel had filled in by about 7 feet in the section above the upper rootwads. It is unclear why this occurred. The profile also showed that weir #9 is providing grade control as planned. Where the river was turned back into its original channel, the profile shows the 2004 slope to be 3 to 4 feet lower than the 1997 profile. Some of this material was removed during construction. The riprap is stable and shows no signs of change. Below the riprap, the elevation of the channel bottom has not changed for about 400 linear feet. A deep pool has developed below the outlet of the gully cut by the landowner. The profile shows that the channel has filled in 2 to 3 feet for a distance of about 350 linear feet below

When the plan views were compared, they showed that most of the reach had only minor changes from 1997 (fig. CS5-1). The biggest change occurred below weir #8. Part of this probably occurred during construction, when the riprap was installed. However, the river has moved more to the right below the riprap, and the outside bank is vertical and unvegetated (fig.

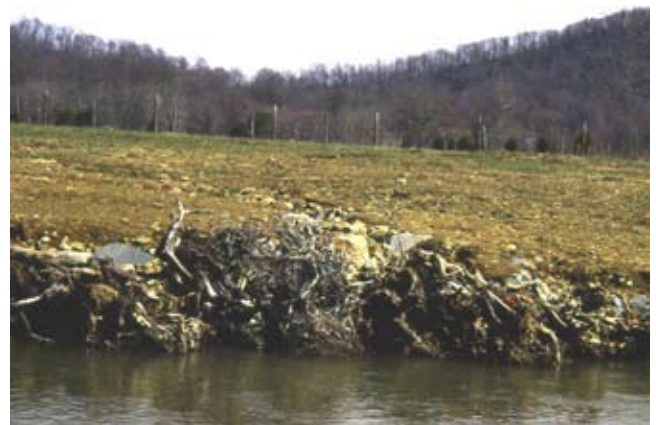
Figure CS5-3 Lower rootwads, March 1998, immediately after construction

The next section that was of major concern was at the large pool. This pool was about 150 feet long and 3 to 4 feet deep at the outside of the curve. The outside bank was 5 to 6 feet high and undercut. Because of the excellent trout habitat provided by the deep water, the DGIF staff was interested in maintaining the pool at the existing depth and location. To do this, one weir (#6) was placed at the head of the pool and one at the foot, at the top of the riffle (#5) (fig. CS5-2). A third weir (#4) was placed at the bottom of this riffle. The vertical bank was graded to a stable slope, and rootwads were trenched in along the pool (fig. CS5-3). At

some time in the past, large slabs of concrete had been placed along the river. These were used as the footers for the first four or five rootwads. Large logs were used as footers for the remaining rootwads. Approximately 60 tons of Class III riprap was placed over the boles of the rootwads at the lower end of the set. These were covered by soil.

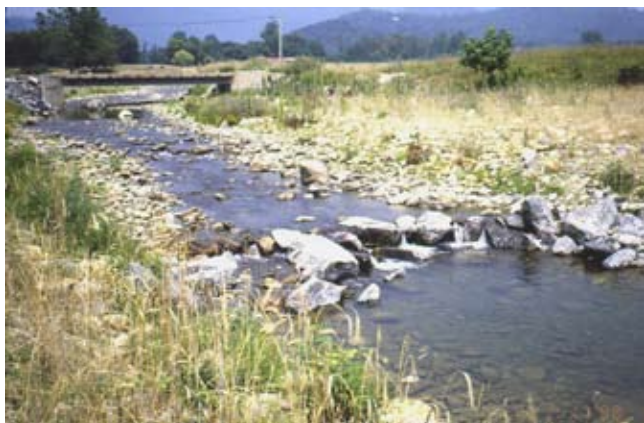
Figure CS5-4 Weir #7, July 1998

Weir #7 was located between the bridge and the curve. The left end was embedded into the cobble bar, and the right end was anchored into natural ground (fig. CS5-4). The scour hole that developed below this weir

was several feet deep and formed excellent fish habitat.

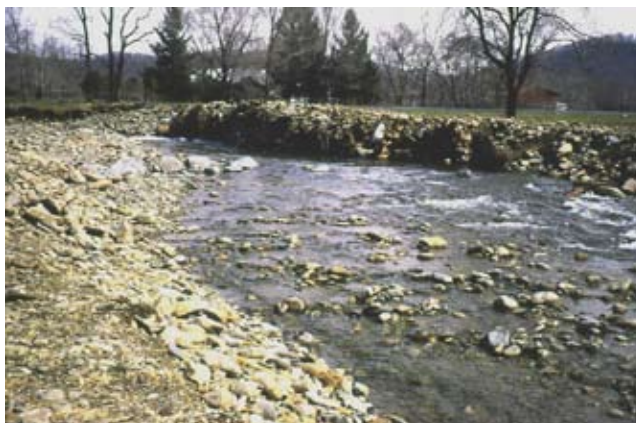
Figure CS5-5 Upper rootwads after construction, July 1998

After the weirs were complete, the water was rerouted back into the original channel. The cut-through channel was blocked with large rootwads and cobble material from the large debris bar above the bridge (fig. CS5-5). The cobble material was trucked up the gully and dumped against the back of the rootwads. This made a very large plug of soil and rocks that would not be vulnerable to washing away if the river overtopped the rootwads. Fill was placed in the gully until the cobble bar material was removed to the bankfull elevation. The gully was then graded and shaped to a stable

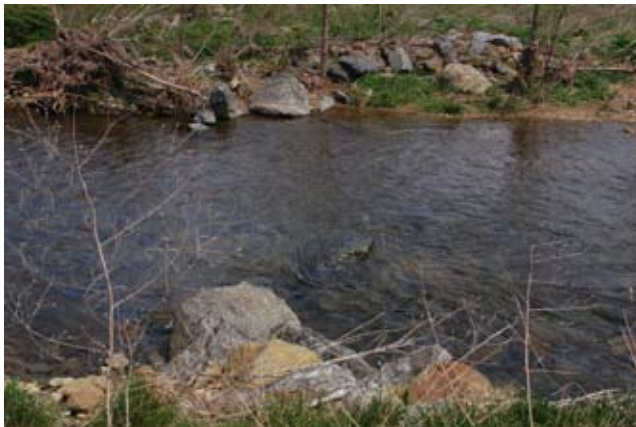
Figure CS5-12 Weir #7, April 2004, after Hurricane Isabel

After Hurricane Isabel (Sept. 2003), the section of the river immediately below the bridge filled in with about 3 feet of cobble material. Weir #7 was completely covered (fig. CS5-12).

Only the rocks on the edges can still be seen. The pool has shifted downstream 50 to 60 feet. The riffle has become longer with no intermediate pools in the curve between weir #7 and weir #6, and weir #6 is unchanged. However, the lower set of rootwads has been almost totally removed. The bank is raw and nearly vertical again (fig. CS5-13). The large pool remains, held in place by weir #5 (fig. CS5-14).

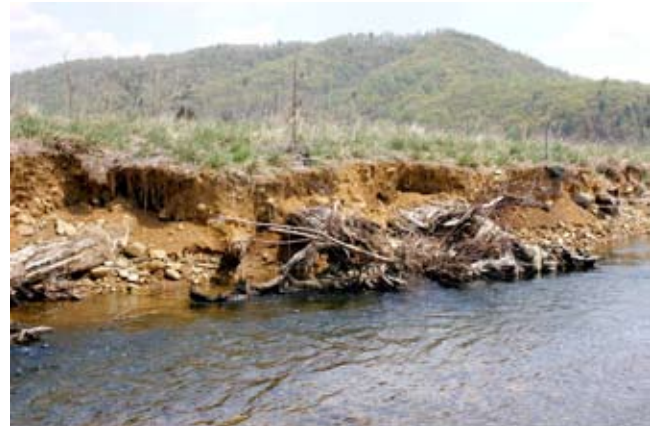
Figure CS5-13 Lower rootwads, April 2004, after Hurricane Isabel

The lower rootwads were trenched into the bank with 10 to 15 feet of the bole embedded. Some of the rootwads at the upper end of this group are still in place. At the lower end, some of the rootwads are missing entirely, while others appear to have been snapped off. One possible explanation is that the flood plain became more entrenched immediately above the rootwads. Starting at the bridge, the right bank was 6 to 8 feet higher than the left bank. The excess cobble had been removed from the left bank to increase the width of the flood plain. Just below weir #6, the left bank intersected the first terrace. This constriction would have increased the flow velocity against the left bank and the rootwads along it. The water elevation may have been above the top of the rootwads, contributing to the problem.

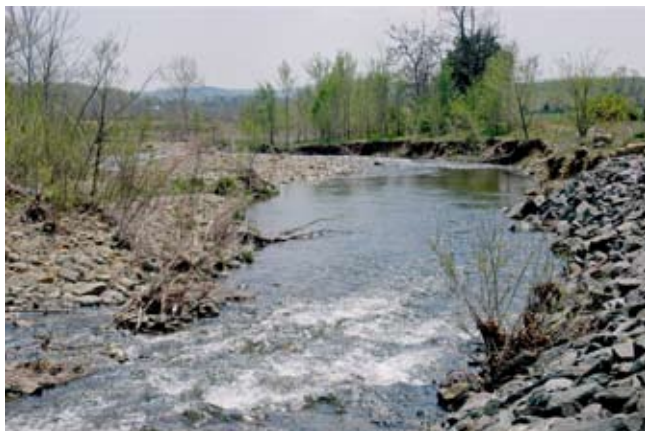
Figure CS5-15 Raw bank downstream of riprap

CS5-15). A large, fairly steep riffle has formed below this point. The second area where major changes occurred is in the curve between weirs #7 and #6. The curve seems to have become sharper, and some meander development has occurred.

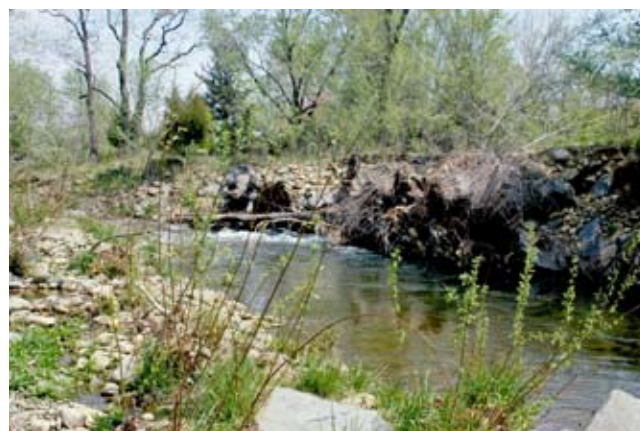
Figure CS5-16 Upper rootwads, April 2004, after Hurricane Isabel

of this general observation. The upper rootwads were used as part of a gully plug to cut off the manmade channel. The material used behind this was primarily cobble with some purchased riprap. To date, there seems to be little or no deterioration in these rootwads (fig. CS5-16). One possible reason is that the flood plain elevation is at least 4 feet lower on the side across from the rootwads. Previous failures on other sites were because of overtopping. This has yet to occur on this site.
