**Case Study 6**

**Big Bear Creek, Lycoming County,  
Pennsylvania**

# Big Bear Creek, Lycoming County, Pennsylvania

*By Dr. Larry K. Brannaka, U.S. Fish and Wildlife Service (USFWS); David B. Putnam, USFWS; William Worobec, Dunwoody-Big Bear Hunting and Fishing Club, Lycoming County, Pennsylvania; and Donald Stover. (All are members of the Keystone Stream Team.)*

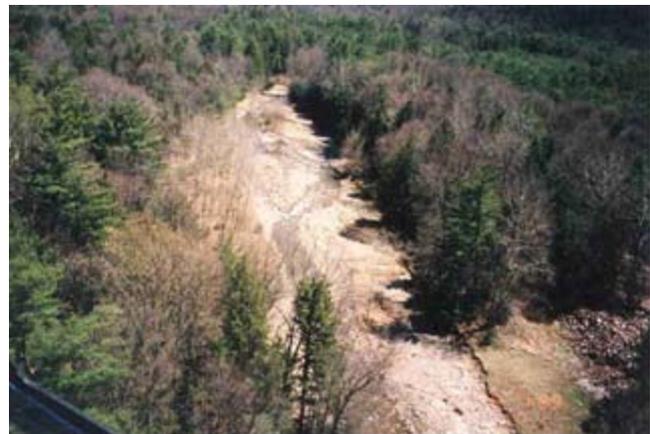
An aerial view of the stream before this project began (fig. CS6-5) provides an illustration of the condition of the stream. Following this flood event, some stream channel work was performed by the U.S. Army Corps of Engineers (USACE) and Federal Emergency Management Agency (FEMA) in Plunketts Creek Township, but this channel work ultimately contributed to the further degradation of fish habitat in the creek. The hurricane flood events put stress on the ecology of the Big Bear Creek system. However, the ecology of the system was more severely affected by the forced removal of the dam on the Dunwoody-Big Bear Hunting Cub property that had fallen into critical disrepair.

**Figure CS6-5** Aerial view of phase II treatment reach of Big Bear Creek prior to restoration

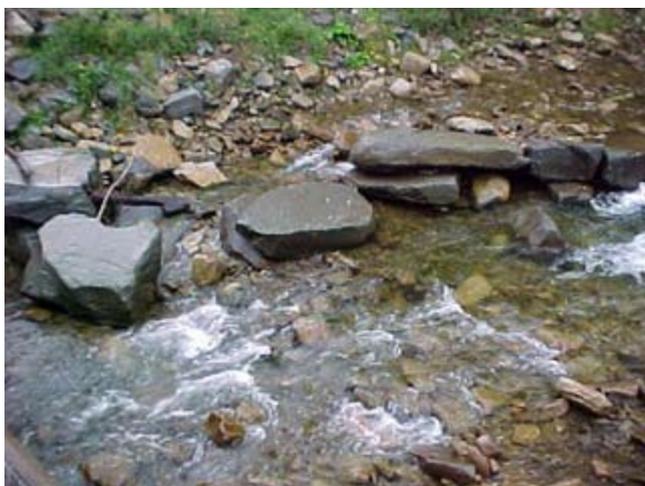
resulted in less excavation into the stream subbase to set the throat rocks at or near the streambed level. Over the long term, it was found that these structures were much more susceptible to washouts and displacement of the throat rocks than those where all the vane rocks were carefully placed on footer rocks of comparable size. High velocity flows moving over the vanes scoured out the downstream pavement and subbase of the streambed, tipping or causing settling of the footer rock, which in turn caused the vane rock to fall into the scour hole. The process repeated itself, eroding a scour hole downstream of the tipped rock until it rolled into the hole, thereby moving the rock downstream. An example of this is shown in figure CS6-12.

**Figure CS6-12** Example of vane rocks with small footer rocks and inadequate long-term performance

Footer rocks of the proper size are typically embedded into the streambed to a depth greater than the scour depth and, thus, resist washout. Figure CS6-13 shows a footer rock being set. Two other features of a properly footed vane rock also help to resist tip-outs of the vane rock. First, the vane rock is typically offset to the upstream side of the footer rock (fig. CS6-11) leaving a small sill at the base of the vane rock. This sill sometimes acts as an energy dissipater for water pouring over the vane rock. The second feature is that a prop-

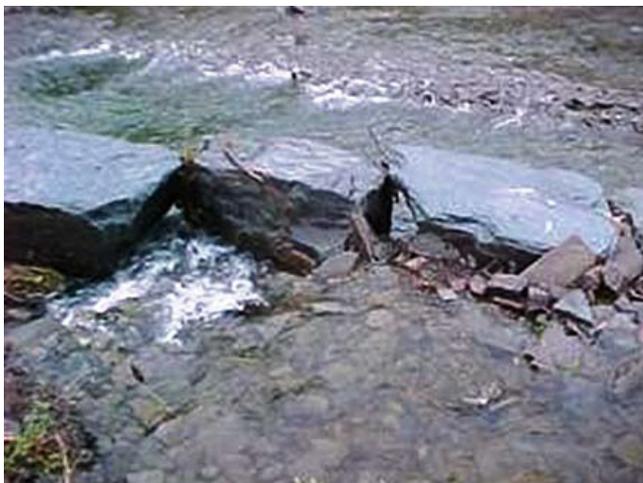
**The most prevalent problem**—Most of the problems observed with structure meltdowns where the vane rocks washout or are displaced during a high-flow event are a result of inattention to detail during construction. There must not be any open spaces between the structure rocks (fig. CS6–14). Open

spaces result in the formation of suck holes during high-flow events. The water becomes accelerated as it passes through the hole between the rocks resulting in a high-velocity water jet. This jet will have much more localized power than the stream in general and can dislodge and cause the erosion of the bed material around and behind the footer rock. If the erosion persists, it can result in the movement or tip-outs of the footer rock, which in turn dislodges the top vane rock. It was noted that filling the gap holes with tightly packed coarse gravel is **not** a sustainable solution or practice. Where the streambed material is of fine material and there is a shortage of delivered cobble rock, grout bags can be used to fill the holes. The grout bags used in this case were sand bags filled approximately one-half to two-thirds of a mixture of sand and Portland Cement. Another method is to use a geotextile fabric (filter fabric) as a barrier to keep finer material from washing through the holes. The fabric is placed on the upstream side with the top of the fabric kept even with the fill line. The upstream side of the rock vane should be filled in with bed material up against the filter fabric. This procedure is labor intensive and may present challenges working in moving water.

**Figure CS6–14** Gap holes, which in high flow, become suck holes

Evidence of this process was observed in many of the failures that occurred in the second year of construction in Big Bear Creek (figs. CS6–15 and CS6–16). The spaces between the rocks must be filled and preferably barricaded on the upstream side using large rocks that will span the hole. In later projects, the authors found that it is advantageous to have smaller rock delivered along with the wall rock for this purpose if the streambed material does not contain sizable cobbles.

In many cases, filling the gap holes makes the difference between a successful and sustained structure and one that will have to be rebuilt following a high-flow event.

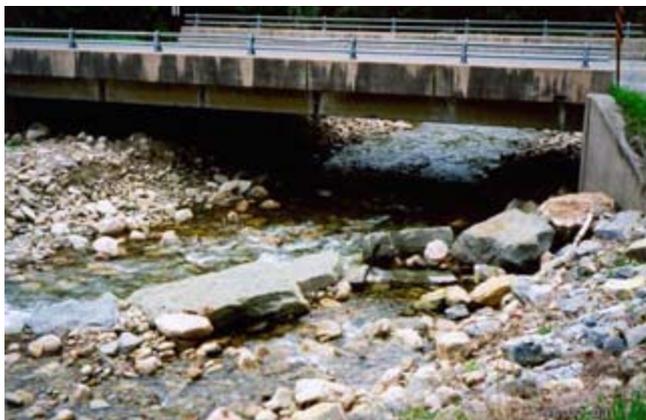
**Figure CS6–15** Vane with a tip-out vane rock due to the scour from a gap hole

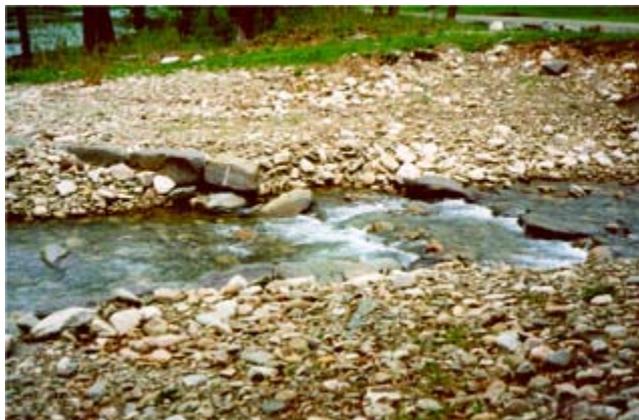
**Figure CS6–16** Tip-out due to scour from a suck hole

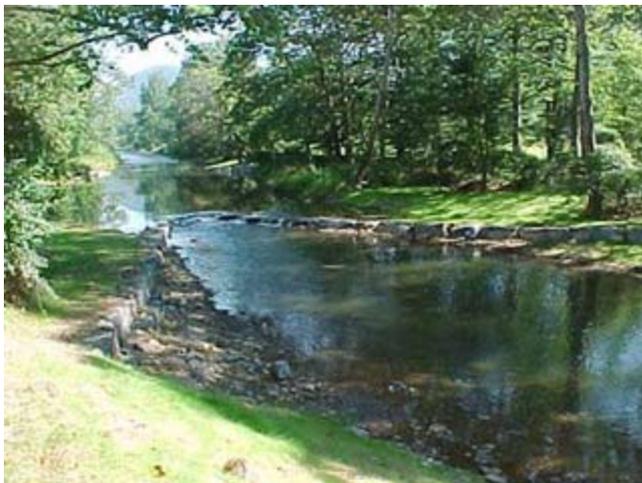
**Figure CS6-17** Cross vane illustrating the proper upstream fill along the vanes, leaving a flat horizontal ramp along the vane

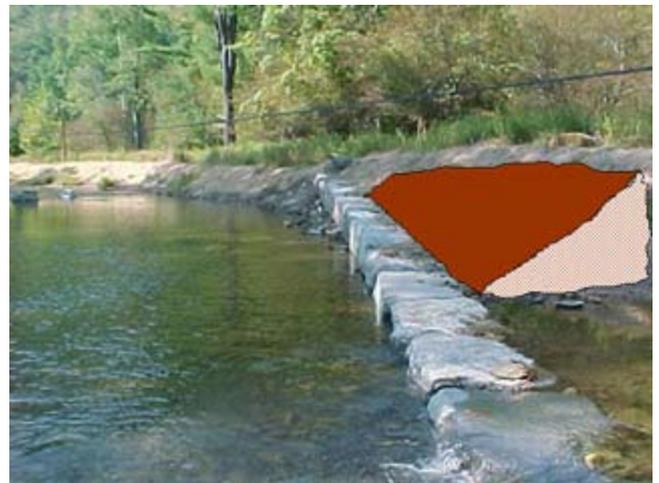
One significant lesson learned was related to the gravel and streambed fill material that is placed between the structure and the bank (representing the acute angle of the structure). In several cases, the

fill placed by one of the construction crews ran from the upstream edge of the vane rock to the top of the bank (at the bankfull level) all along the leg of the vane. So, instead of a relatively flat, tapering ramp extending horizontally to the bank bordered on the downstream side by the vane rock (fig. CS6-17), the fill in these cases ran from the vane rock to the top of the bank all along the leg of the vane. The bank then extended to the edge of the vane (now at a different slope), illustrated schematically in figure CS6-18. The result of this mistaken practice was a reduction in the cross-sectional area and an increase in flow depth and high-flow velocities. The structures could not function as designed since there were no ramps for the water to run up on and expend its energy on. Rather, the flow was deflected away from the vane rocks and maintained much of its velocity as it was channeled to the center. The vane functioned as a channel constriction. Once discovered, the construction crew was required to dig out the fill along these structures until flat ramps were formed.

**Figure CS6-18** Schematic representation of the improper fill technique on the upstream side of the vane

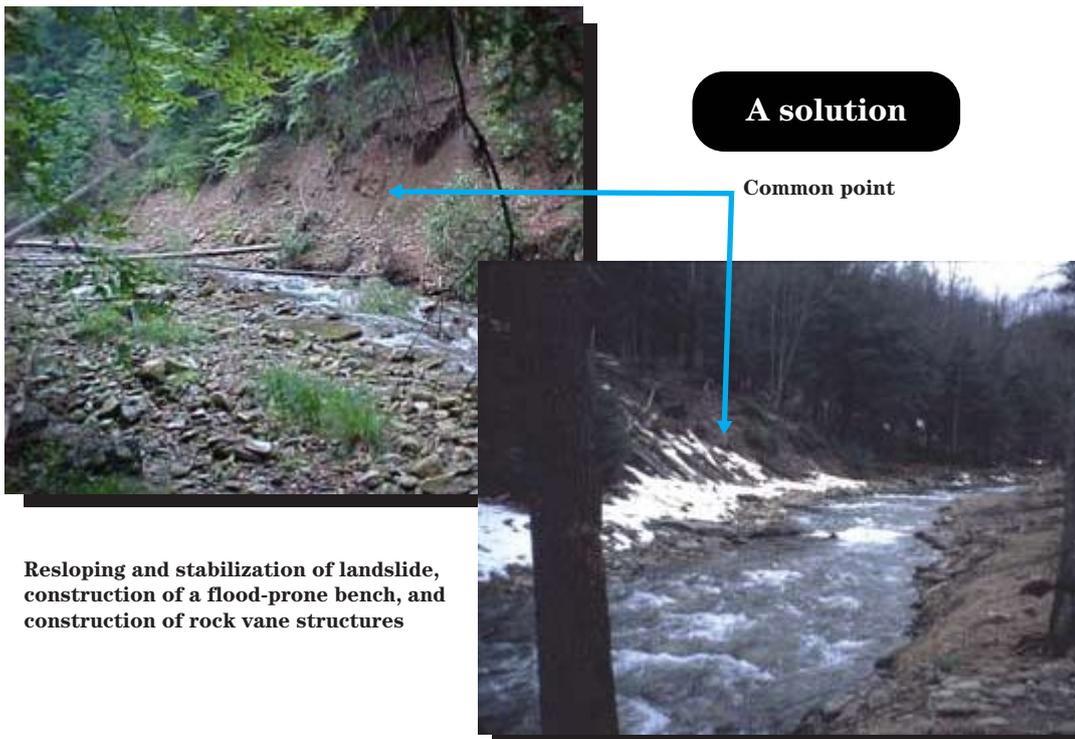
Examples of successful restoration techniques are shown in figures CS6–20 and CS6–21. In figure CS6–20, a landslide area is shown before restoration. A flood-prone area was constructed along the eroding bank to

move the main channel away from the bank, leaving only relatively slow moving water on the flood-prone bench next to the susceptible slope. The relocated and resized channel was stabilized with several cross vanes along the reach. A completely aggraded channel reach that resulted in the formation of a channel avulsion is depicted in figure CS6–21. The gravel was excavated from the original channel, and the banks were resloped. The channel avulsion was filled in. The newly excavated channel was stabilized with cross vanes. As vegetation fills in, the need for the vanes lessens.

**Figure CS6-20** Treatment technique used for a landslide area

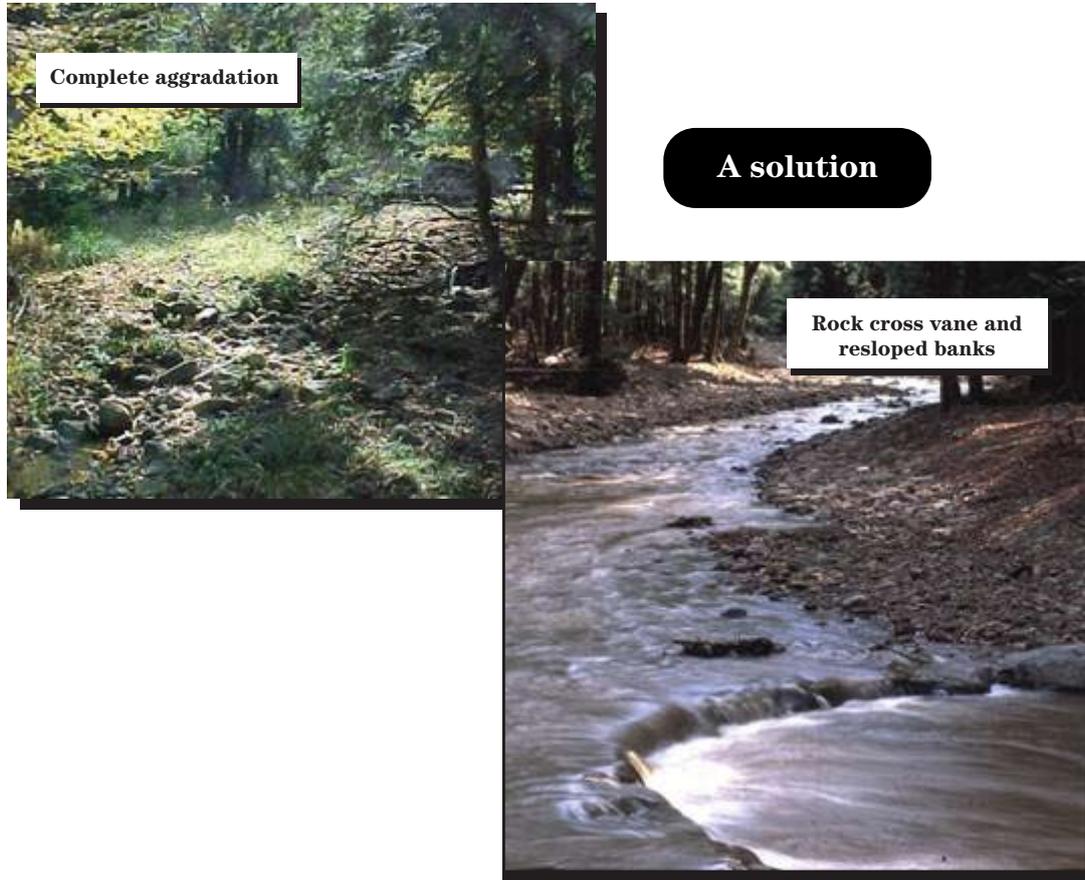
**Figure CS6-21** Treatment of a channel avulsion with rock structures
