Case Study 6

**Big Bear Creek, Lycoming County,
Pennsylvania**

Big Bear Creek, Lycoming County, Pennsylvania

By Dr. Larry K. Brannaka, U.S. Fish and Wildlife Service (USFWS); David B. Putnam, USFWS; William Worobec, Dunwoody-Big Bear Hunting and Fishing Club, Lycoming County, Pennsylvania; and Donald Stover. (All are members of the Keystone Stream Team.)

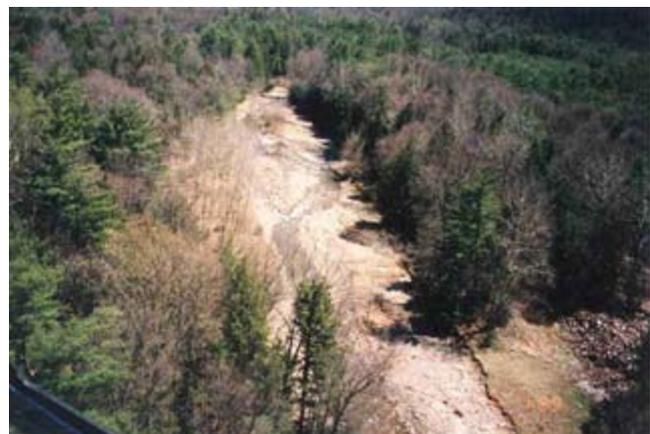
An aerial view of the stream before this project began (fig. CS6-5) provides an illustration of the condition of the stream. Following this flood event, some stream channel work was performed by the U.S. Army Corps of Engineers (USACE) and Federal Emergency Management Agency (FEMA) in Plunketts Creek Township, but this channel work ultimately contributed to the further degradation of fish habitat in the creek. The hurricane flood events put stress on the ecology of the Big Bear Creek system. However, the ecology of the system was more severely affected by the forced removal of the dam on the Dunwoody-Big Bear Hunting Cub property that had fallen into critical disrepair.

Figure CS6-5 Aerial view of phase II treatment reach of Big Bear Creek prior to restoration

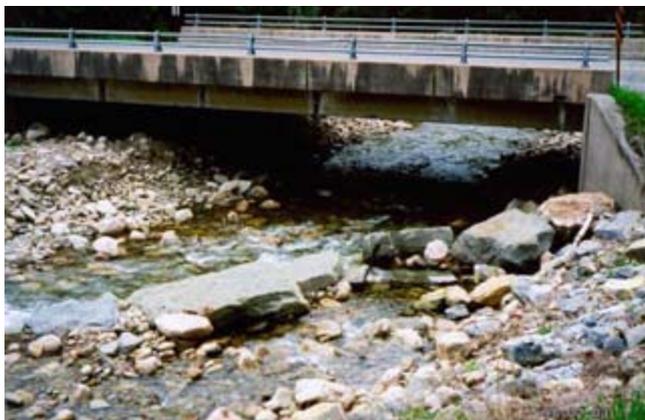
Evidence of this process was observed in many of the failures that occurred in the second year of construction in Big Bear Creek (figs. CS6–15 and CS6–16). The spaces between the rocks must be filled and preferably barricaded on the upstream side using large rocks that will span the hole. In later projects, the authors found that it is advantageous to have smaller rock delivered along with the wall rock for this purpose if the streambed material does not contain sizable cobbles.

Figure CS6-15 Vane with a tip-out vane rock due to the scour from a gap hole

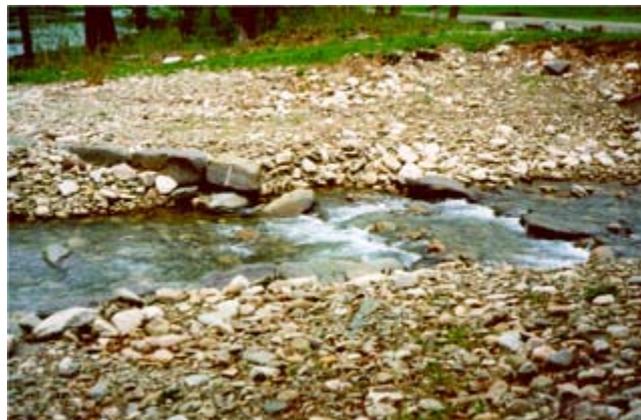
Figure CS6-16 Tip-out due to scour from a suck hole

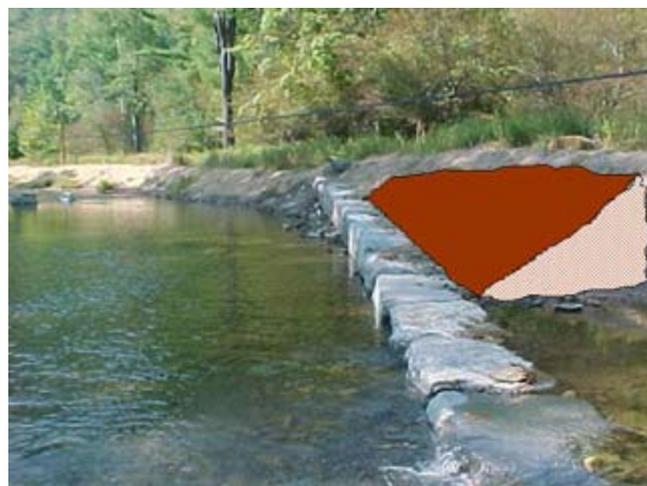
One significant lesson learned was related to the gravel and streambed fill material that is placed between the structure and the bank (representing the acute angle of the structure). In several cases, the

fill placed by one of the construction crews ran from the upstream edge of the vane rock to the top of the bank (at the bankfull level) all along the leg of the vane. So, instead of a relatively flat, tapering ramp extending horizontally to the bank bordered on the downstream side by the vane rock (fig. CS6-17), the fill in these cases ran from the vane rock to the top of the bank all along the leg of the vane. The bank then extended to the edge of the vane (now at a different slope), illustrated schematically in figure CS6-18. The result of this mistaken practice was a reduction in the cross-sectional area and an increase in flow depth and high-flow velocities. The structures could not function as designed since there were no ramps for the water to run up on and expend its energy on. Rather, the flow was deflected away from the vane rocks and maintained much of its velocity as it was channeled to the center. The vane functioned as a channel constriction. Once discovered, the construction crew was required to dig out the fill along these structures until flat ramps were formed.

Figure CS6-18 Schematic representation of the improper fill technique on the upstream side of the vane

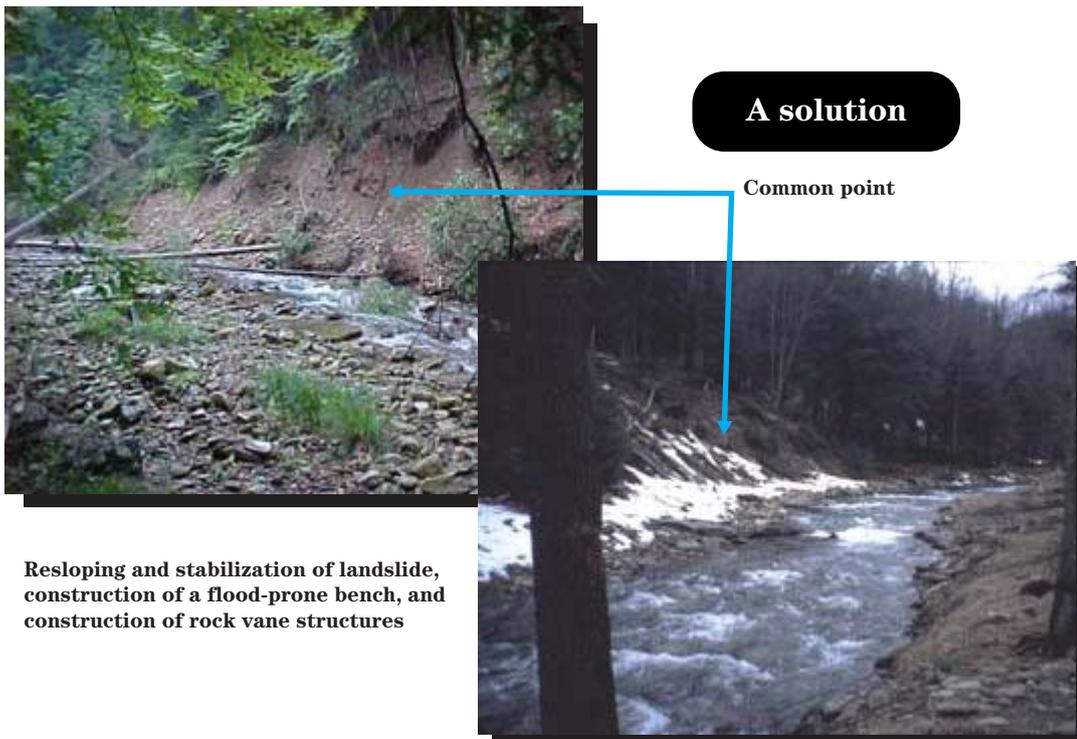
Examples of successful restoration techniques are shown in figures CS6–20 and CS6–21. In figure CS6–20, a landslide area is shown before restoration. A flood-prone area was constructed along the eroding bank to

Figure CS6-20 Treatment technique used for a landslide area

move the main channel away from the bank, leaving only relatively slow moving water on the flood-prone bench next to the susceptible slope. The relocated and resized channel was stabilized with several cross vanes along the reach. A completely aggraded channel reach that resulted in the formation of a channel avulsion is depicted in figure CS6–21. The gravel was excavated from the original channel, and the banks were resloped. The channel avulsion was filled in. The newly excavated channel was stabilized with cross vanes. As vegetation fills in, the need for the vanes lessens.
