Case Study 6

**Big Bear Creek, Lycoming County,
Pennsylvania**

Big Bear Creek, Lycoming County, Pennsylvania

By Dr. Larry K. Brannaka, U.S. Fish and Wildlife Service (USFWS); David B. Putnam, USFWS; William Worobec, Dunwoody-Big Bear Hunting and Fishing Club, Lycoming County, Pennsylvania; and Donald Stover. (All are members of the Keystone Stream Team.)

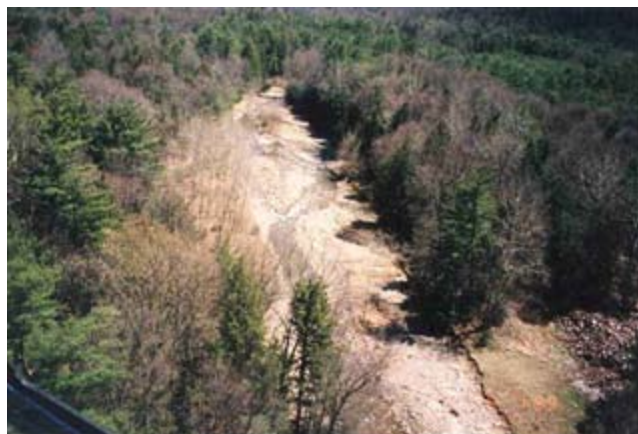
An aerial view of the stream before this project began (fig. CS6-5) provides an illustration of the condition of the stream. Following this flood event, some stream channel work was performed by the U.S. Army Corps of Engineers (USACE) and Federal Emergency Management Agency (FEMA) in Plunketts Creek Township, but this channel work ultimately contributed to the further degradation of fish habitat in the creek. The hurricane flood events put stress on the ecology of the Big Bear Creek system. However, the ecology of the system was more severely affected by the forced removal of the dam on the Dunwoody-Big Bear Hunting Cub property that had fallen into critical disrepair.

Figure CS6-5 Aerial view of phase II treatment reach of Big Bear Creek prior to restoration

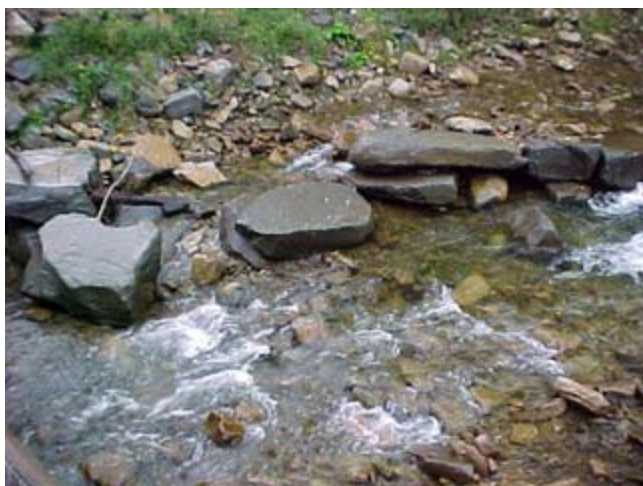
resulted in less excavation into the stream subbase to set the throat rocks at or near the streambed level. Over the long term, it was found that these structures were much more susceptible to washouts and displacement of the throat rocks than those where all the vane rocks were carefully placed on footer rocks of comparable size. High velocity flows moving over the vanes scoured out the downstream pavement and subbase of the streambed, tipping or causing settling of the footer rock, which in turn caused the vane rock to fall into the scour hole. The process repeated itself, eroding a scour hole downstream of the tipped rock until it rolled into the hole, thereby moving the rock downstream. An example of this is shown in figure CS6-12.

Figure CS6-12 Example of vane rocks with small footer rocks and inadequate long-term performance

Footer rocks of the proper size are typically embedded into the streambed to a depth greater than the scour depth and, thus, resist washout. Figure CS6-13 shows a footer rock being set. Two other features of a properly footed vane rock also help to resist tip-outs of the vane rock. First, the vane rock is typically offset to the upstream side of the footer rock (fig. CS6-11) leaving a small sill at the base of the vane rock. This sill sometimes acts as an energy dissipater for water pouring over the vane rock. The second feature is that a prop-

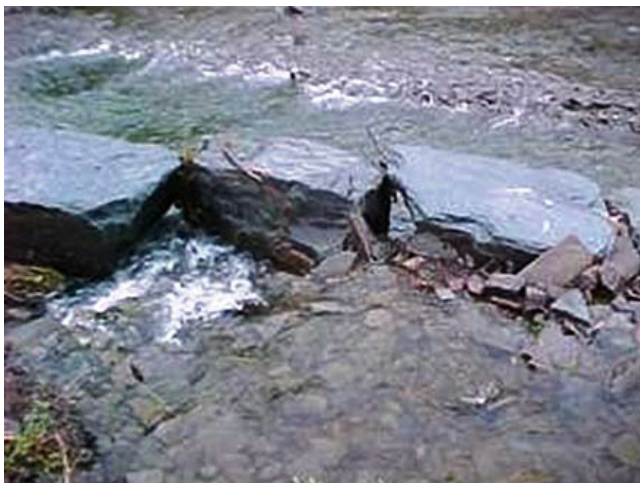
The most prevalent problem—Most of the problems observed with structure meltdowns where the vane rocks washout or are displaced during a high-flow event are a result of inattention to detail during construction. There must not be any open spaces between the structure rocks (fig. CS6–14). Open

spaces result in the formation of suck holes during high-flow events. The water becomes accelerated as it passes through the hole between the rocks resulting in a high-velocity water jet. This jet will have much more localized power than the stream in general and can dislodge and cause the erosion of the bed material around and behind the footer rock. If the erosion persists, it can result in the movement or tip-outs of the footer rock, which in turn dislodges the top vane rock. It was noted that filling the gap holes with tightly packed coarse gravel is **not** a sustainable solution or practice. Where the streambed material is of fine material and there is a shortage of delivered cobble rock, grout bags can be used to fill the holes. The grout bags used in this case were sand bags filled approximately one-half to two-thirds of a mixture of sand and Portland Cement. Another method is to use a geotextile fabric (filter fabric) as a barrier to keep finer material from washing through the holes. The fabric is placed on the upstream side with the top of the fabric kept even with the fill line. The upstream side of the rock vane should be filled in with bed material up against the filter fabric. This procedure is labor intensive and may present challenges working in moving water.

Figure CS6–14 Gap holes, which in high flow, become suck holes

Evidence of this process was observed in many of the failures that occurred in the second year of construction in Big Bear Creek (figs. CS6–15 and CS6–16). The spaces between the rocks must be filled and preferably barricaded on the upstream side using large rocks that will span the hole. In later projects, the authors found that it is advantageous to have smaller rock delivered along with the wall rock for this purpose if the streambed material does not contain sizable cobbles.

In many cases, filling the gap holes makes the difference between a successful and sustained structure and one that will have to be rebuilt following a high-flow event.

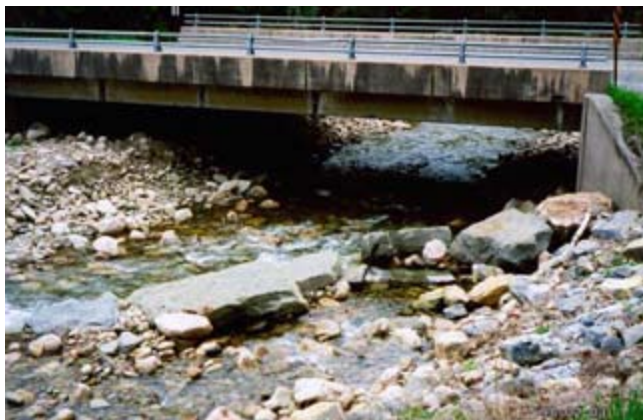
Figure CS6–15 Vane with a tip-out vane rock due to the scour from a gap hole

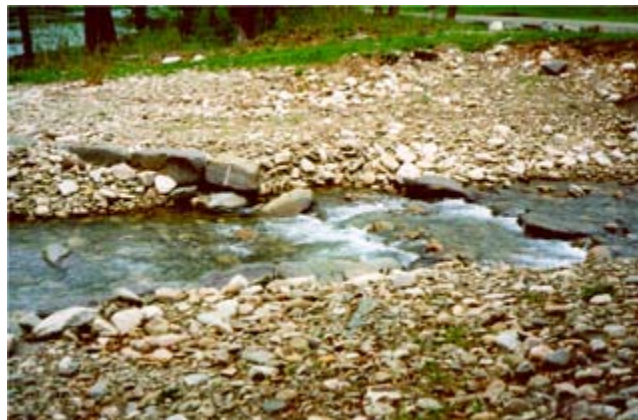
Figure CS6–16 Tip-out due to scour from a suck hole

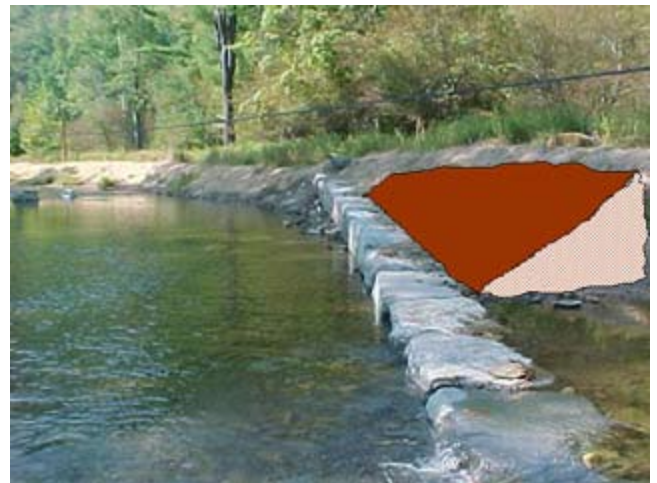
One significant lesson learned was related to the gravel and streambed fill material that is placed between the structure and the bank (representing the acute angle of the structure). In several cases, the

fill placed by one of the construction crews ran from the upstream edge of the vane rock to the top of the bank (at the bankfull level) all along the leg of the vane. So, instead of a relatively flat, tapering ramp extending horizontally to the bank bordered on the downstream side by the vane rock (fig. CS6–17), the fill in these cases ran from the vane rock to the top of the bank all along the leg of the vane. The bank then extended to the edge of the vane (now at a different slope), illustrated schematically in figure CS6–18. The result of this mistaken practice was a reduction in the cross-sectional area and an increase in flow depth and high-flow velocities. The structures could not function as designed since there were no ramps for the water to run up on and expend its energy on. Rather, the flow was deflected away from the vane rocks and maintained much of its velocity as it was channeled to the center. The vane functioned as a channel constriction. Once discovered, the construction crew was required to dig out the fill along these structures until flat ramps were formed.

Figure CS6–18 Schematic representation of the improper fill technique on the upstream side of the vane

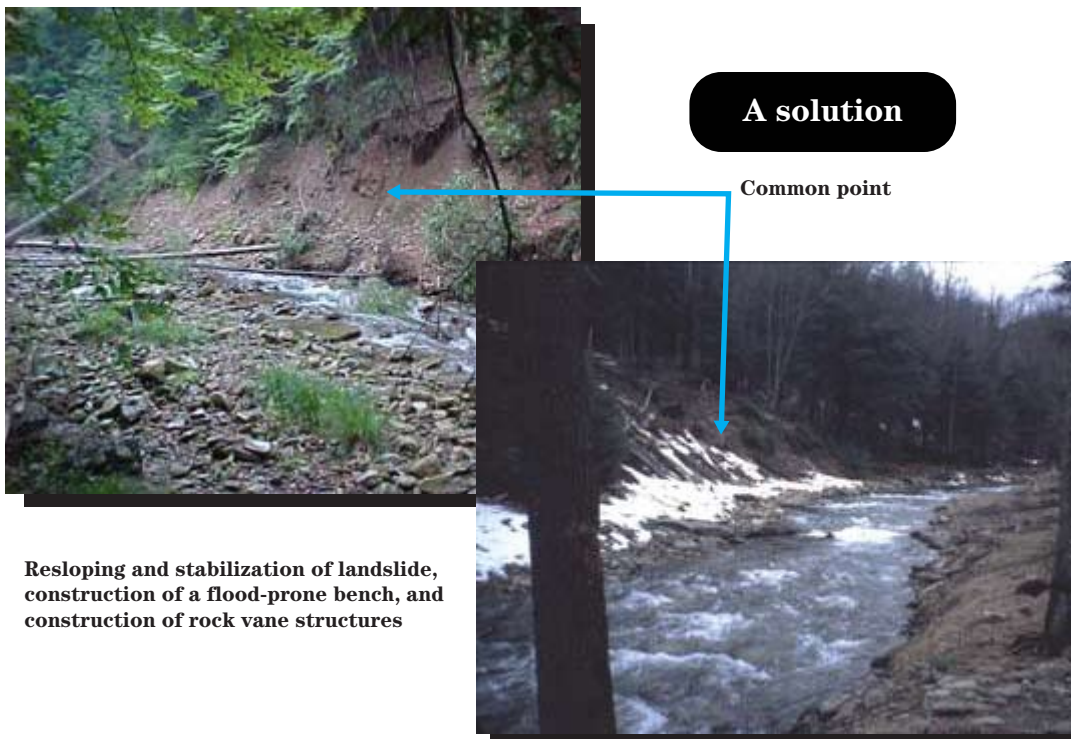
Examples of successful restoration techniques are shown in figures CS6–20 and CS6–21. In figure CS6–20, a landslide area is shown before restoration. A flood-prone area was constructed along the eroding bank to

move the main channel away from the bank, leaving only relatively slow moving water on the flood-prone bench next to the susceptible slope. The relocated and resized channel was stabilized with several cross vanes along the reach. A completely aggraded channel reach that resulted in the formation of a channel avulsion is depicted in figure CS6–21. The gravel was excavated from the original channel, and the banks were resloped. The channel avulsion was filled in. The newly excavated channel was stabilized with cross vanes. As vegetation fills in, the need for the vanes lessens.

Figure CS6-20 Treatment technique used for a landslide area

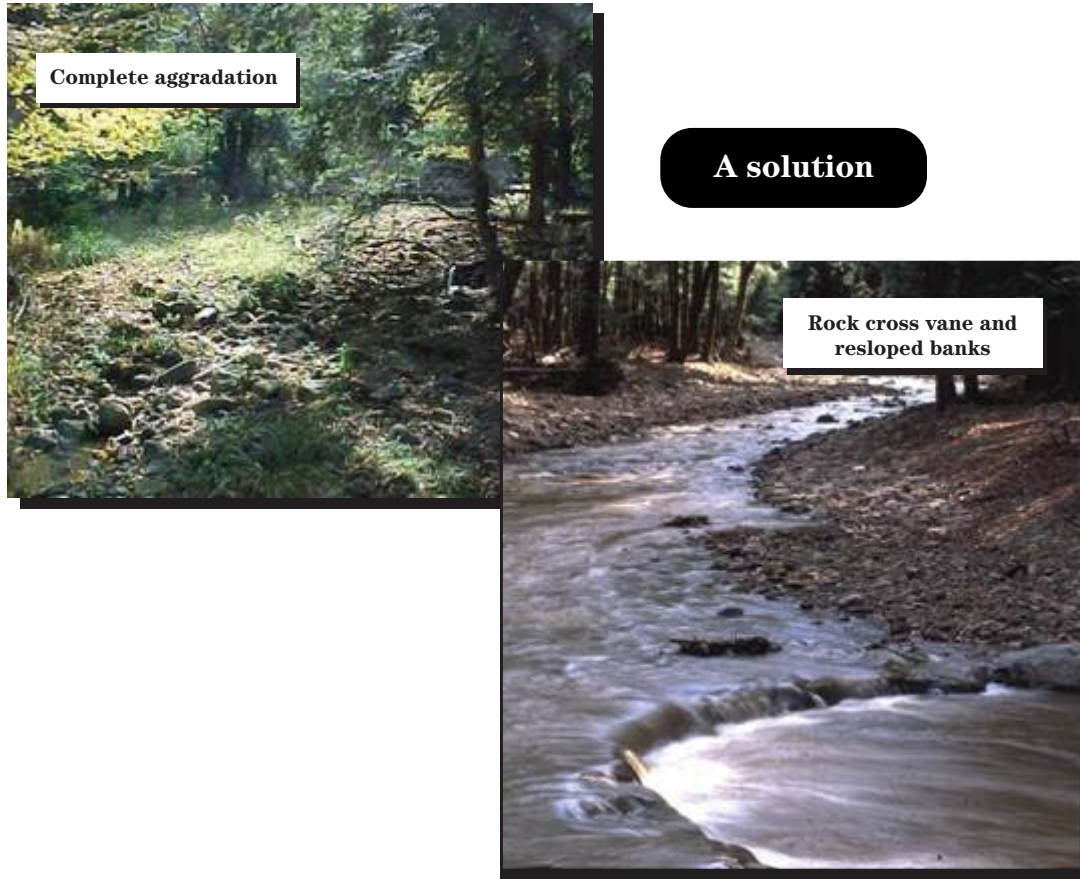
Figure CS6-21 Treatment of a channel avulsion with rock structures
