Case Study 14

Streambank Stabilization in the Merrimack River Basin, New Hampshire

Part 654 National Engineering Handbook

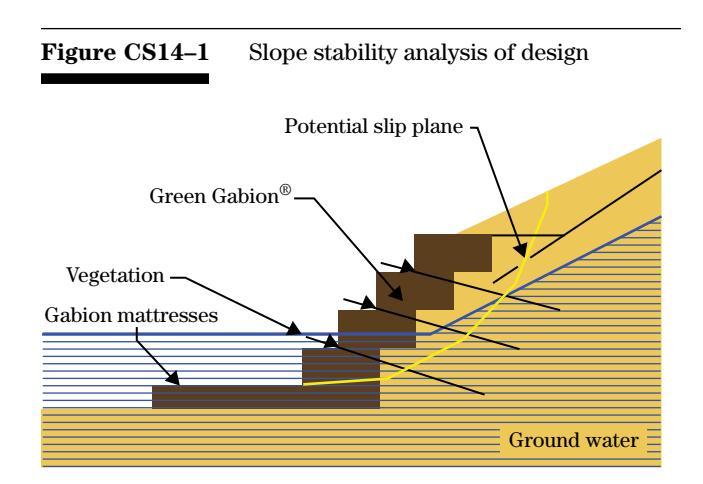
The slope stability analysis, done immediately after installation, resulted in a safety factor of 1.55 for global stability and 4.02 for internal stability (fig. CS14–1). The impact of the vegetation on slope stability was determined based on measured shear resistance of willow roots. The shear resistance of a 3-year-old willow can have an ultimate shear stress of 9.1 kilonewtons per square meter (kN/m²) (191 lb/ft²) (Goldsmith 1996). The reinforcing root length was considered to be 2 meters (6 ft) deep. To represent the root reinforcement in the structure, the density of the vegetation was considered at 30 centimeters (1 ft) spacing between each plant for each row of units. The analysis of the impact of vegetation on slope stability was performed using the shear resistance of a willow after 3 years of growth. A reduction factor of 3 was applied to the ultimate strength to represent the uncertainties of the growing vegetation. A shear resistance of 3.0 kilonewtons per square meter (63 lb/ft²) was used in the calculation. With the contribution of the vegetation, the internal stability of the structure (fig. CS14–1) gave a safety factor of 4.55 and a global safety factor of 1.55. The internal stability of the slope may increase 10 percent after the establishment of the vegetation. This last analysis was considered as information only and not for the design stability analysis. The global stability was not affected because the potential slip plane did not pass through the vegetation.

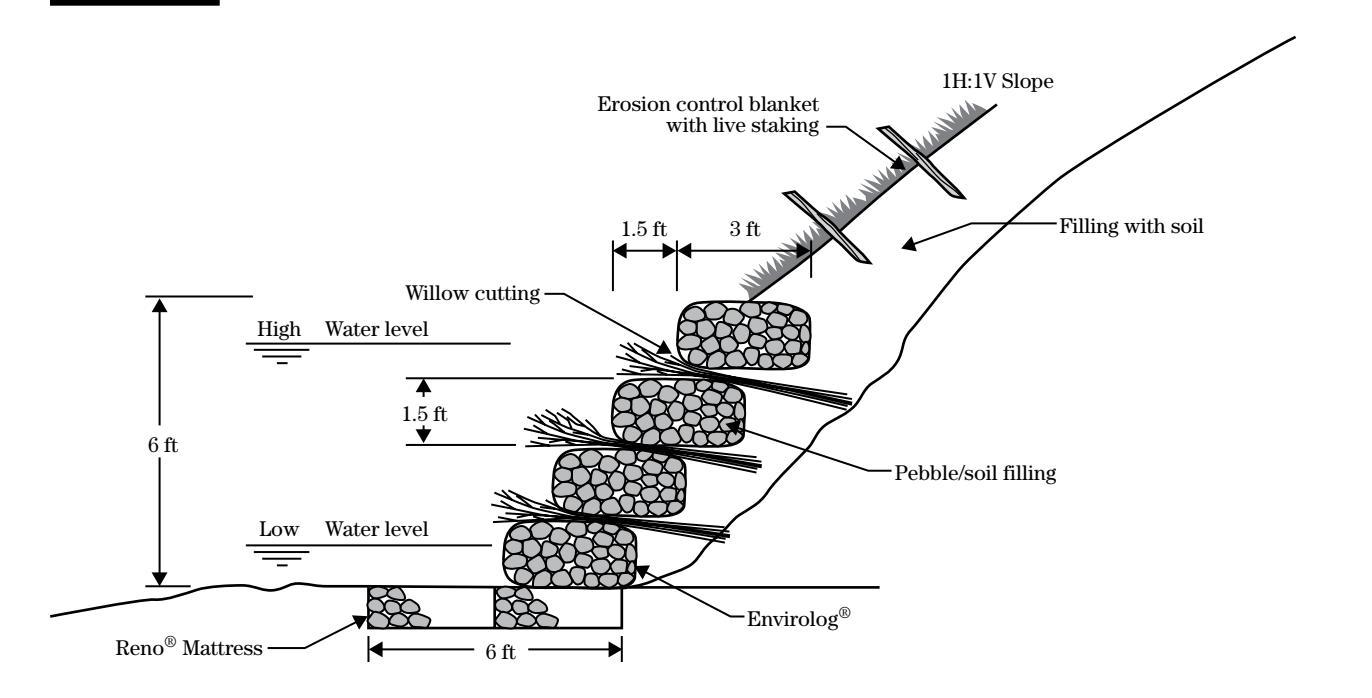
$\label{eq:Figure CS14-2} Figure \ CS14-2 \qquad {\rm Reno}^{\textcircled{R}} \ {\rm Mattress}, {\rm gabions}, {\rm and vegetation form a stable streambank design}$

To prevent any potential scour under the structure, a Reno[®] Mattress of 30 centimeters (12 in) by 1.9 meters (6 ft) was installed at the base of the units, with an extension of 1 meter (3 ft) streamward to stop any erosion (figs. CS14-2 and CS14-3).

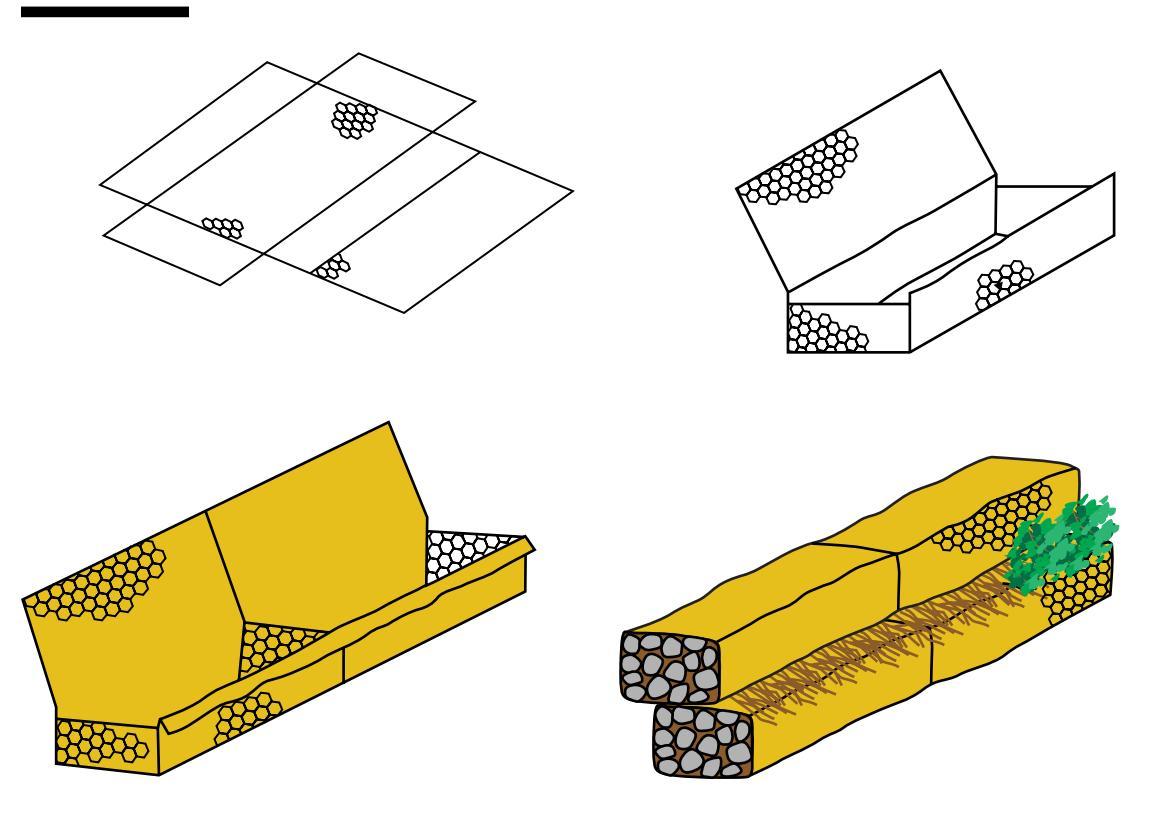
Figure CS14–6 Green Gabions[®] preassembled with coir fiber mat

The units were preassembled as a box and lined with the coconut mat before being placed on the site (figs. CS14–6 and CS14–7).

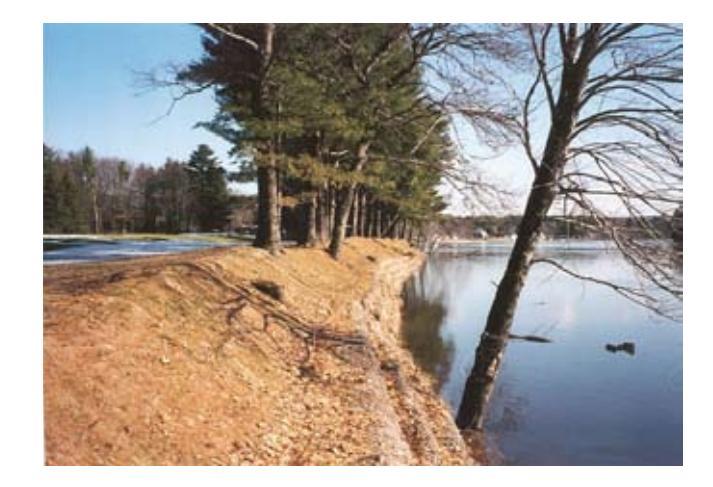
Figure CS14-9Project in spring after initial installation

After only one growing season, the vegetation is generally well established where it was planted. Some areas where the plants were too small or not properly placed during the installation have some problems with establishment in the structure. Figures CS14–9 and CS14–10 show the progression of the growth of vegetation. Figure CS14–9 was taken in the spring, and figure CS14–10 in the midsummer of the first growing season. The modified gabions used on this project combined with thick coconut blanket can resist erosion for 3 to 5 years before seeing any degradation of the coconut blanket. Live staking was recommended by the designer to enhance vegetation where it was missing.

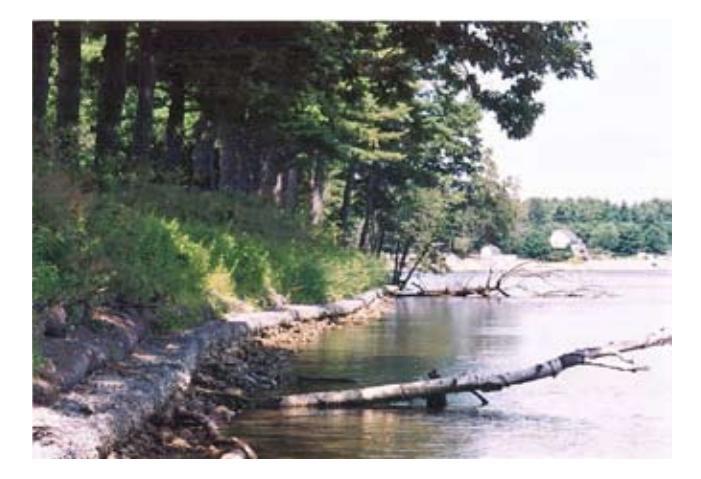
Figure CS14–10

Completed project in midsummer after installation
