Case Study 16

Project background

In October 2000, an extreme flood event caused severe erosion and lateral instability of a portion of Coffee Creek located along the southeastern edge of the Steeplechase subdivision in Edmond, Oklahoma (fig. CS16–1).

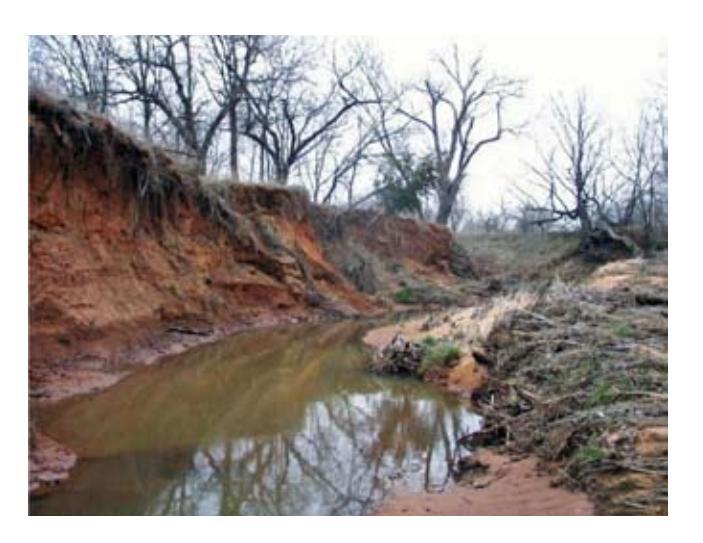
Figure CS16–4 Streambank erosion prior to the project

Coffee Creek is a deeply incised channel with a width/ depth ratio of less than 5H:1V. The entrenchment ratio for this reach of Coffee Creek, the ratio of flood plain width to channel width, is approximately 2H:1V. Coffee Creek is a highly meandering stream and has undergone active lateral migration leading to a high degree of instability (figs. CS16–3, CS16–4, and CS16–5.) The channel cross section is highly irregular. Near vertical banks have developed in several locations. Previous attempts to prevent lateral migration through the use of riprap and retaining walls have been unsuccessful.

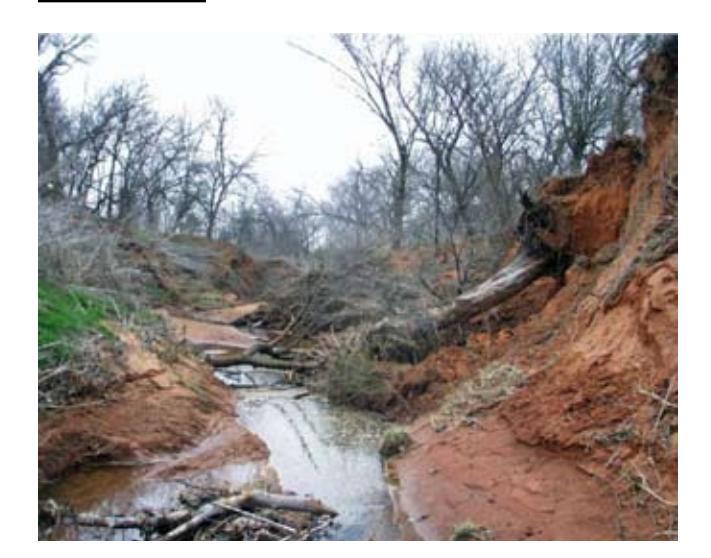
Figure CS16–3 St

Streambank erosion prior to the project

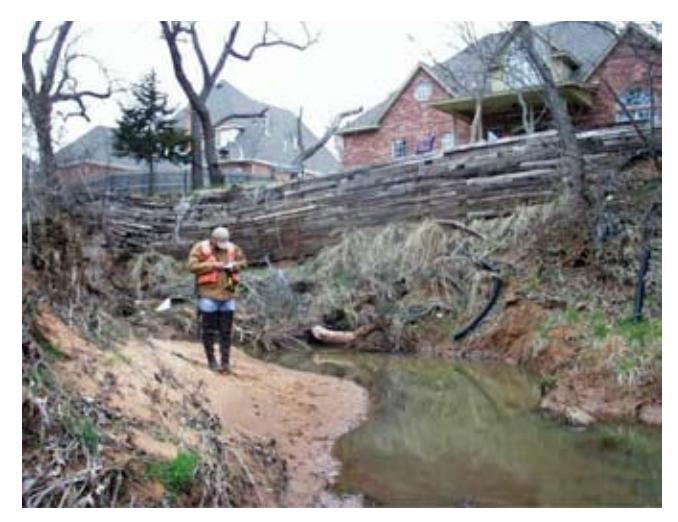
Figure CS16-5
 Proximity to infrastructure imposed restrictions on design approaches

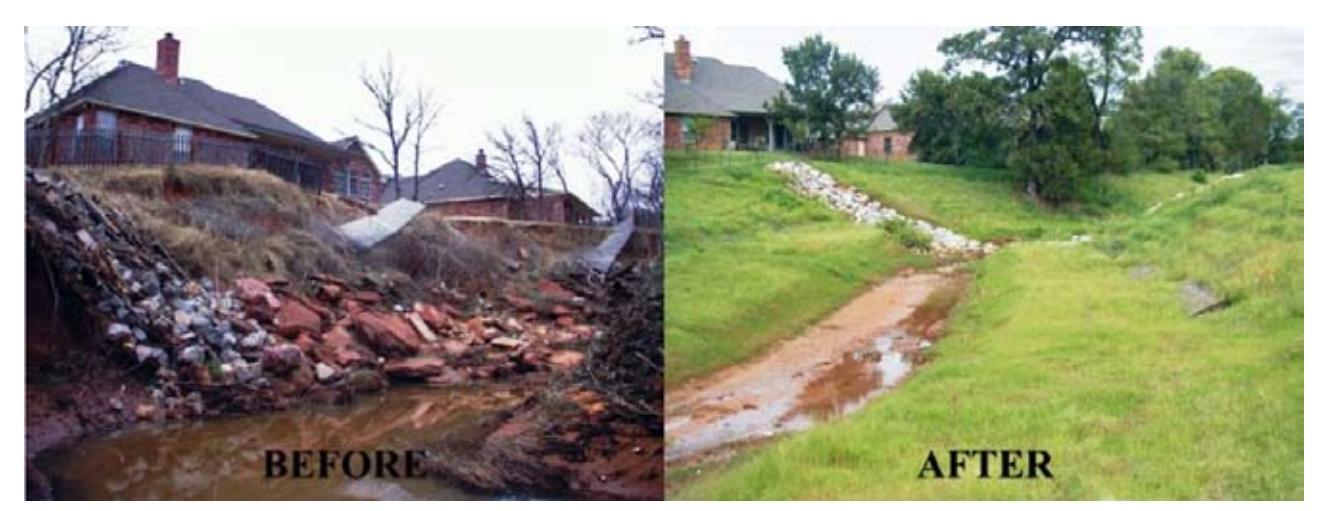
Figure CS16–9

6-9 Eroding channel prior to construction, and after project implementation; house and property lines imposed restrictions on the design

Project construction began in October 2002 and was substantially complete in August 2003. The project has been subjected to several significant postconstruction runoff events including an event that inundated the flood plain bench. Vegetation has begun to establish, and the channel is stable. As expected, the low-flow channel has begun to change shape and alignment. In a few locations, the low-flow channel has migrated to, and exposed, the buried riprap toe. The excessive erosion and scour, lateral migration, and general widening of the channel have ceased. The channel banks are stable, and the infrastructure has been protected. The project will continue to be monitored to help assess and document long-term performance of the design elements. Figures CS16-9 through CS16-11 show a comparison of preconstruction photos and photos taken after construction was substantially complete.

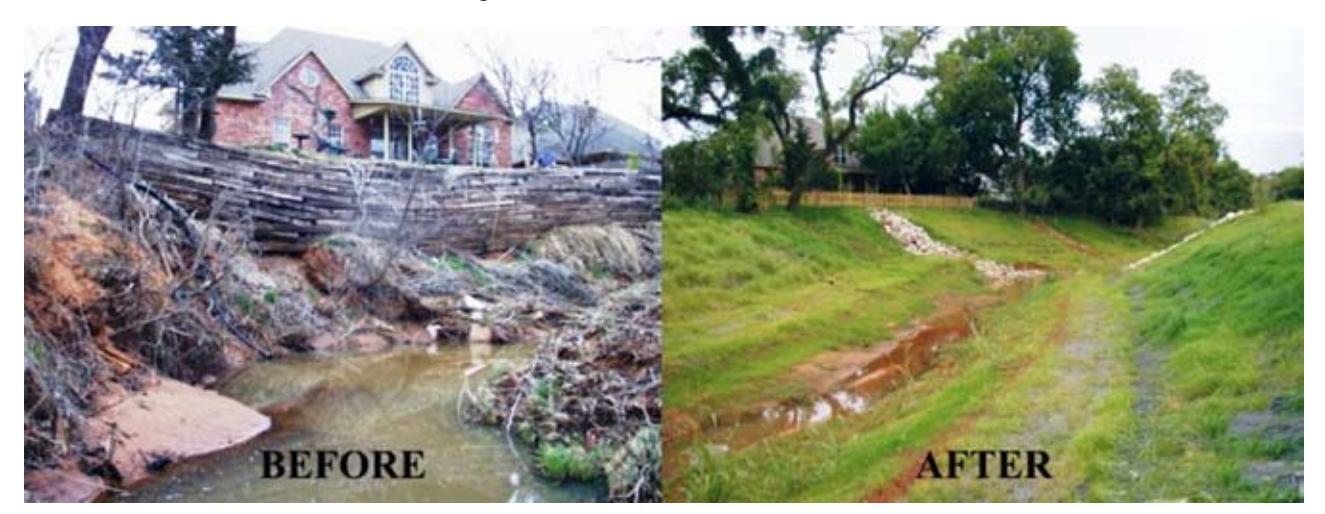
Figure CS16–10 Eroding channel prior to construction, and after project implementation; house and property lines imposed restrictions on the design

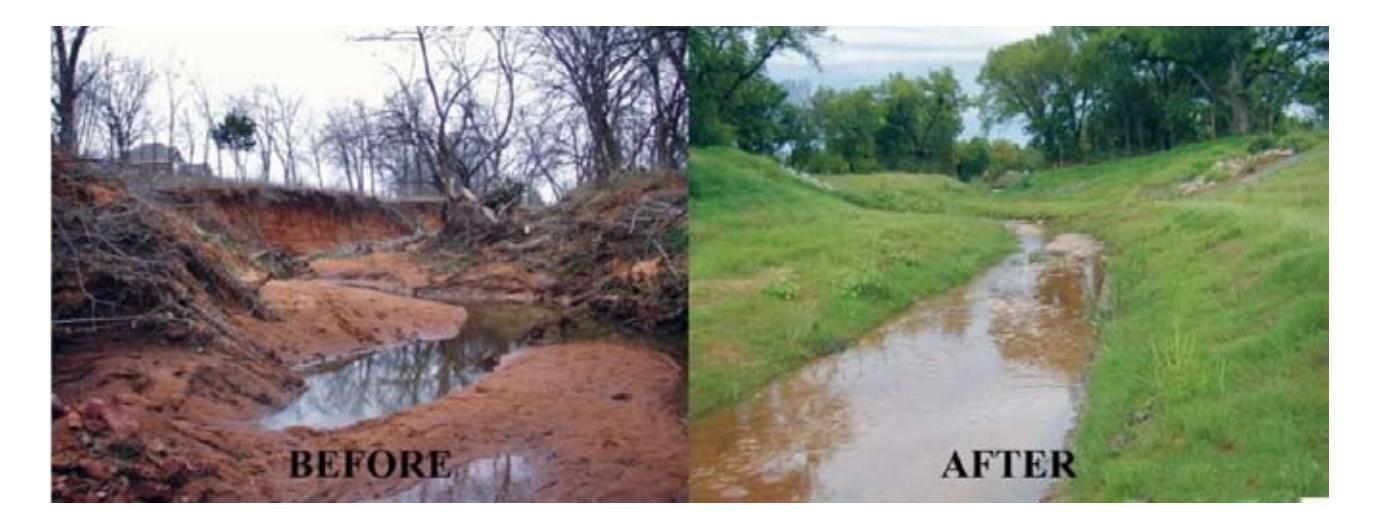
Figure CS16–11 Eroding channel prior to construction and after project implementation
