Case Study 17

Stream Barbs on the Calapooia River, Oregon

By Scott Wright, P.E., area engineer, U.S. Department of Agriculture, Natural Resources Conservation Service, Tangent, Oregon

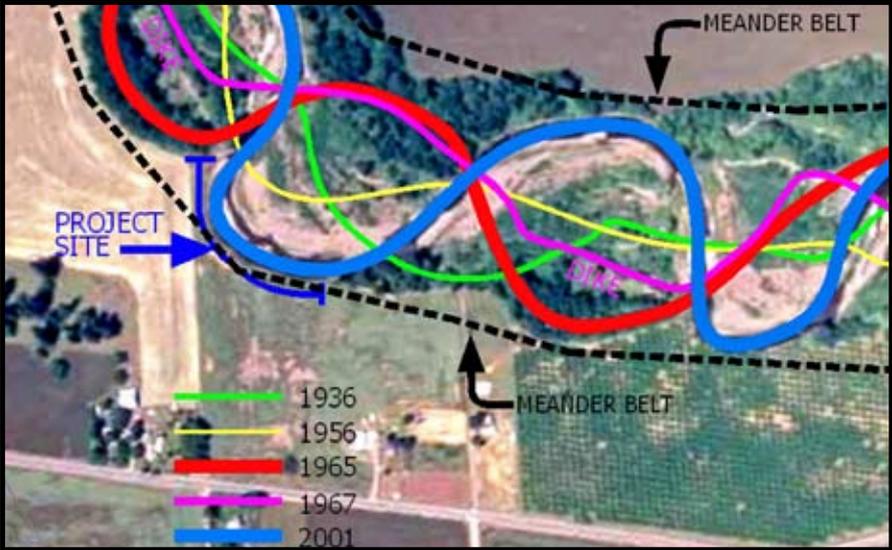
Cover photo: Historic channel traces of the Calapooia River in Oregon

To document historic channel alterations and natural changes, a composite picture of channel alignments was assembled. Figure CS17-4 shows the historic channel alignments from 1936, 1956, 1965, 1967, and 2001, superimposed on the 2001 aerial photo. The river's response to the 1966 meander cutoff dikes is readily visible as the meander phase shifted 180 degrees based on a sine curve relationship. The current river location mirrors the predike conditions in 1965. Analysis of traces of the historic channel highlights the heavily altered state of the river and the dynamic response to stream modifications. Based on nearly 70 years of channel traces, the meander belt width measures approximately 1,000 feet.

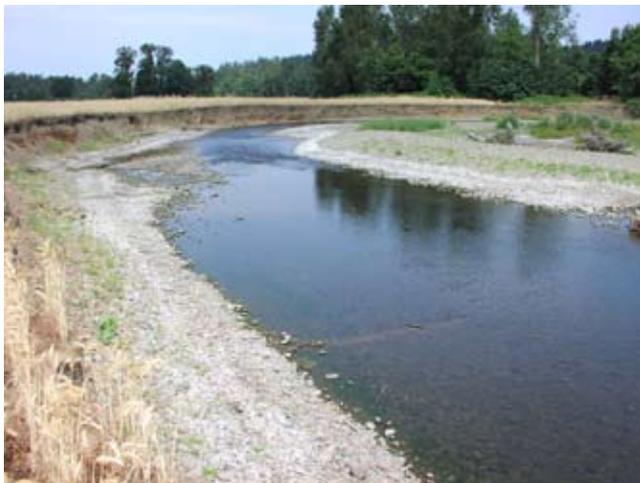
Figure CS17-1 Calapooia River project (*Photos courtesy of Scott Wright*)

(a) Preproject conditions looking downstream at outside bank during summer low flows

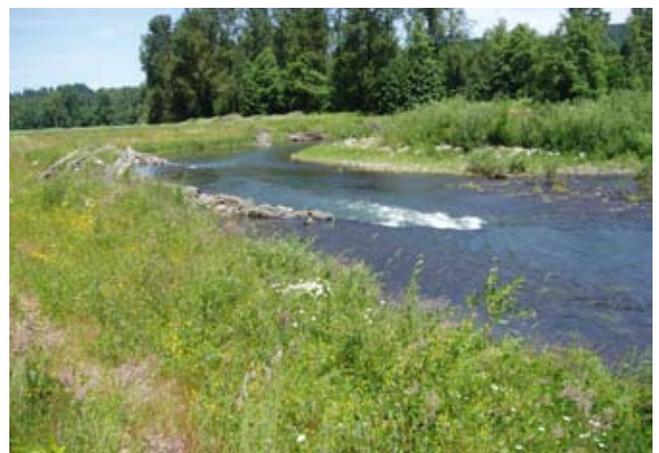
(b) Postproject conditions looking downstream at outside bank during summer low flows

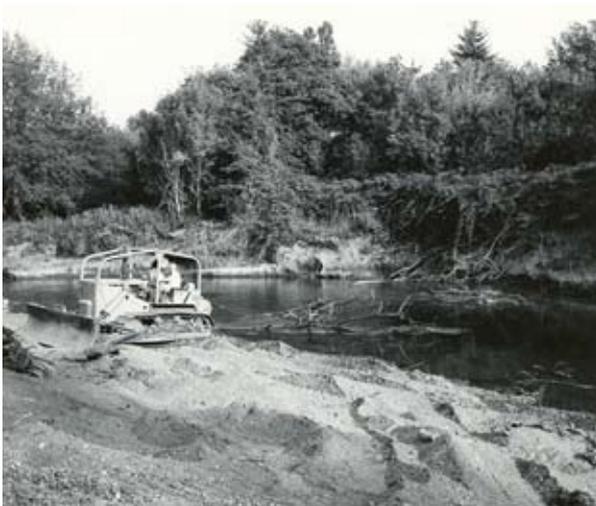
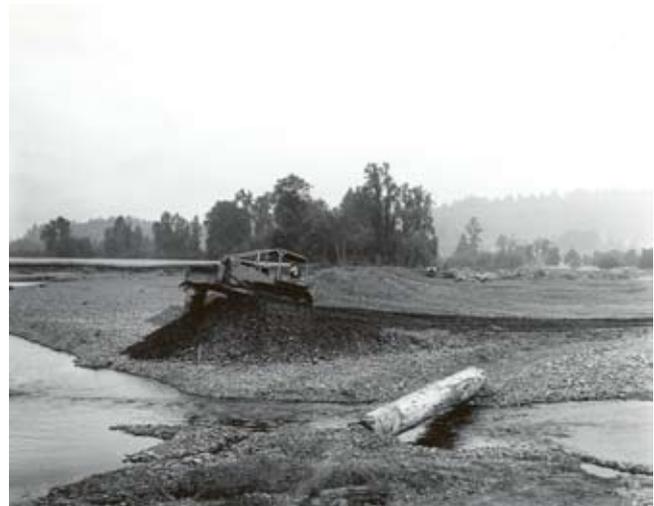
Figure CS17-2 Channel alterations in the Calapooia River in 1950s

Based on the Calapooia Watershed Assessment by the local watershed council, significant channel alterations had been performed from 1900 to 1980. Figure CS17-2 illustrates typical work in the watershed.

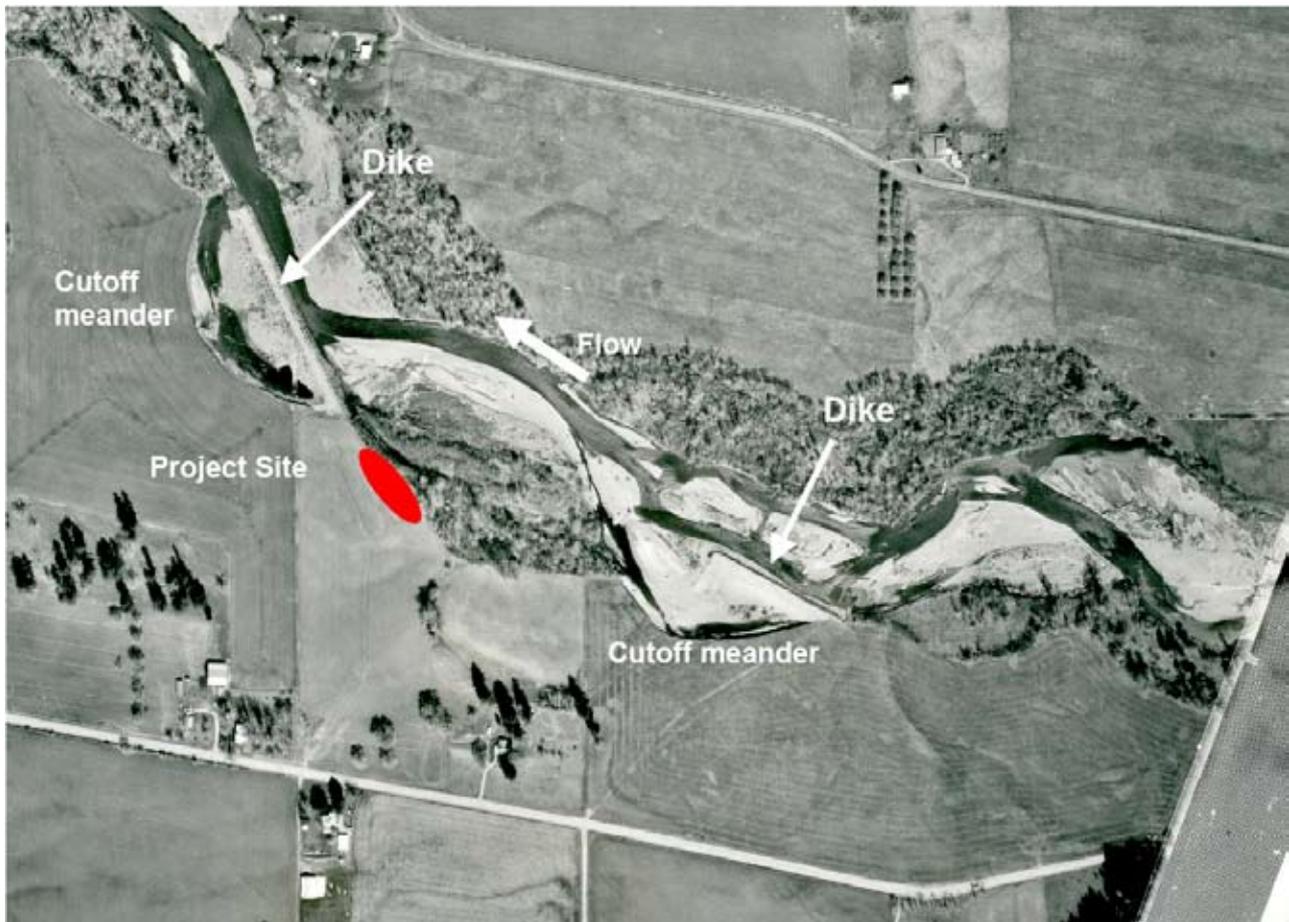
Figure CS17-3 Aerial view of project area in 1966 showing dikes used to cut off meanders

An aerial photo from 1966 (fig. CS17-3 (modified from U.S. Army Corps of Engineers (USACE) photo)) shows a dike just downstream of the project site constructed from excavated instream materials placed to cut off a meander bend. In addition to the channel realignment at the project site, another cutoff dike was constructed

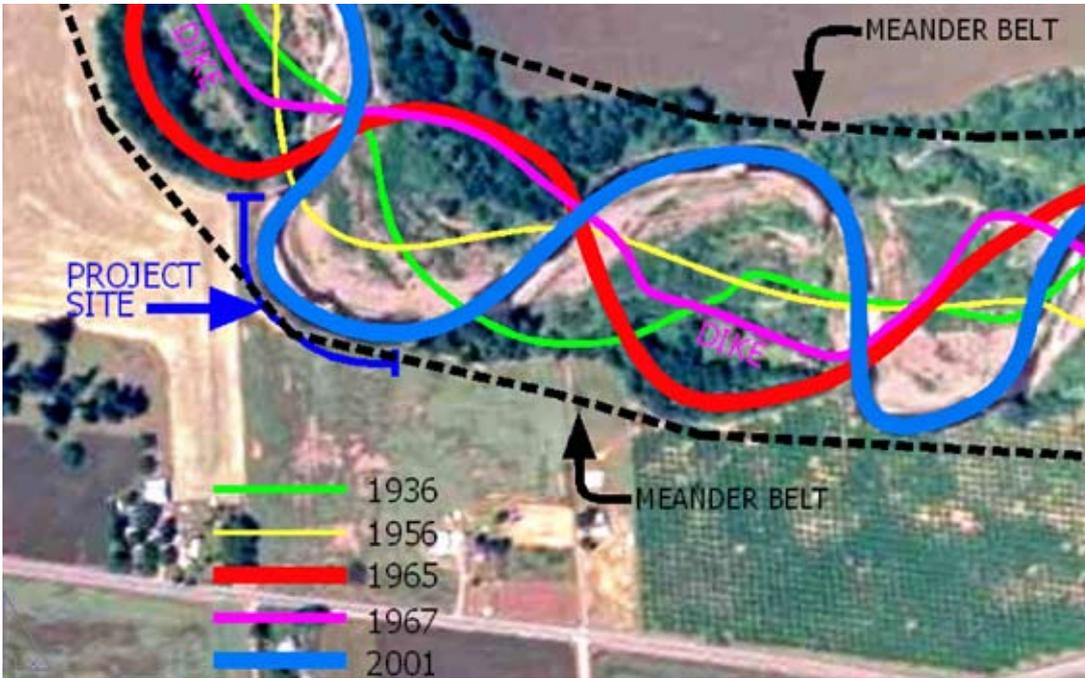
Figure CS17-4 Historic channel traces with corresponding year designated by color

It is clear from the analysis of the historic channel that the project area is located near the outer edge of the historic meander migration zone. This allows for more streambank stabilization options because the stabilization will not have an impact on overall planform, nor would it affect flood plain connectivity since the project would not change top-of-bank elevations.

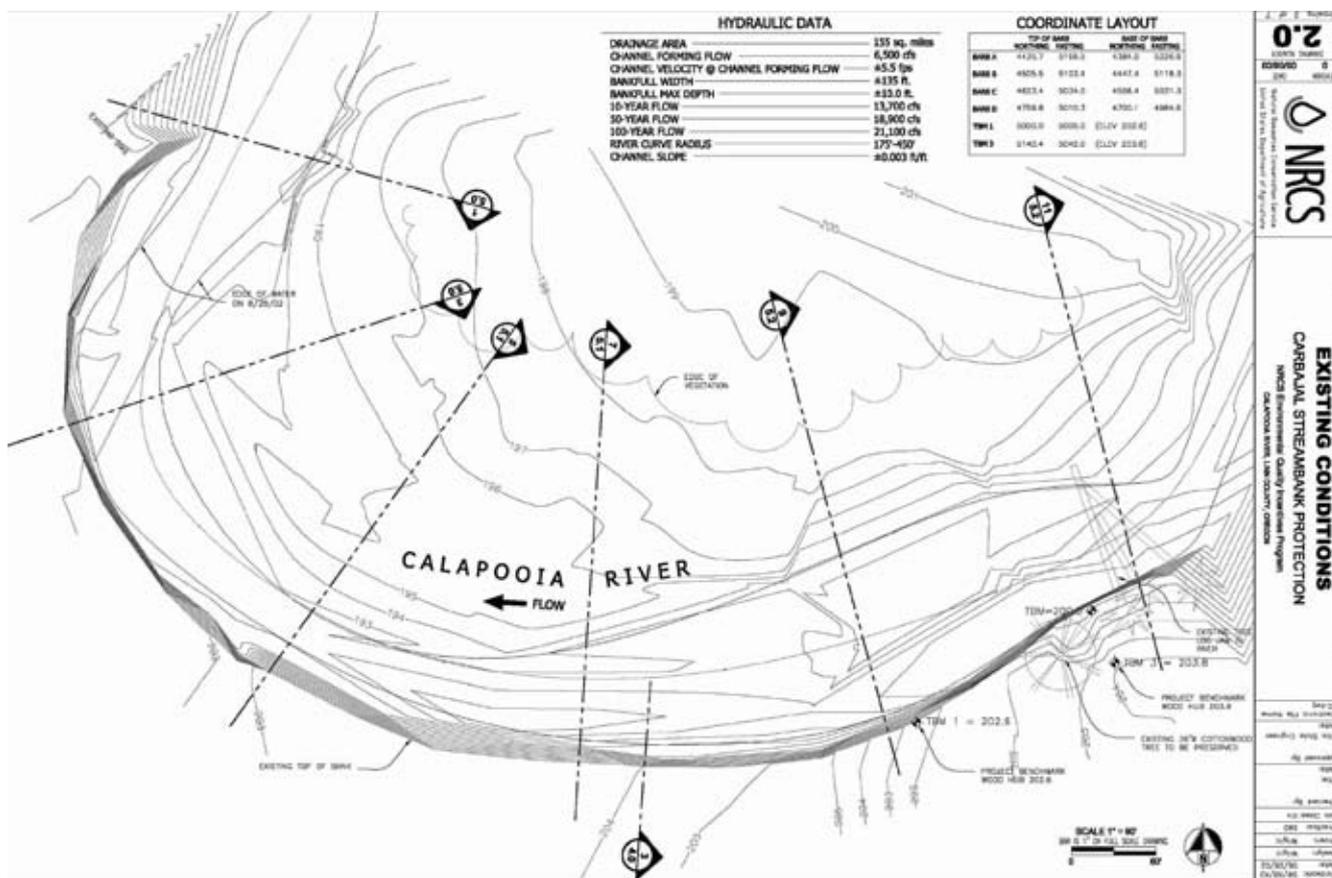
Figure CS17-5 Existing topographic drawing used for making HEC-RAS model and construction drawings

A thorough topographic survey of the project reach was performed with a Topcon GTS-211D total station, equipped with a handheld HP-48 data collector. Survey points were downloaded from the data collector into Eagle Point Civil Design software. The data points and breaklines were used in the CAD environment to generate contours and a base map (fig. CS17-5) used for design and construction drawings. River cross sections were exported to HEC-RAS (USACE 1995a) to create a hydraulic model of the site.

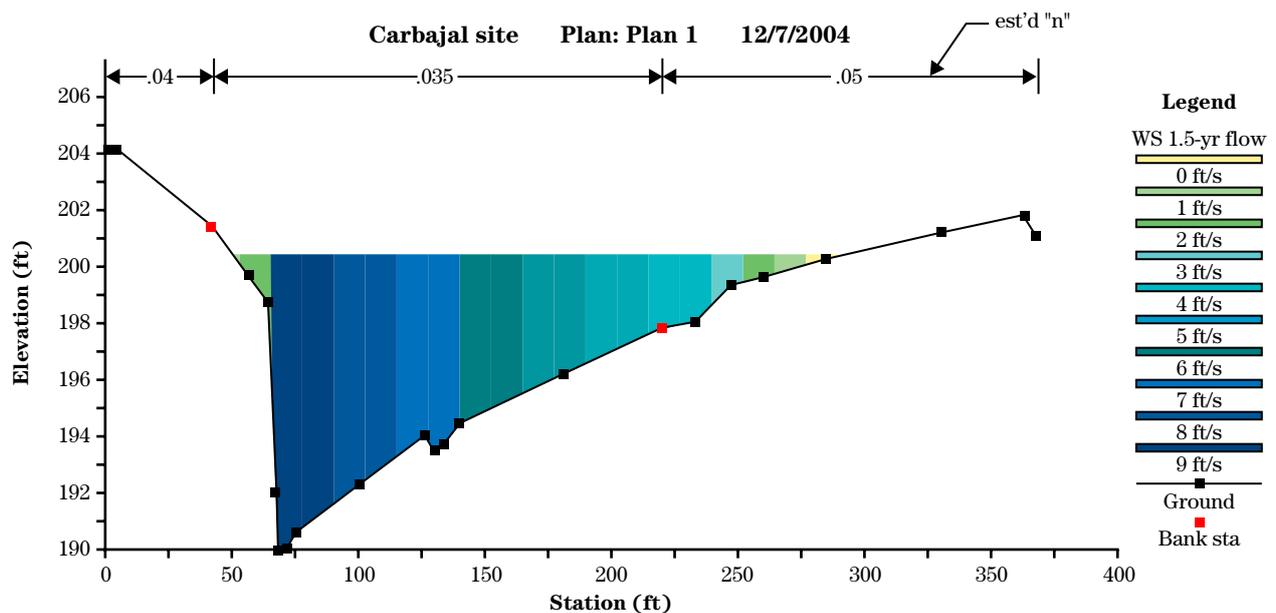
Figure CS17-6 HEC-RAS velocity distribution output for a typical cross section

A steady-state HEC-RAS model was developed based on topographic site survey and hydrologic conditions. The model was used to generate hydraulic characteristics of the site, as well as velocity distributions. In addition, the bankfull flow was determined based on physical features from the site survey combined with the HEC-RAS model and peak flow records. A typical velocity distribution cross section from HEC-RAS is shown in figure CS17-6 at bankfull stage.

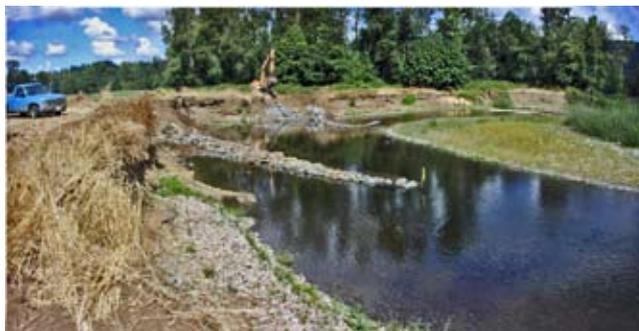
Figure CS17-7 Looking downstream at initial installation of two barbs before bank shaping, during low summer flows (*Photo courtesy of Scott Wright*)

The rock barbs were the first component to be constructed. The barbs were staked out using steel “T” posts driven into the riverbed along the design alignment. This practice allowed the contractor to work on the streambank and have a constant view of the proper barb alignment. Figure CS17-7 shows the two downstream barbs immediately after construction and prior to any bank shaping.

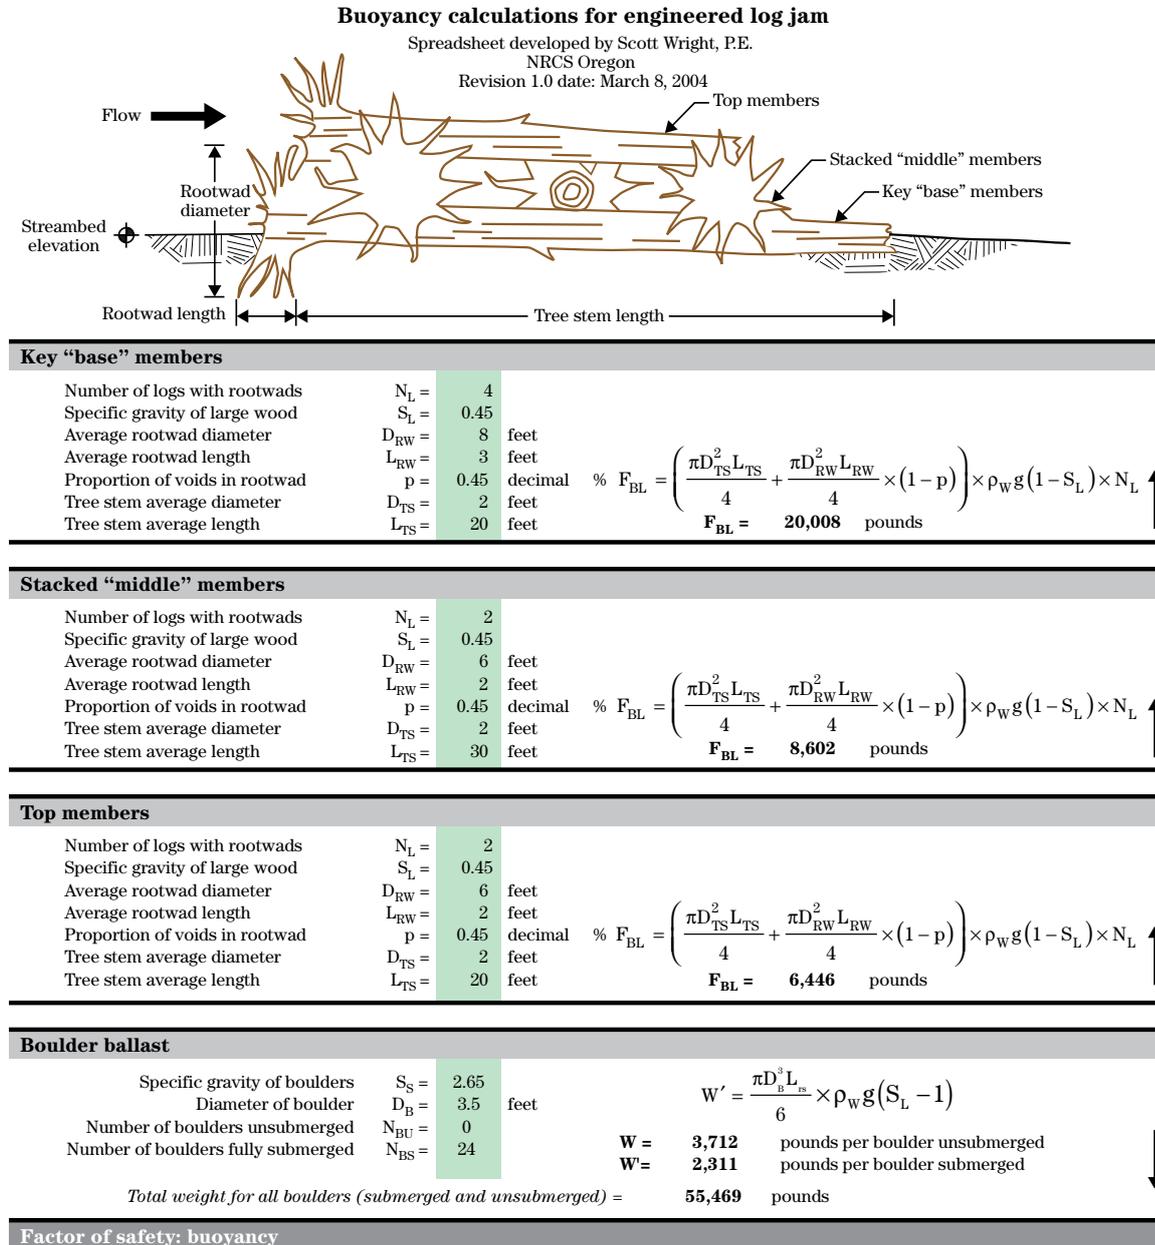
Figure CS17-8 Typical spreadsheet for calculating factor of safety against log structure buoyancy

(2000) performance-based research which is similar to NEH654 TS14J. These authors state “lateral drag forces do not need to be considered explicitly and the factor of safety against buoyancy can be used as a simple design criterion” for multiple log structures that are tied together. Therefore, a buoyancy calculation was used as the design basis for the log structures (fig. CS17-8).

A simplified approach is used to estimate buoyancy where the logs and ballast boulders in the logjam are fully submerged. In addition, the logjam and boulders act as a composite structure and are assumed fully connected. Water velocity inside the logjam is highly turbulent and near zero, therefore, vertical uplift forces are assumed negligible.

$$FS_B = \frac{W + W'}{\sum F_{BL}}$$

$$= 1.58 \quad \mathbf{FS_B = 1.58}$$

D'Aoust and Millar (2000) recommend a minimum factor of safety of 1.5 against buoyancy for log structures. Based on experience using log structures in Oregon, this minimum factor of safety against buoyancy is an adequate design parameter. However, it is recommended that the factor of safety be closer to 2.0 and that the large wood be connected together to allow the structure to act as a single unit. These connections also provide better stability in the structure for placing ballast material. The higher factor of safety also allows for greater flexibility during construction when working with imperfect and irregular logs.

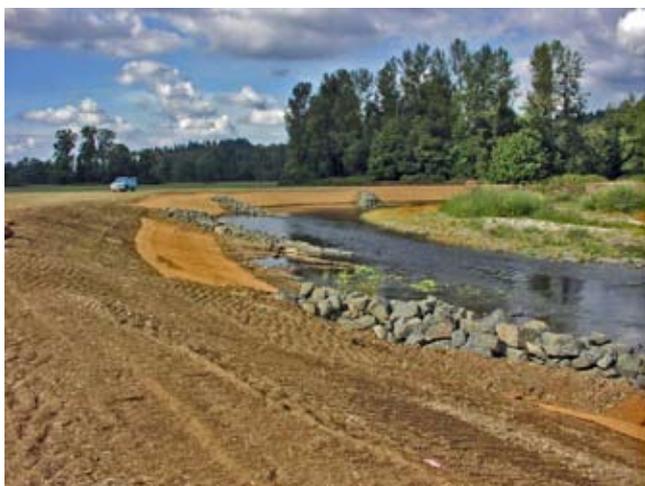
Figure CS17-9 Looking downstream at completed project showing barbs and erosion control mat during summer flow (*Photo courtesy of Scott Wright*)

al grass seed was planted, along with a 3-year, degradable erosion control blanket. The blanket provided immediate stabilization of the soil and exposed bank until the vegetation could establish (fig. CS17-9). The erosion control blanket had a permissible shear stress of 2.25 pounds per square foot that easily exceeded the 10-year flow maximum shear stress of 1.2 pounds per square foot predicted in the HEC-RAS model.

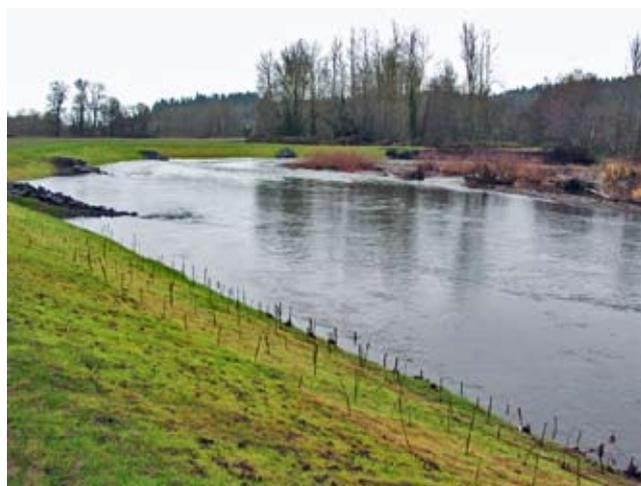
Figure CS17-10 Winter baseflow with planted willows and grass

Just 3 months after project completion, a gaged storm event occurred that measured between a 5- and 10-year peak flow. The project withstood the storm event with no noticeable erosion or adverse effects to the surrounding area (fig. CS17-10). Large amounts of wood collected on top of each barb and especially near the downstream third of the meander bend—at the engineered log structure (fig. CS17-11).

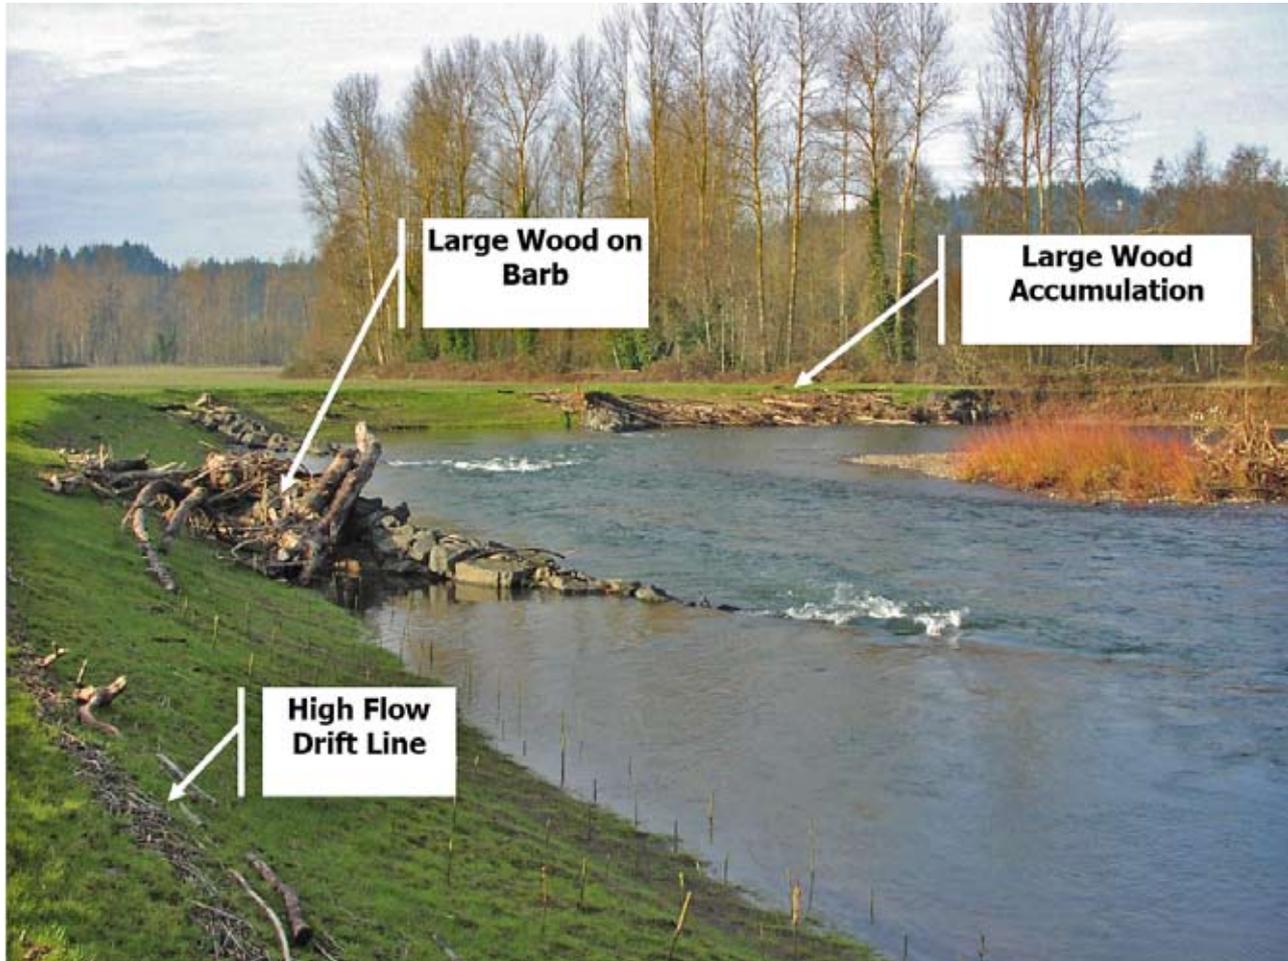
Figure CS17-11 Looking downstream at completed project area after 10-year storm event (*Photo courtesy of Scott Wright*)

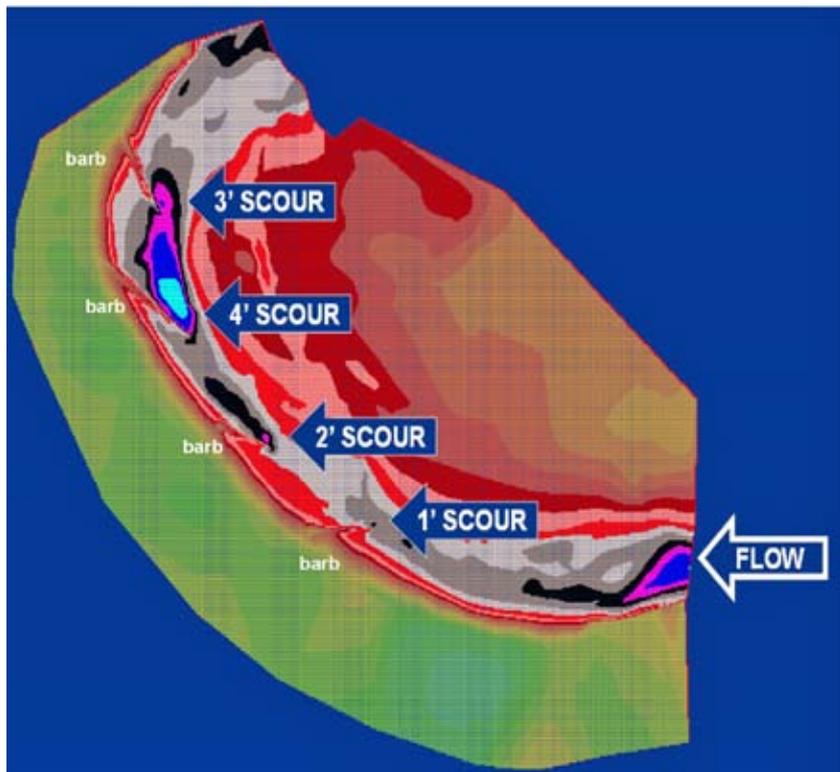
Figure CS17-12 Actual scour around each barb following 5- to 10-year peak flow event. Each color band gradient represents a 1-foot elevation increment. (Photo courtesy of Scott Wright)

Detailed topographic information was collected pre- and postconstruction to identify actual geomorphic effects of the stream barbs and overall performance. Figure CS17-12 identifies the actual scour that occurred around each barb and the streambed.

Because of the barbs, no scour or erosion occurred along the outside bank of the meander. As illustrated in figure CS17-12, the hydraulic effect of the barbs caused local scour and constriction scour. The scour pattern begins around the tip of the barb and extends downstream in an elliptical shape. This pattern is similar to other observations made in Oregon around barb groups on C3 and C4 gravel-bed rivers.

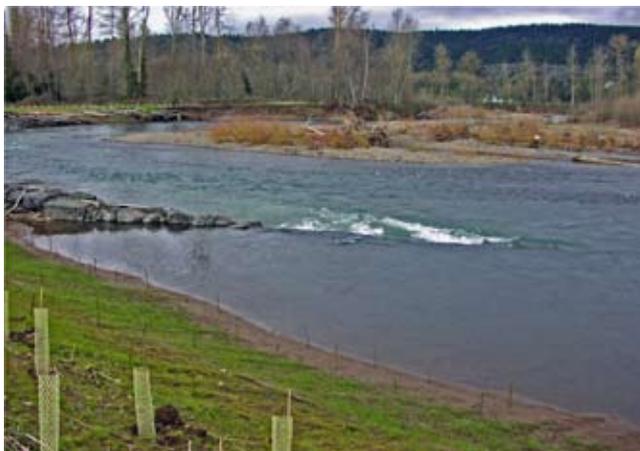
Figure CS17–13 Example of energy dissipation from a hydraulic jump formed over one of the project barbs during winter baseflow (Photo courtesy of Scott Wright)

Energy dissipation within the project reach is caused by scour and a hydraulic jump at each barb. Figure CS17-13 shows the distinct hydraulic jump as water flows over the barb. This jump is progressive with stage because of the crest slope of the barb weir. Based on this project and several other observations of barbs, a 15H:1V slope appears to be an optimal weir slope to enact the hydraulic jump throughout various discharge stages.

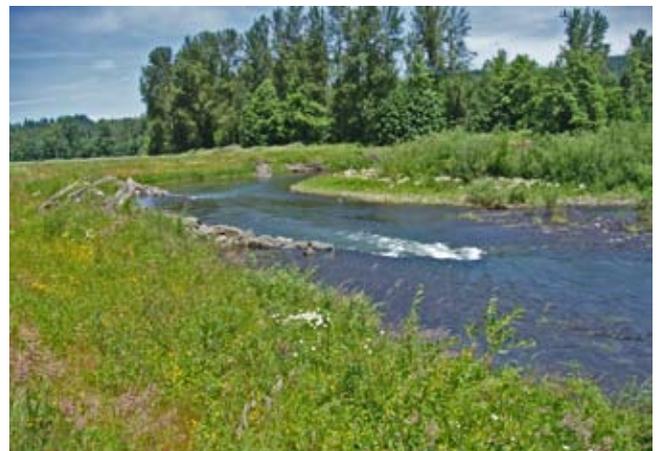
Figure CS17–14 Looking downstream 3 years after project completion with extensive vegetation growth (Photo courtesy of Scott Wright)

erosion problems downstream. Figure CS17–14 shows the completed project 3 years after construction. A significant number of willows now grow in the reach corridor and further reduce near bank flow velocities. The vegetation provides habitat to promote biodiversity that was not present in the preproject state.
