Case Study 4

**Silver Creek,
Silver Creek, New York**

Reinforced Soil Wall Silver Creek, New York

*By Frank T. Cousin, Jr., soil bioengineer, P.E.;
and Fred Gasper, civil engineer, P.E.; U.S.
Department of Agriculture, Natural Resources
Conservation Service, East Lansing, Michigan*

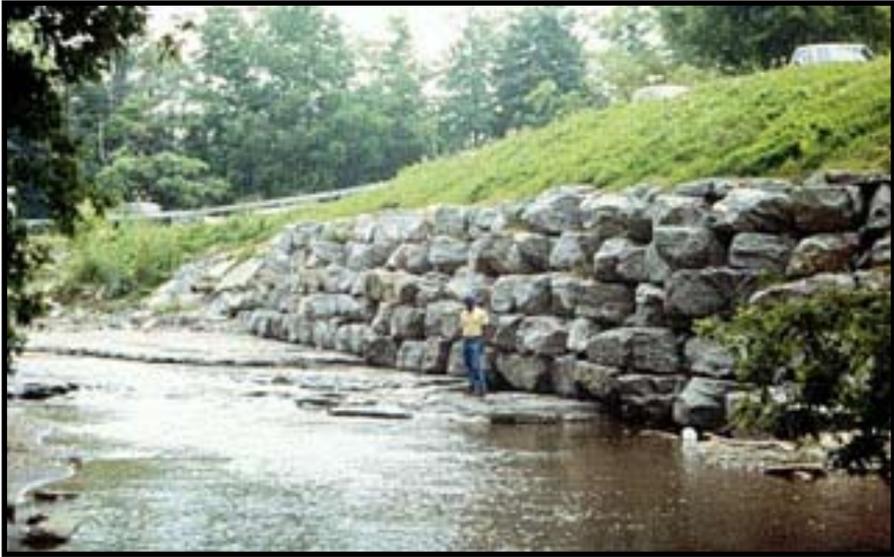
Cover photo: Completed section of Silver Creek, Silver Creek, New York

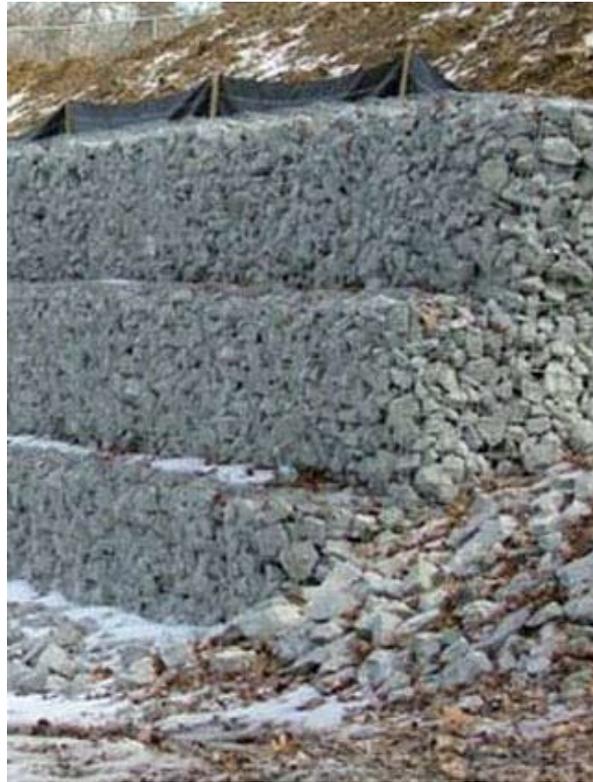
Figure CS4-2 Gabion wall

The gabion wall (fig. CS4-2) was not selected because of abrasion expected from bed-load and suspended load.

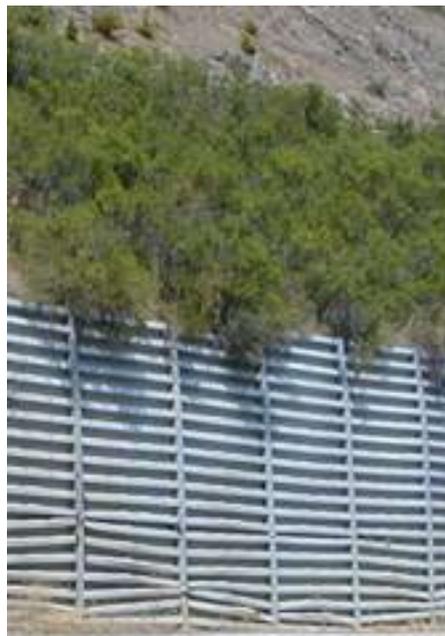
Figure CS4-3 Bin wall

Both the bin wall (fig. CS4-3) and the concrete retaining wall (fig. CS4-4) were considered as viable alternatives. The cost estimate for a bin wall or concrete retaining wall was \$90,000.

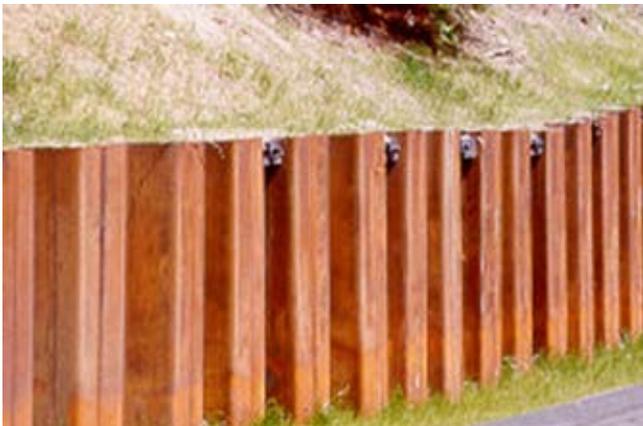
Figure CS4-1 Sheet pile wall

The sheet pile wall (fig. CS4-1) was not considered a viable alternative because of the shale bedrock foundation.

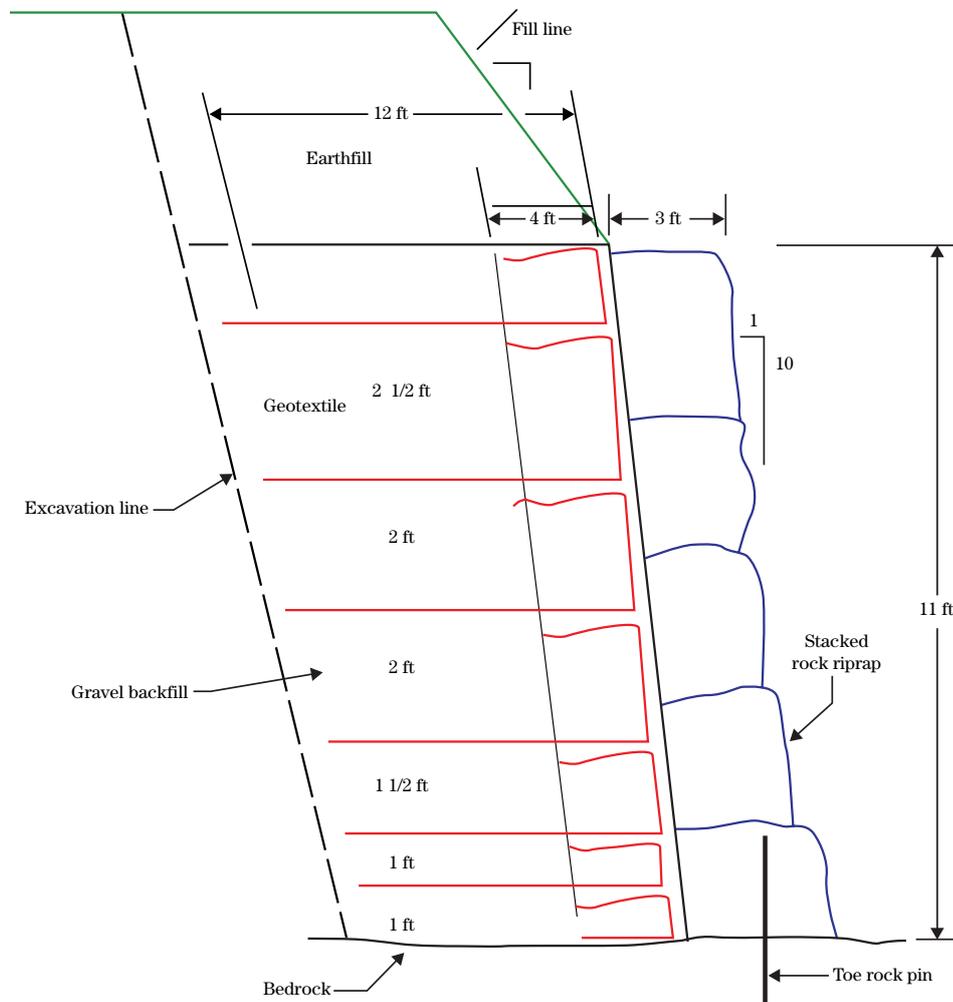
Figure CS4-5 Reinforced soil wall detail, Silver Creek, NY

A fourth alternative, a reinforced soil wall or slope, was investigated (fig. CS4-5). The estimated cost for a reinforced soil wall or slope was \$45,000. After researching this technique, it was chosen as the best alternative for stabilizing the site.

The height of the slope varies from 4.6 meters (15 ft) to 5.8 meters (19 ft). The height of the reinforced soil wall is 3.4 meters (11 ft) (fig. CS4-5).

The spacing of the geotextile ranged from 0.31 meters (1 ft) to 0.76 meters (2.5 ft), with an embedment length equal to the height of the wall (fig. CS4-5). No secondary reinforcement was required because the backfill soil was compacted against the rock riprap facing. This resulted in no sagging of the geotextile-wrapped face.

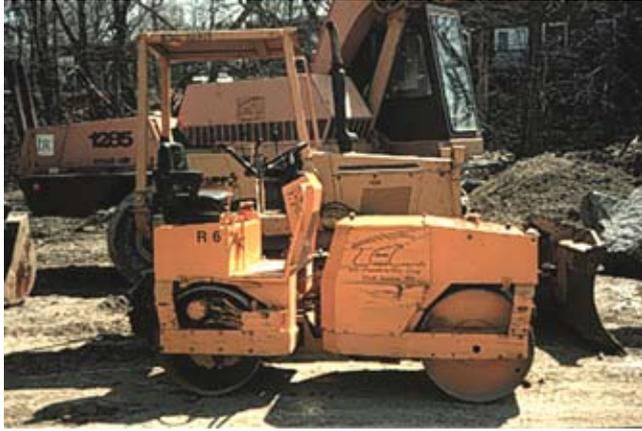
Figure CS4-6 Compaction equipment

The geotextile reinforcement and gravel backfill were “brought up” with the stacked riprap facing (figs. CS4–8 and CS4–9). The gravel backfill was compacted with a rubber-tired Case 1285 backhoe, a small bulldozer (Caterpillar® D4 equivalent), and a manually directed vibrating drum roller (figs. CS4–6 and CS4–7). The backfill within 2 feet of the wall facing was compacted with a manually directed power tamper (plate).

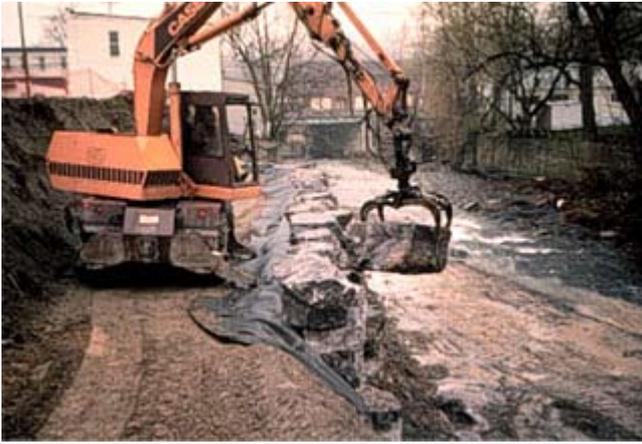
Figure CS4-10 Stacked riprap face placement

One of the big advantages of using stacked rock riprap as the facing was that the gravel backfill could be compacted against the facing, eliminating the need for slip forms or some other method of compacting the backfill material near the facing. Small pieces of limestone were used to fill in the voids between the larger stacked riprap to protect the wrapped geotextile face.

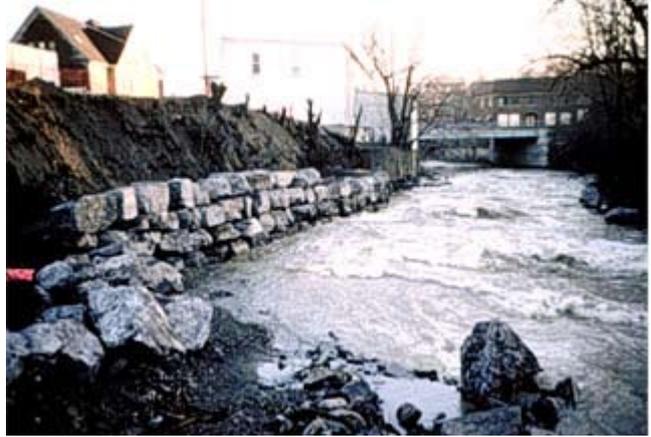
Figure CS4-11 Flow during construction

Of concern was the potential for erosion of the first course of rock being at high velocity flows. This concern was addressed by pinning the first course of rock (toe rock) to the underlying shale bedrock. The pinning was accomplished by 1-inch-diameter steel bars driven through the toe rock into the bedrock.

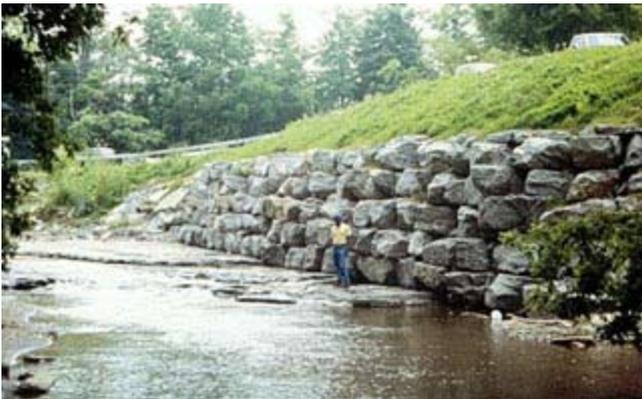
Figure CS4-12 Completed wall

The reinforced soil wall was completed within 15 construction days (figs. CS4–12 and CS4–13). John Burt, Silver Creek Village Manager, reported that 2 weeks after the wall was completed, flows within Silver Creek came within 2 feet of the top of the wall. He stated that, “we would have lost the (Spencer Place) road for sure without the wall.”

The reinforced soil wall has been tested by high flows and is functioning as designed. The limestone riprap provided an aesthetically pleasing face. There is some herbaceous vegetation growing on ledges and openings within the rock face. Over time, sediment trapped within the interstices of the stacked riprap should expedite vegetation growing on the rock face. This will add to the aesthetics of the reinforced soil wall.
