Case Study 4

**Silver Creek,
Silver Creek, New York**

Reinforced Soil Wall Silver Creek, New York

*By Frank T. Cousin, Jr., soil bioengineer, P.E.;
and Fred Gasper, civil engineer, P.E.; U.S.
Department of Agriculture, Natural Resources
Conservation Service, East Lansing, Michigan*

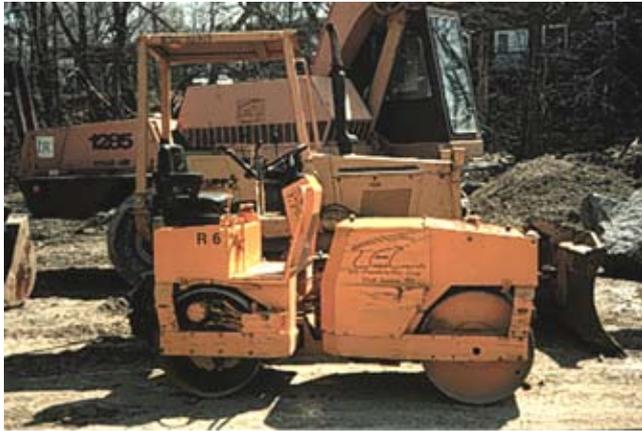
Figure CS4-6 Compaction equipment

The geotextile reinforcement and gravel backfill were “brought up” with the stacked riprap facing (figs. CS4–8 and CS4–9). The gravel backfill was compacted with a rubber-tired Case 1285 backhoe, a small bulldozer (Caterpillar® D4 equivalent), and a manually directed vibrating drum roller (figs. CS4–6 and CS4–7). The backfill within 2 feet of the wall facing was compacted with a manually directed power tamper (plate).

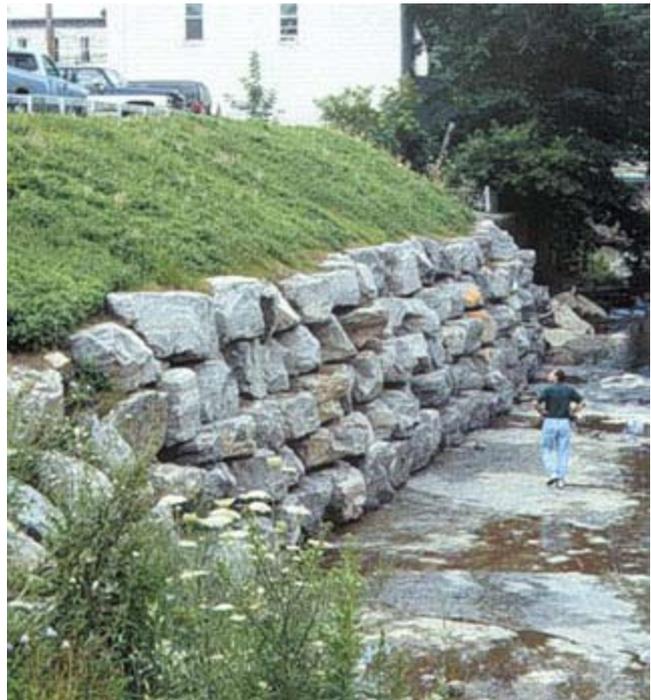
Figure CS4-12 Completed wall

The reinforced soil wall was completed within 15 construction days (figs. CS4–12 and CS4–13). John Burt, Silver Creek Village Manager, reported that 2 weeks after the wall was completed, flows within Silver Creek came within 2 feet of the top of the wall. He stated that, “we would have lost the (Spencer Place) road for sure without the wall.”

The reinforced soil wall has been tested by high flows and is functioning as designed. The limestone riprap provided an aesthetically pleasing face. There is some herbaceous vegetation growing on ledges and openings within the rock face. Over time, sediment trapped within the interstices of the stacked riprap should expedite vegetation growing on the rock face. This will add to the aesthetics of the reinforced soil wall.
