Case Study 9

Little Blue River, Washington County, Kansas

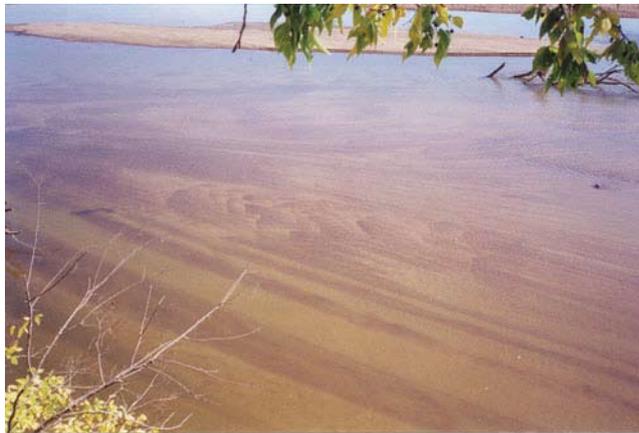
The Little Blue River flows through the eastern portion of rural Washington County, Kansas, and has a drainage basin of approximately 9,065 square kilometers (3,500 mi²). More than half of the river basin is in south-central Nebraska. The bed material is predominantly sand and gravel (.062–64 mm in diameter) (fig. CS9–1).

Figure CS9–1 Little Blue River streambed

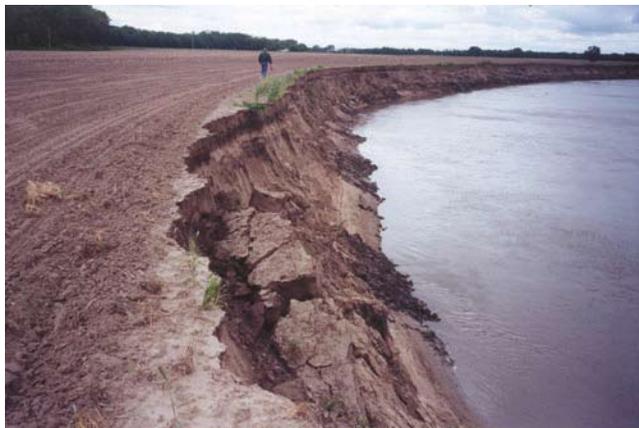
Most fields along the stream were under cultivation within a few meters of the streambank edge each year (fig. CS9–2). Among the stabilized areas, only site 3 had any permanent riparian vegetation.

Figure CS9–2 Site 22, prior to construction

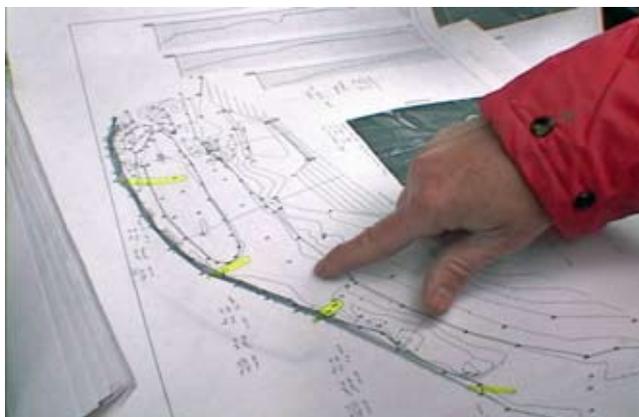
Each site was surveyed by the SCC and NRCS staff with a total station survey instrument. Data points were downloaded into computers, and topographic maps were produced for each site. The maps were then used for measurements and project stabilization design (fig. CS9–3).

Figure CS9–3 Typical project map and design

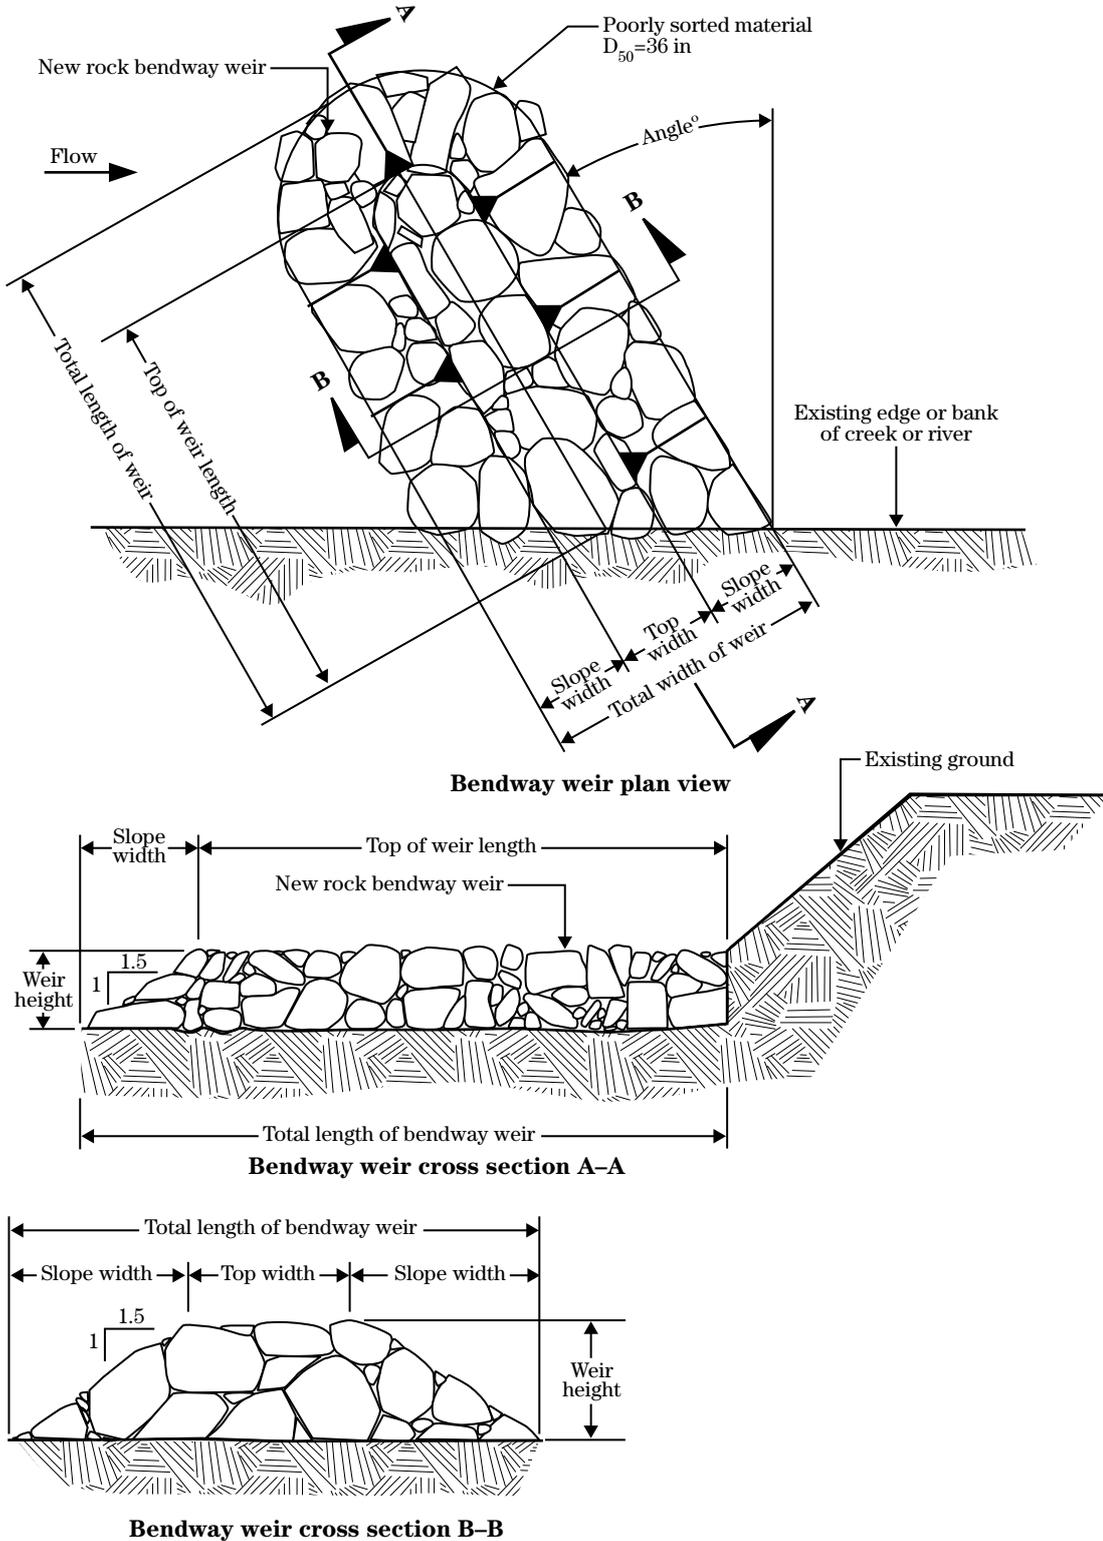
shallow. The areas surveyed with water depths greater than 0.5 to 0.75 meter (18–25 in) were upstream of a few isolated, large, woody material piles. The SCC and KDHE staffs designed all projects, choosing bendway weirs for the primary stabilization structure because of the stream's high width/depth ratio (fig. CS9–4).

Bendway weirs redirect water flowing over them, which slows water velocities along the near bank region (Derrick 2001). A weir also moves the thalweg away from the bank to the end of the weir. The design height of all bendway weirs was a third to a half meter (1–1.5 ft) above the water surface at low flow. David Derrick, USACE, reviewed the initial 20 project designs.

Figure CS9-4 Bendway weir detail

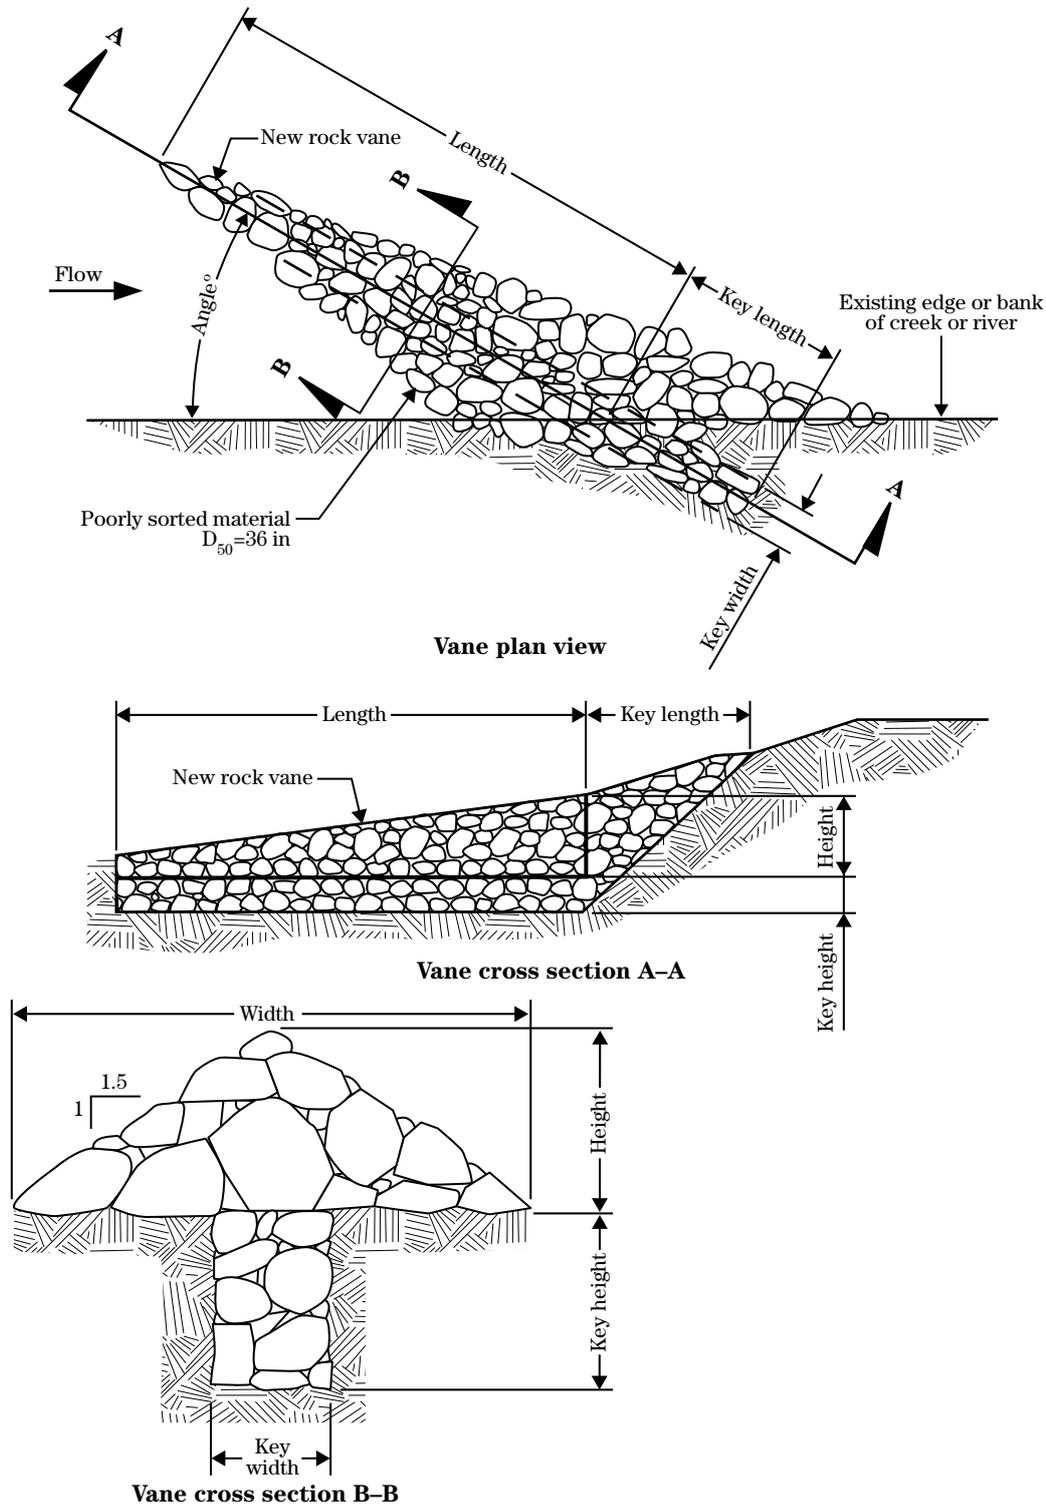
On sites 8 and 21, the radius of curvature was very low. To keep from pushing the thalweg a great distance from the bank and keep from radically redirecting streamflow, rock vanes were chosen as the stabilization method for these sites (fig. CS9–5).

Figure CS9-5 Rock vane design detail

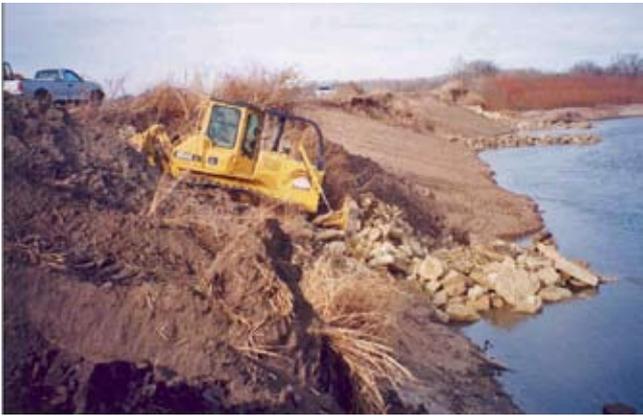
On early projects, weirs were constructed by excavating ramps into the streambanks, dumping rock on the ramp, and then pushing the rock into the stream with bulldozers (fig. CS9–6).

Figure CS9-6 Building weir on site 28

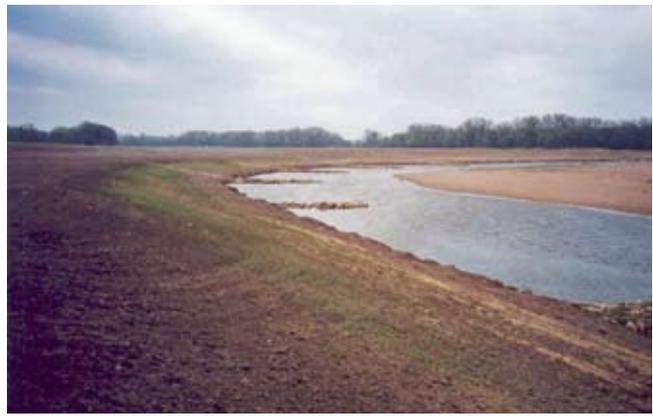
After reshaping the vertical banks, winter wheat or oats were sown on the slopes and mulched with native prairie hay. Projects constructed in phases 2 and 3 were sown to wheat or oats but not mulched (fig. CS9–9).

Figure CS9-9 Site 1, 04/02/03: Oats beginning to grow

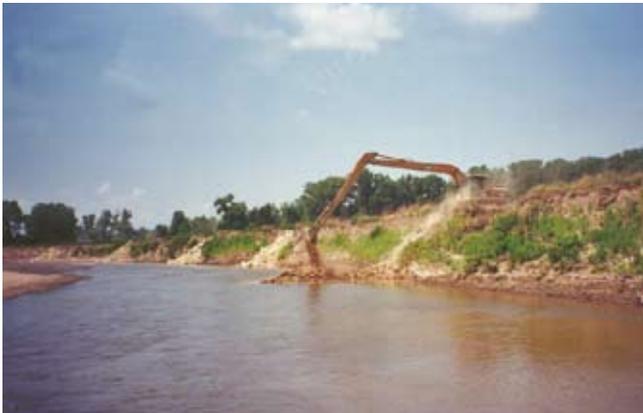
After the first few projects, rock was dumped directly over the streambank and then moved into place with an excavator (fig. CS9–7).

Figure CS9-7 Weir construction on site 22

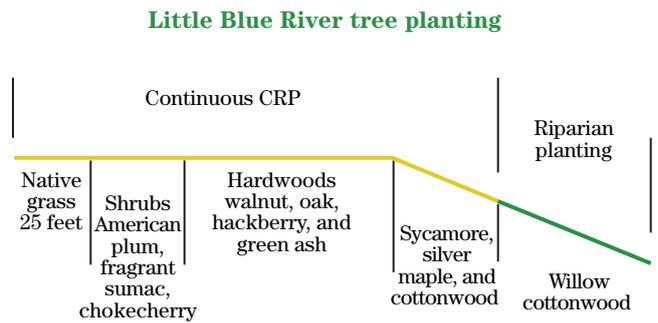
The riparian area between the CCRP strip and edge of water was planted with live willow stakes and bare-root cottonwood seedlings. Live willow stakes were planted on 1.2- by 1.2-meter (4 by 4 ft) spacing. Cottonwood seedlings were planted on 1.8- by 1.8-meter (6 by 6 ft) spacing. In the CCRP strip, trees were planted on 2.4- by 2.4-meter (8 by 8 ft) spacing or 3.0- by 3.7-meter (10 by 12 ft) spacing. All shrubs were planted on 1.8- by 1.8-meter (6 by 6 ft) spacing. Planting a 7.62-meter-wide (25 ft) strip of native grasses and forbs between the shrubs and the cultivated crop field completed the CCRP (fig. CS9–10).

Figure CS9-10 Planting diagram

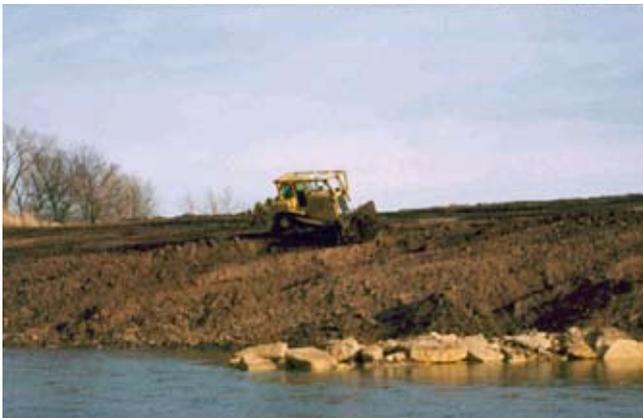
Following construction of the bendway weirs, the vertical banks were reshaped to a 3H:1V slope (fig. CS9–8). On all sites using bendway weirs for stabilization, the near vertical banks were shaped by pushing them into the river channel (cut and fill method). This accomplished three things: it eliminated the need to key the weirs into the bank, reduced construction costs by reducing required equipment time, and reduced the amount of valuable cropland required for the slope.

Figure CS9-8 Bank shaping with bulldozer

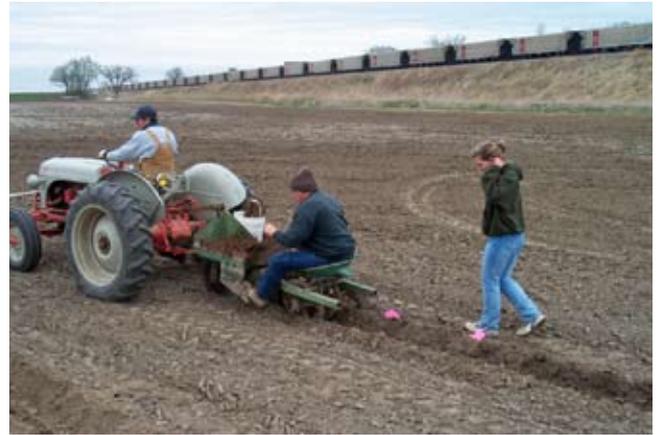
All trees on the slope were planted by hand. Trees on the flat portion of the buffer were planted with farm tractors and tree planters (fig. CS9–11).

Figure CS9–11 Tree planting on site 11

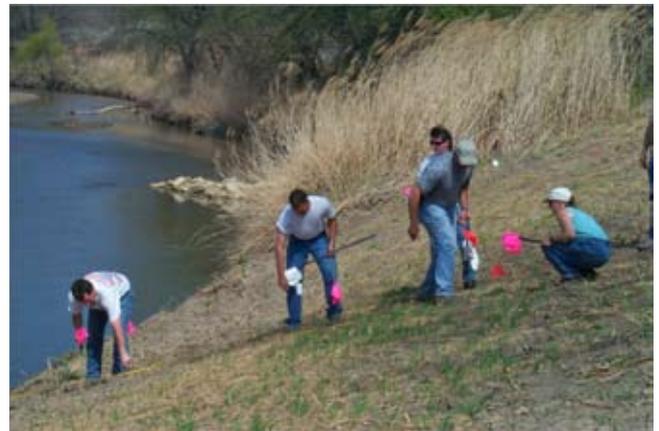
Agency personnel with NRCS, SCC, and the KFS measured and flagged the tree rows (fig. CS9–12).

Figure CS9–12 Measuring and flagging tree rows

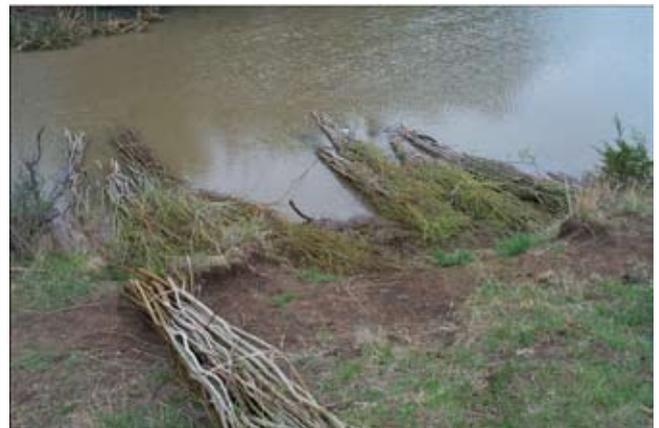
Prior to planting, willows were soaked for a minimum of 10 days (fig. CS9–13).

Research has shown that the survival rate for live willow stakes doubles when the stakes are soaked for this amount of time prior to planting (Schaff, Pezeshki, and Shields 2002). Student members of area Future Farmers of America chapters harvested all willow stakes used in the 2002 planting season. Live willow stakes for the 2003 planting season were purchased from the KFS.

Figure CS9–13 Willow cuttings soaking in ponds

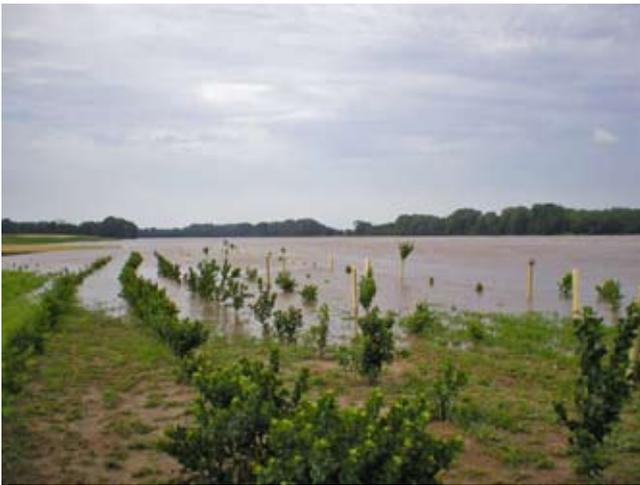
Projects completed in early 2002 were inundated with two flows that approached the bankfull magnitude in June and September 2002. Another bankfull flow event occurred in early May 2003. Minimal erosion occurred at the stabilized sites during these flows. Slight erosion from the moderate flows required the addition of one structure on two sites. In late June 2003, severe weather and torrential rainfall in south-central Nebraska resulted in substantial flooding along the Little Blue River (fig. CS9–14).

Figure CS9-14 Site 1, June 24, 2003, prior to peak flood

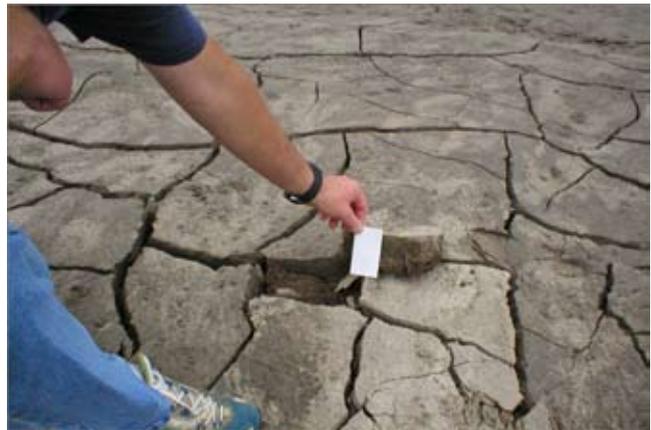
Sediment deposition occurred on several sites. This was evident between the weirs and on the banks (fig. CS9-16).

Figure CS9-16 Sediment deposition

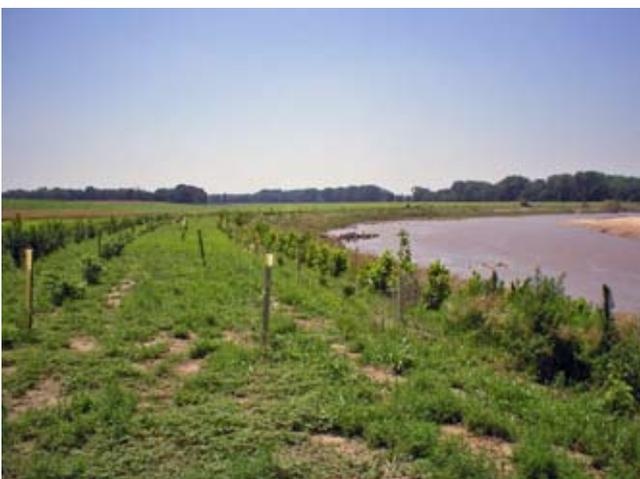
second ($40,000 \text{ ft}^3/\text{s}$) at the Hollenberg, Kansas, stream gage. Downstream, at the USGS gage near Barnes, Kansas, flows peaked at 906.3 cubic meters per second ($32,000 \text{ ft}^3/\text{s}$). No damage occurred at 20 of the 24 completed sites (fig. CS9-15). Four sites did incur slight damage that was limited to a small portion of each. The problems all appeared on the lower third of the

Figure CS9-15 Site 1, July 2, 2003, following $1,133$ cubic meter ($40,000 \text{ ft}^3/\text{s}$) flow

project sites and were corrected in the fall and winter of 2003 by installing Longitudinal Peaked Stone-Toe Protection or additional rock on the weirs.

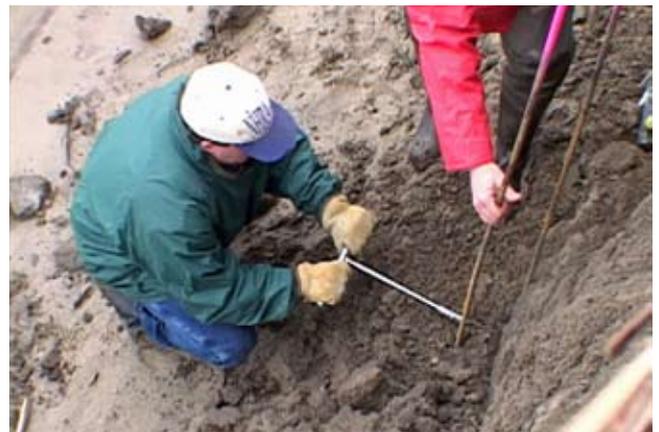
Soil samples were also taken at each site. On most sites, one sample was taken for every meter of bank height (fig. CS9-18).

Figure CS9-18 Taking soil samples, site 6

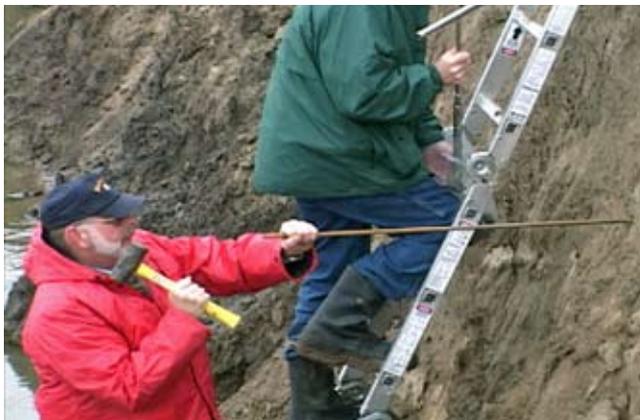
Various types of research projects were conducted at project sites. One of the first was installation of bank erosion pins. In April 2001, 1.2-meter-long (4 ft) and 1.8-meter-long (6 ft) bank (erosion monitoring) pins were installed at six sites (fig. CS9-17). At another site, severe erosion warranted placing two benchmarks 8.5 meters (28 ft) away from the bank edge.

Five weeks later, an inspection trip discovered all pins lost at the six sites due to streambank erosion. At the other site, only 2.4 meters (8 ft) of the original 8.5 meters (28.3 ft) remained between the bank and one remaining benchmark.

Figure CS9-17 Installing bank erosion pins

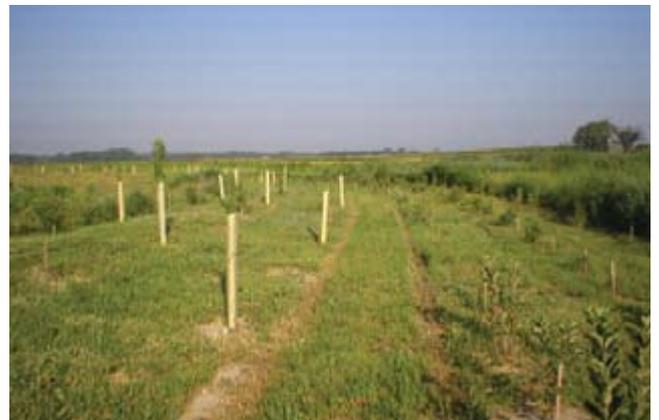
Dr. Charles Barden, KSU Research and Extension forester, assisted with tree planting design and also conducted research on various types of tree shelters (fig. CS9-19).

Figure CS9-19 Tree shelter test on site 11

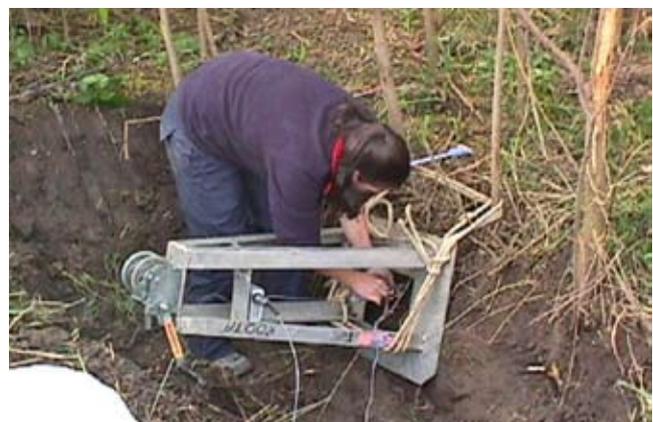
In October 2001, researchers with the USDA Agricultural Research Station (ARS), National Sediment Laboratory in Oxford, Mississippi, conducted research on the root strength and density of various species of willow and eastern cottonwood (fig. CS9–21).

Figure CS9–21 Root strength testing

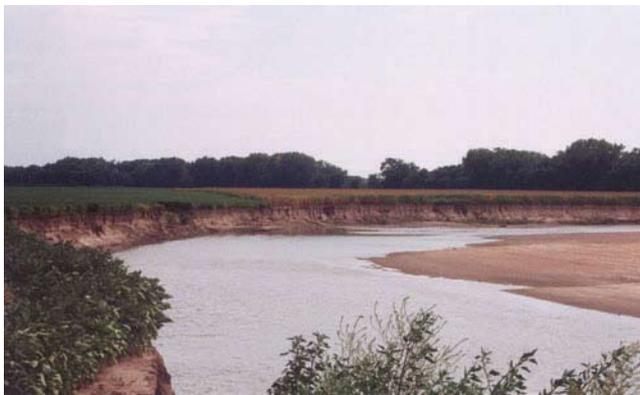
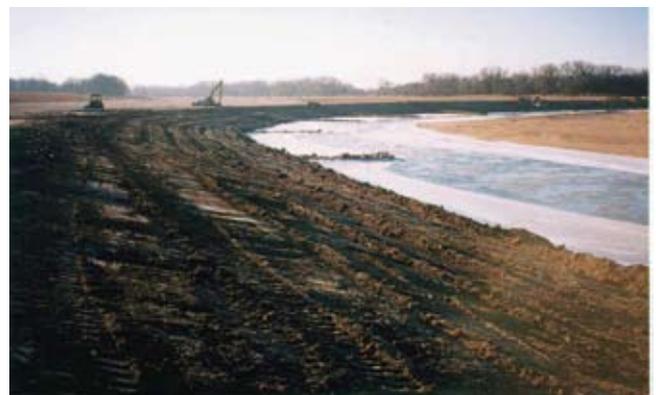
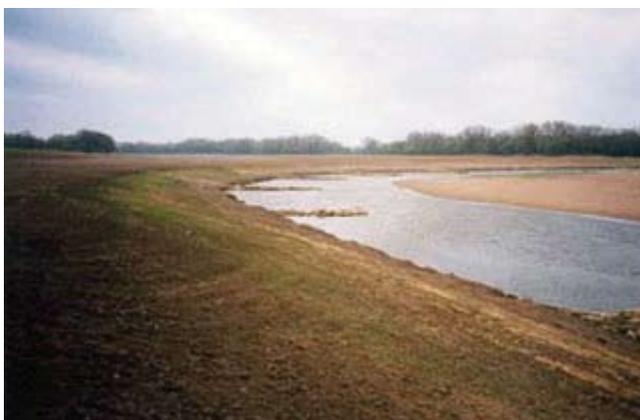
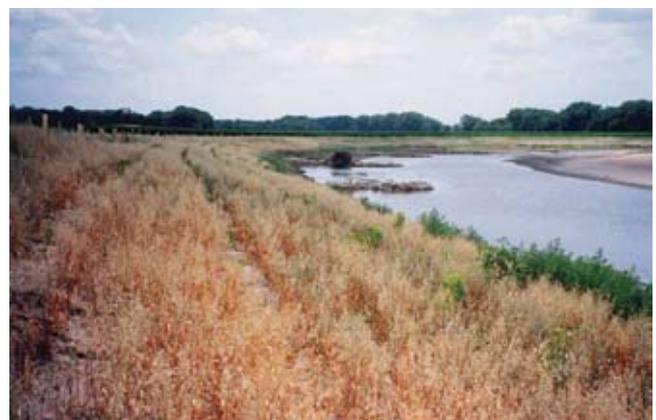
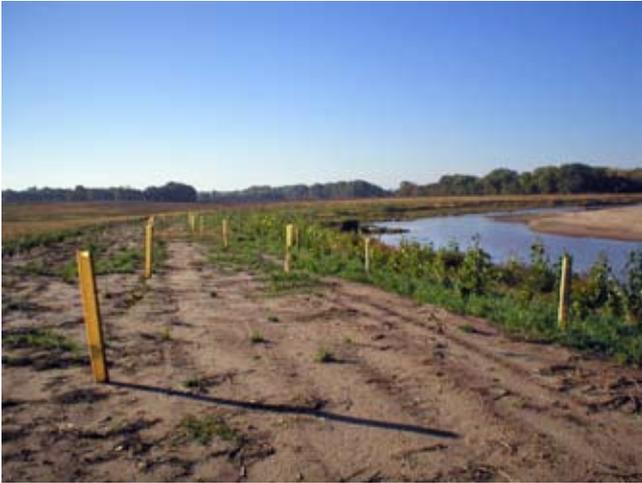
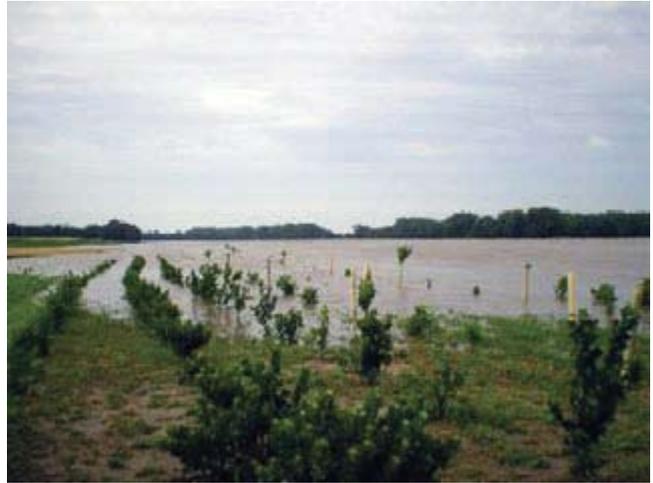
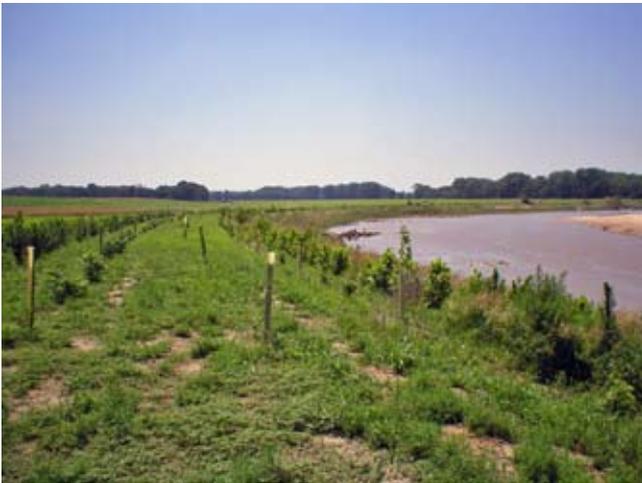
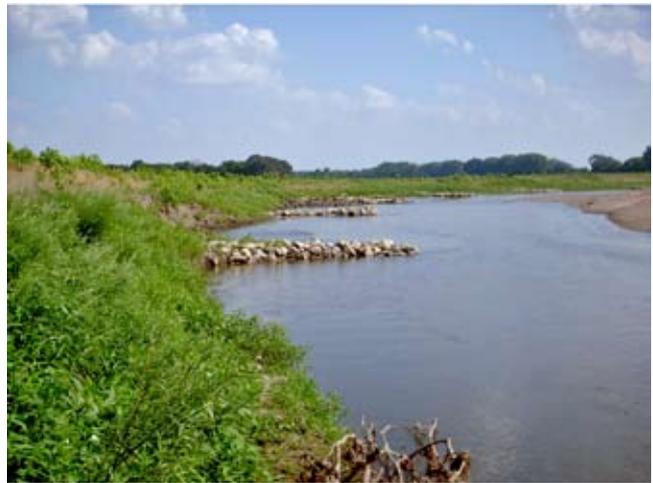
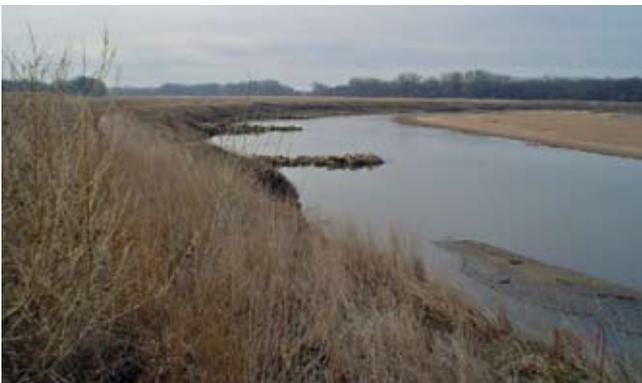
Figure CS9-22 Photo sequence of site 1

The Little Blue River Stabilization and Riparian Corridor Establishment Project has reduced loss of valuable cropland to bank erosion, extended downstream reservoir life, increased wildlife habitat, increased fisheries habitat diversity, and improved water quality. Figure CS9-22 shows the sequence changes of site 1.
