Issued August 2007

Abstract

This technical supplement presents an example of using an aerial assessment and classification of streams in the deep loess region of western Iowa. This is a large-scale effort directed by the Hungry Canyons Alliance involving approximately 5,250 miles of stream in 22 western Iowa counties. This effort has determined areas of active stream erosion and the impact streambed stabilization structures have had on controlling stream degradation. The stream assessment consisted of flying along streams in a small helicopter videotaping the stream channel and recording positions with a global positioning system receiver. Streams were classified based on a six-stage channel evolution model to describe the dominant channel processes occurring along stream reaches. Streams across the region in 1993 and 1994, and in a smaller area in 2000, were similarly classified.

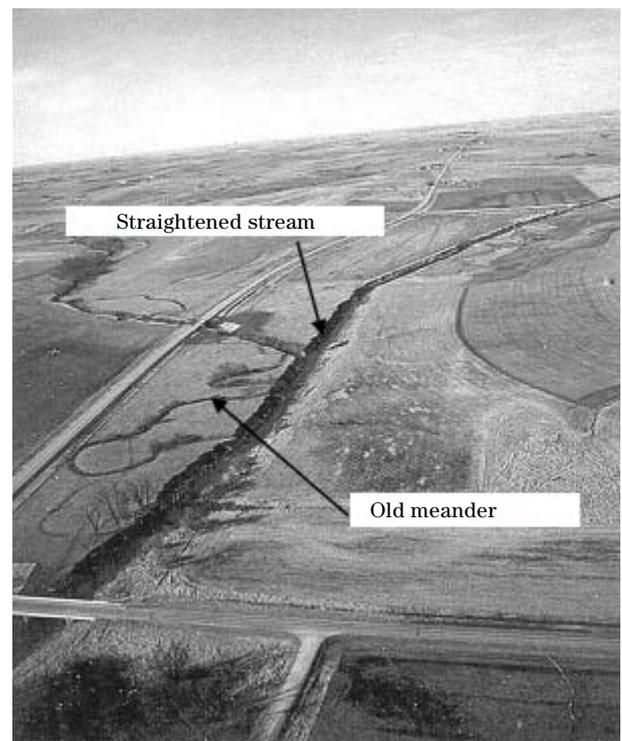
Figure TS3B-1 Straightened versus meandering stream (Walnut Creek, Pottawattamie County, IA)

Stream channel dredging, straightening, and land use changes since the early 1900s have caused many problems. After straightening, the streambed is steeper because the stream still had the same amount of fall per mile, yet there was now a shorter distance over which that fall occurred. The steeper slope increased water velocities. To reduce the water velocity, streams either had to meander or downcut. Due to the high erodibility of loess soils, the streams began downcutting, causing accelerated soil erosion in western Iowa (fig. TS3B-1).

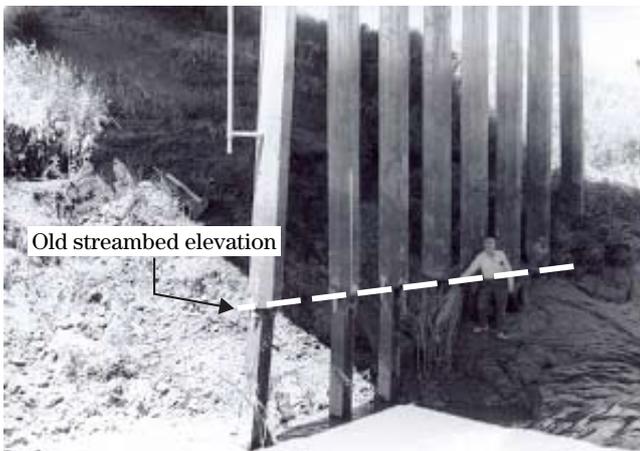
Figure TS3B-2 Bridge endangered by exhumation of pilings

As the streambed downcuts, it destabilizes bridge pilings (fig. TS3B-2), and the vertical streambanks will slump to a more stable slope, in effect widening the stream and necessitating longer bridges.

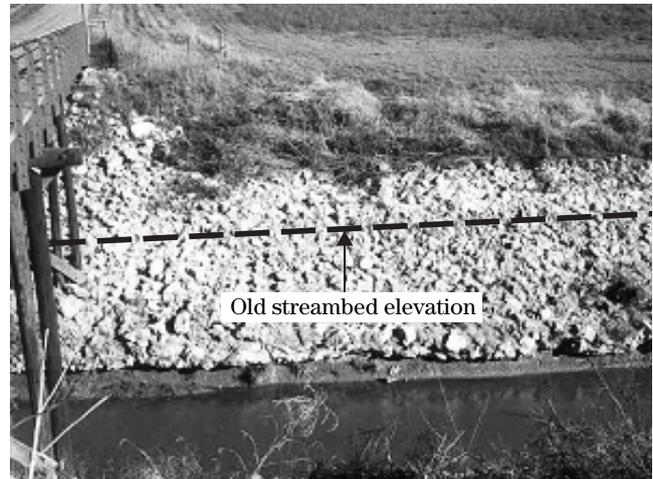
Figure TS3B-4 An NRCS bank stabilization site that did not include streambed stabilization, (Page County, IA)

Streambed stabilization is the key to preventing further erosion and protecting infrastructure (fig. TS3B-4). After the stream downcut 6 feet in 7 years, the bank stabilization was left high and dry. Dams or weirs at regular intervals will help streams stabilize by changing their profile from a steep incline to a stable stair-step pattern. Structures normally have a raised weir section, like a low-head dam. Most structures use steel sheet pile driven into the streambed 20 to 25 feet (6.1–7.6 m) and riprap to protect the banks (fig. TS3B-5).

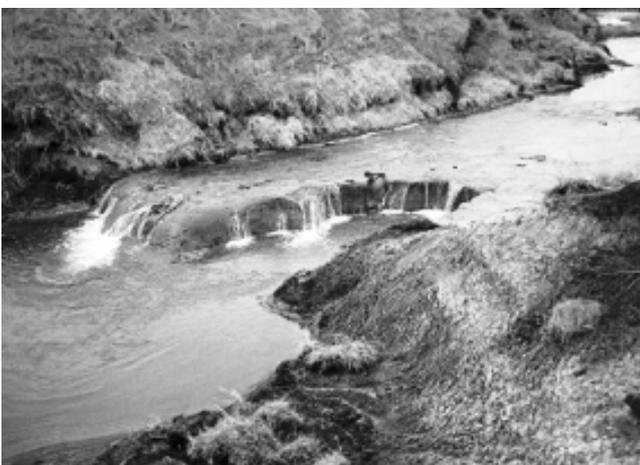
Figure TS3B-3 Nickpoint eroding headward

Nickpoints, which are naturally occurring overfalls (fig. TS3B-3), will continue to erode and advance upstream, eventually affecting the entire watershed. Bed degradation of stream channels will force the channel's tributaries to also adjust to the lowered base level, often initiating gully formation where no channel had previously existed.

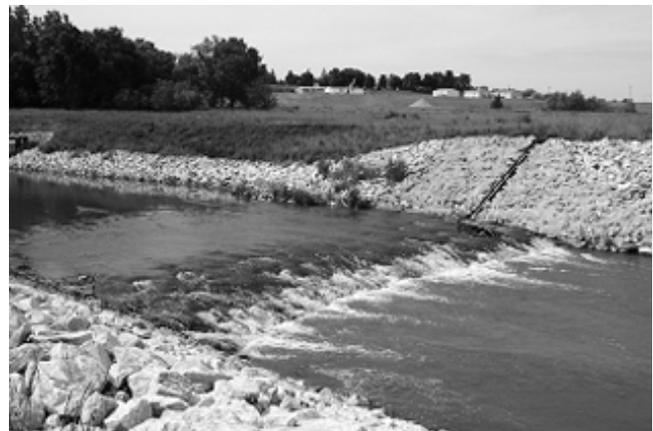
Figure TS3B-5 HCA steel sheet pile weir with riprap and cement grout that protects a large sewer main for the City of Denison, IA

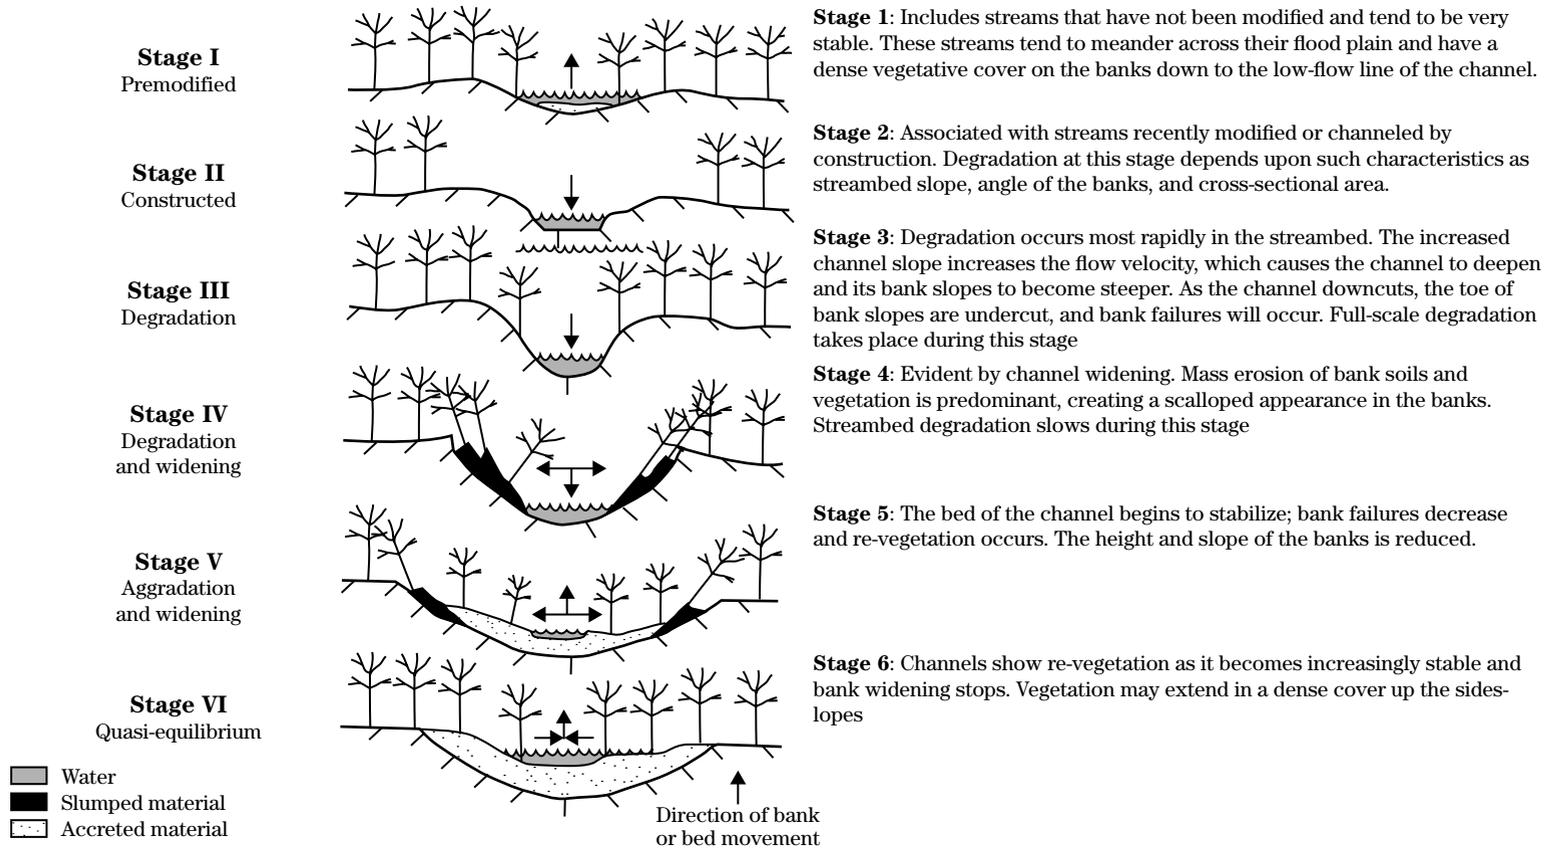
Figure TS3B-6 Six-stage channel evolution model

A six-stage channel evolution model (fig. TS3B-6, developed by Simon and Hupp (1986), was used to describe the dominant channel processes occurring along stream reaches.

In conjunction with a set of manually transcribed notes, the videotape and narration was used to classify streams by Simon's six-stage channel evolution model. Classified stream reach locations were transferred to USGS 1:100,000 scale topographic base maps by hand. These hard copy maps were then converted to a digital data set using the Geographic Resources Analysis Support System (GRASS) geographic information system (GIS) software package. GRASS GIS is an open source free software GIS that is largely command line driven. In 2000, the NRCS reclassified streams in four counties and classified streams in two additional counties using the same process.

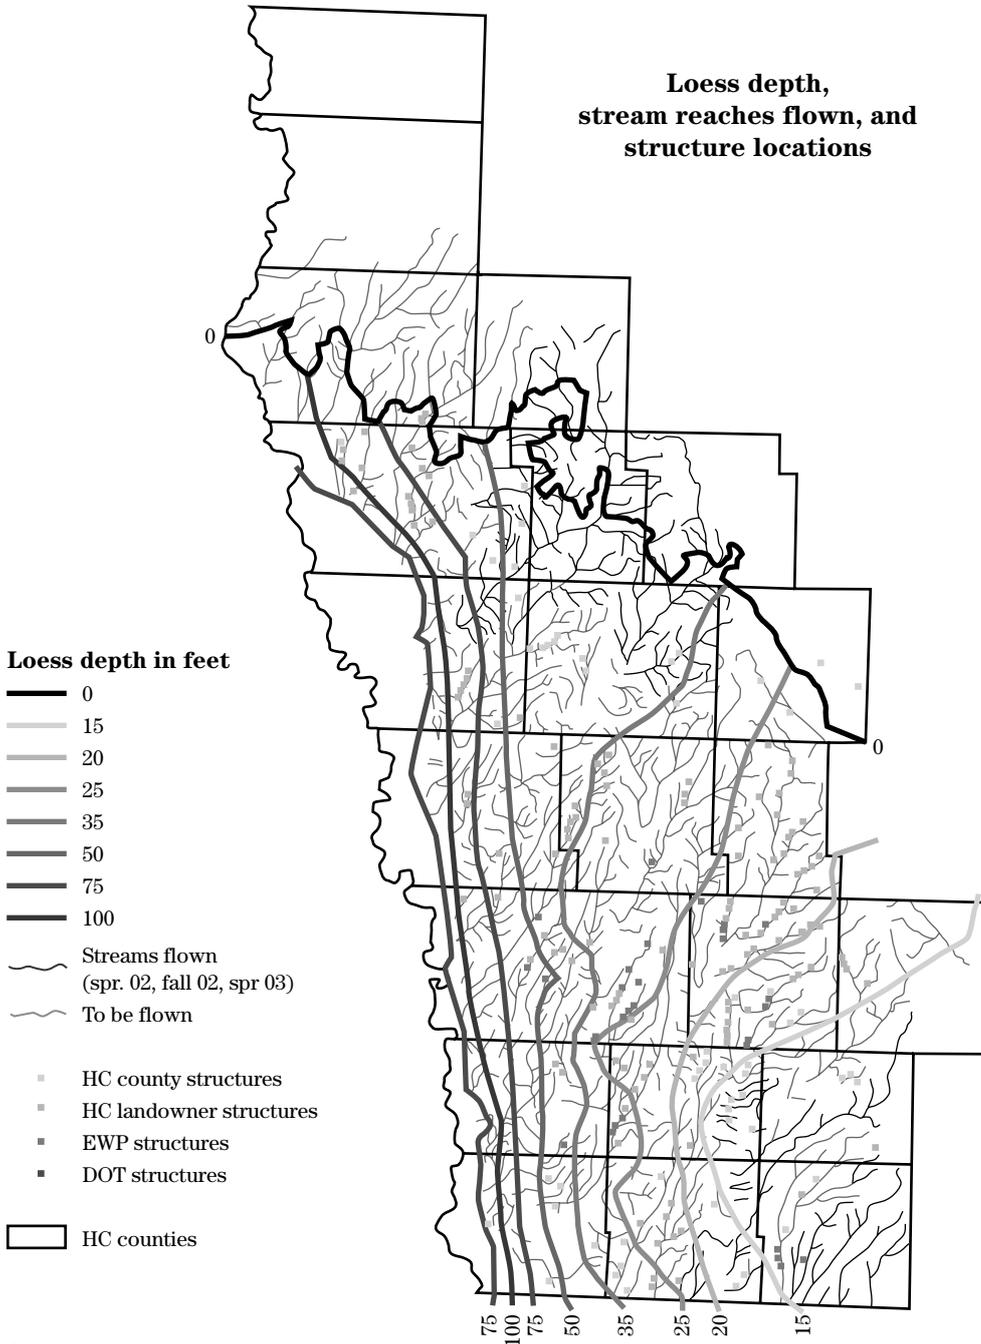
Figure TS3B-7 Stream reaches flown and classified in 2002 and 2003, grade control structure locations, loess depth, and 22 western Iowa counties in the HCA

The stream reaches that were flown in the spring and fall of 2002 and the spring of 2003 are shown in figure TS3B-7. Also shown in figure TS3B-7 is the 22-county HCA region, loess thickness, and locations of known grade control structures (207 HCA, 300 EWP, 6 Iowa DOT, and 39 landowner-installed grade control structures).

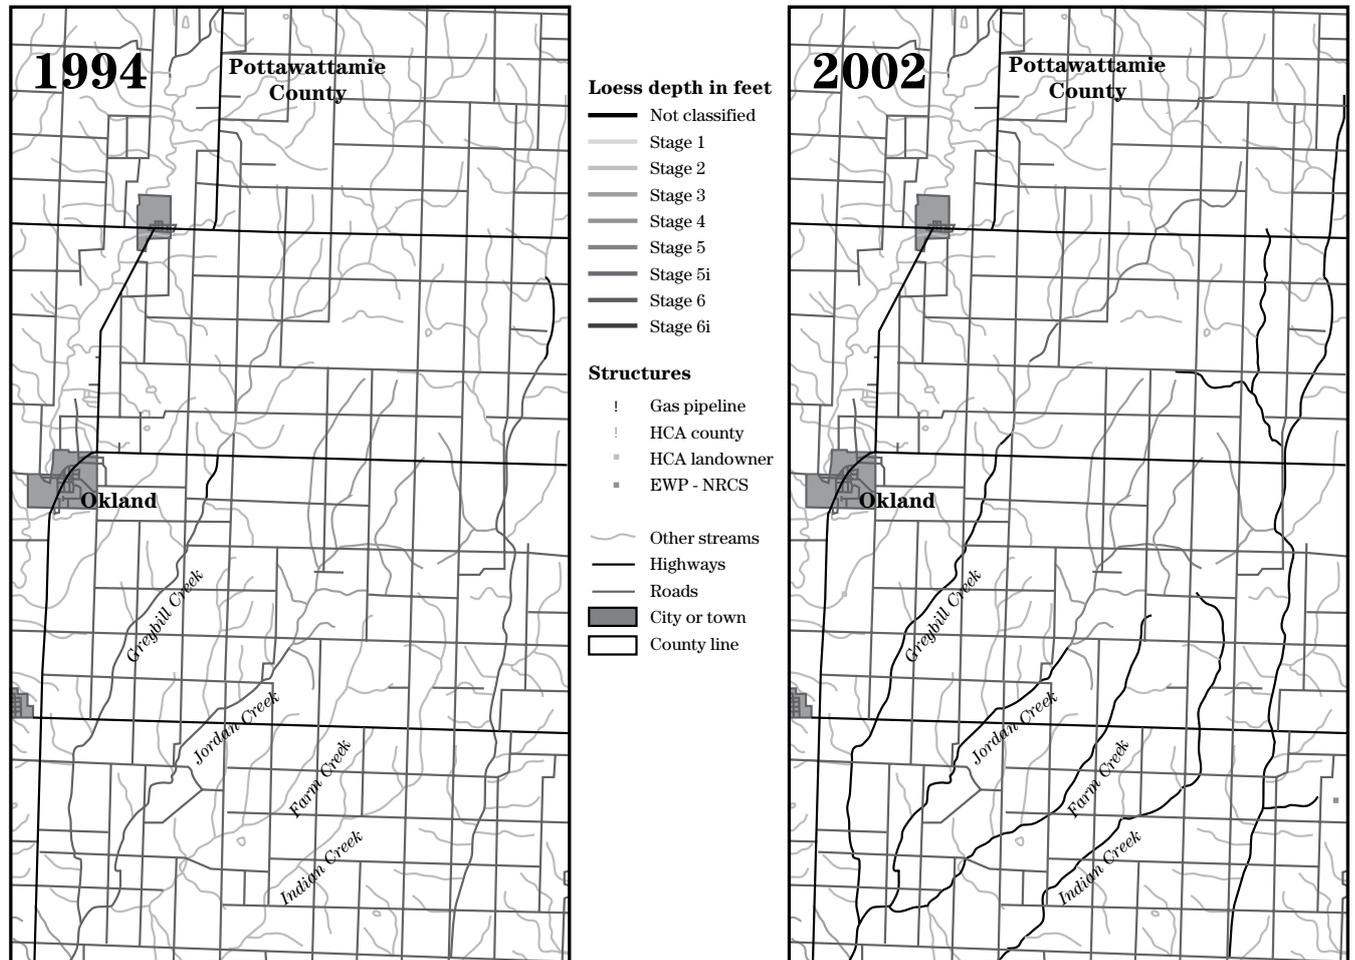
Figure TS3B-8 Comparison of two classified stream reaches on Graybill and Jordan Creeks in 1994 and 2002

To determine the progression of erosion through time and the impact streambed stabilization structures have had on controlling stream degradation, two segments of stream that were classified in 1994 and again in 2002 are shown for comparison in figure TS3B-8. In 1994, Graybill and Jordan Creeks in Pottawattamie County were predominately stage 4, with stage 3 farther upstream in the watersheds. Only two structures had been built on these streams at that time. The arrow

points to a bridge where 23 feet (7 m) of degradation was recorded between 1972 and 1993. By 2002, 14 additional structures had been built on these two creeks. The streams have become less erosive and more stable, with the average stream at stage 5.

Degradation has migrated about 5 miles (8 km) upstream with stages 3 and 4 occurring only near the headwaters of the streams.

Grade control structures appear to have helped stabilize large stretches of stream. Streambeds up to 1 mile (1.6 km) upstream from the structures have been stabilized (fig. TS3B-8). For example, the rapid stabilization of Graybill and Jordan Creeks is largely due to the construction of grade control structures at regular intervals.
