Figure TS3B-1	Straightened versus meandering stream (Walnut Creek, Pottawattamie County, IA)	TS3B-1
Figure TS3B-2	Bridge endangered by exhumation of pilings	TS3B-2
Figure TS3B-3	Nickpoint eroding headward	TS3B-2
Figure TS3B-4	NRCS bank stabilization site that did not include streambed stabilization (Page County, IA)	TS3B-2
Figure TS3B-5	HCA steel sheet pile weir with riprap and cement grout that protects a large sewer main for the City of Denison, IA	TS3B-2
Figure TS3B-6	Six-stage channel evolution model	TS3B-4
Figure TS3B-7	Stream reaches flown and classified in 2002 and 2003, grade control structure locations, loess depth, and 22 western Iowa counties in the HCA	TS3B-6
Figure TS3B-8	Comparison of two classified stream reaches on Graybill and Jordan Creeks in 1994 and 2002	TS3B-7

This technical supplement presents an example of using an aerial assessment and classification of streams in the deep loess region of western Iowa. This is a large-scale effort directed by the Hungry Canyons Alliance involving approximately 5,250 miles of stream in 22 western Iowa counties. This effort has determined areas of active stream erosion and the impact streambed stabilization structures have ha

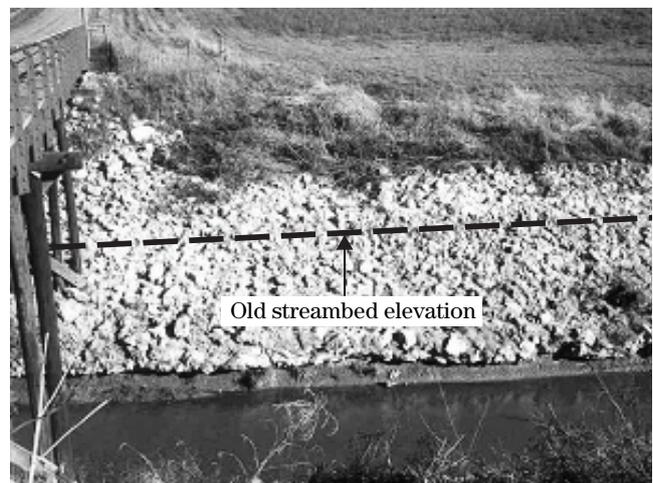
Figure TS3B-4 An NRCS bank stabilization site that did not include streambed stabilization, (Page County, IA)

Streambed stabilization is the key to preventing further erosion and protecting infrastructure (fig. TS3B-4). After the stream downcut 6 feet in 7 years, the bank stabilization was left high and dry. Dams or weirs at regular intervals will help streams stabilize by changing their profile from a steep incline to a stable stair-step pattern. Structures normally have a raised weir section, like a low-head dam. Most structures use steel sheet pile driven into the streambed 20 to 25 feet (6.1-7.6 m) and riprap to protect the banks (fig. TS3B-5).

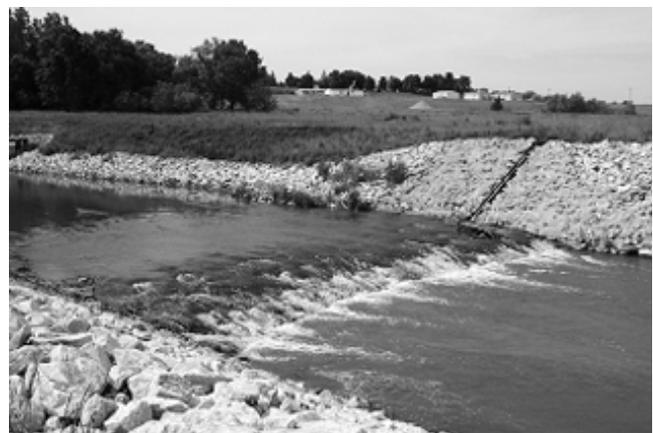
Figure TS3B-5 HCA steel sheet pile weir with riprap and cement grout that protects a large sewer main for the City of Denison, IA
