## Case Study 2

## Goode Road/Cottonwood Creek, Hutchins, Texas

# Goode Road/Cottonwood Creek, Hutchins, Texas

*By Ming-Han Li, Ph.D., P.E., R.L.A.,  
Assistant Professor, Department of Landscape  
Architecture and Urban Planning, Texas A&M  
University, College Station, Texas*

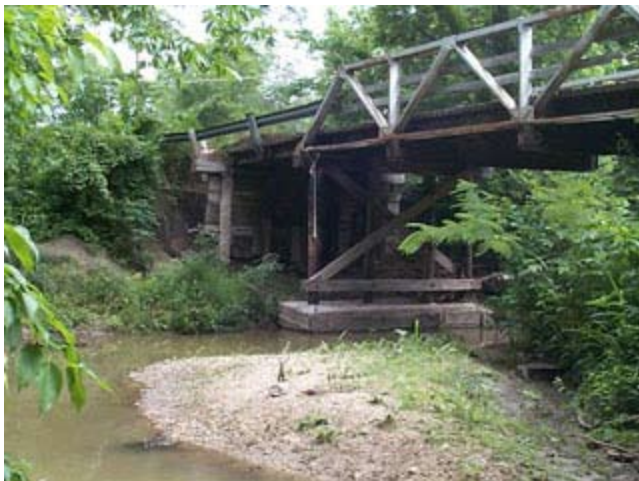
**Figure CS2-1** Original timber-plank bridge structure

Beginning in 1996, an existing TxDOT bridge on Goode Road in Hutchins, Texas, a few miles southeast of Dallas, was closed due to severe erosion on its abutment and a roadway embankment failure. The bridge, built in the 1960s, crosses Cottonwood Creek and is a single span timber plank structure (fig. CS2-1). In the 1990s,

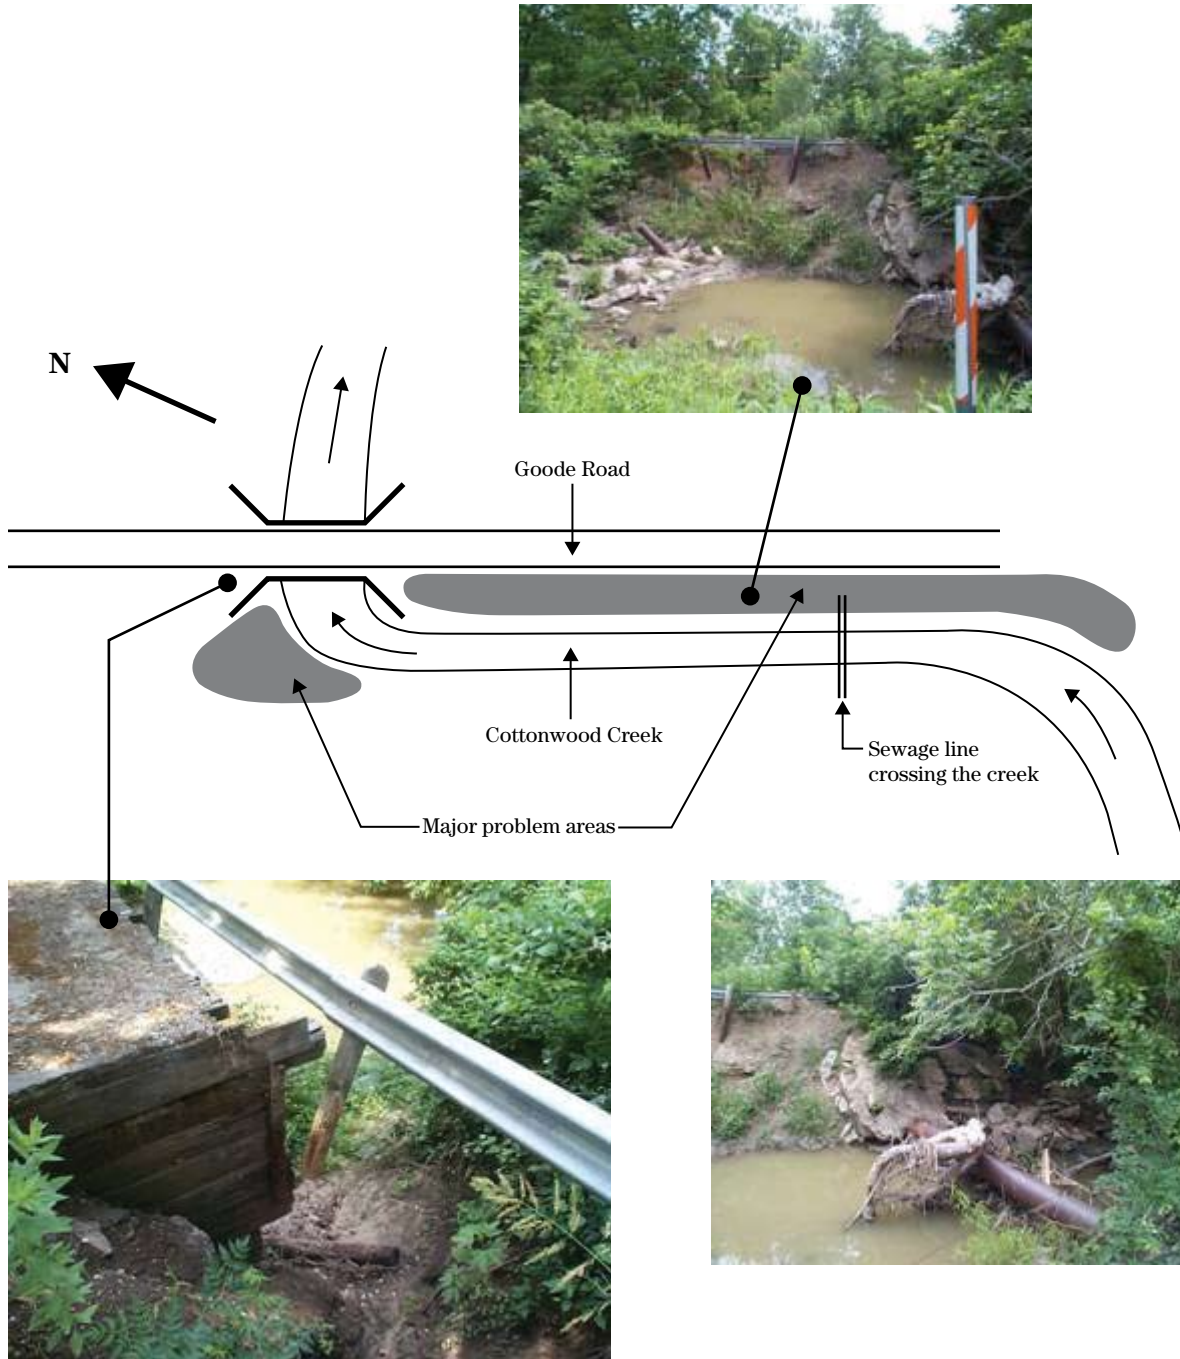
**Figure CS2-2** Goode Road was closed due to scouring of the roadway embankment and abutment areas.

Cottonwood Creek experienced large flows after some storm events, and these flows occasionally overtopped the bridge. Because Goode Road's west-facing embankment is also a streambank of Cottonwood Creek, the roadway embankment was severely eroded by the flow (fig. CS2-2). Specifically, a sewer and a water line crossing the creek caught large amounts of debris, which indirectly led to erosive currents downstream. In 1998, TxDOT sought to reopen Goode Road by replacing the old bridge and stabilizing the streambank. The Texas Transportation Institute (TTI) worked with TxDOT engineers and designed the streambank reinforcement using both soil bioengineering methods and traditional structures. Vegetated geogrids, dormant post plantings, turf reinforcement mats, and gabion mattresses were used to stabilize roadway embankments, creek banks, and bends.

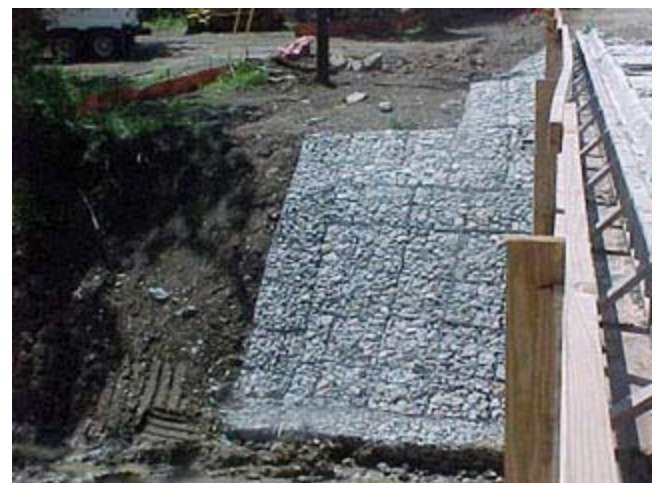
**Figure CS2-3** Gabion mattress was used for the bridge abutment area.

Streambank soil bioengineering methods are not applicable where there is little or no sunlight. Gabion was chosen to complement this weakness of soil bioengineering methods. Gabion mattress composed of wire cages and rocks was used to stabilize the bridge abutment (fig. CS2-3). The flexibility of installation on irregular areas, as well as shady spots, makes gabion mattress practical to this project.

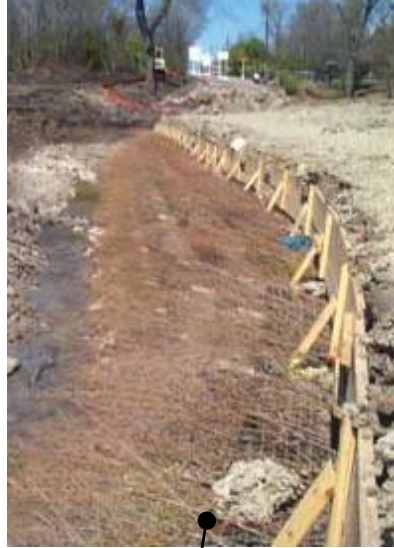
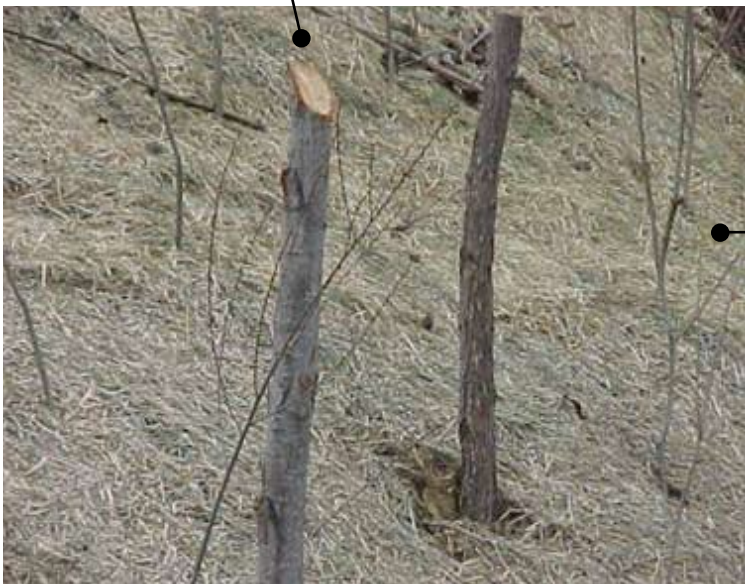
**Figure CS2-4** Vegetated geogrids and dormant post plantings are the two primary streambank soil bioengineering measures.

Vegetated geogrids were used for stabilizing banks and roadway embankments.

Dormant posts were used in two creek bends.

Vegetated geogrids (U.S. Department of Agriculture (USDA) Natural Resources Conservation Service (NRCS) 1996b) were the primary stabilization measure for the west-facing roadway embankment, which is also the creek bank (fig. CS2-4).

This technique was chosen because the shear stress level that can be sustained by vegetated geogrids is intermediate from 145 to 290 pascal (Li and Eddleman 2002), which brackets the calculated 156 pascal shear stress from a 100-year flood. In addition, the sandy clay onsite can be protected from erosion by geotextiles used in this technique. Rocks of 0.15 to 0.3 meters, wrapped by geogrids, were used at the bottom layer as the foundation and to protect the toe area. This stabilization method provides immediate streambank protection at the early stage after installation.

Dormant posts (USDA NRCS 1996b) of black willow (*Salix nigra*), 76 to 127 millimeters in diameter, were installed on two creek bend areas (fig. CS2-4). Boulders of 0.3 meters or larger were keyed into the toe of the bend areas to protect the streambank. In addition, turf reinforcement mats were installed along with the dormant posts to reduce the surface erosion.

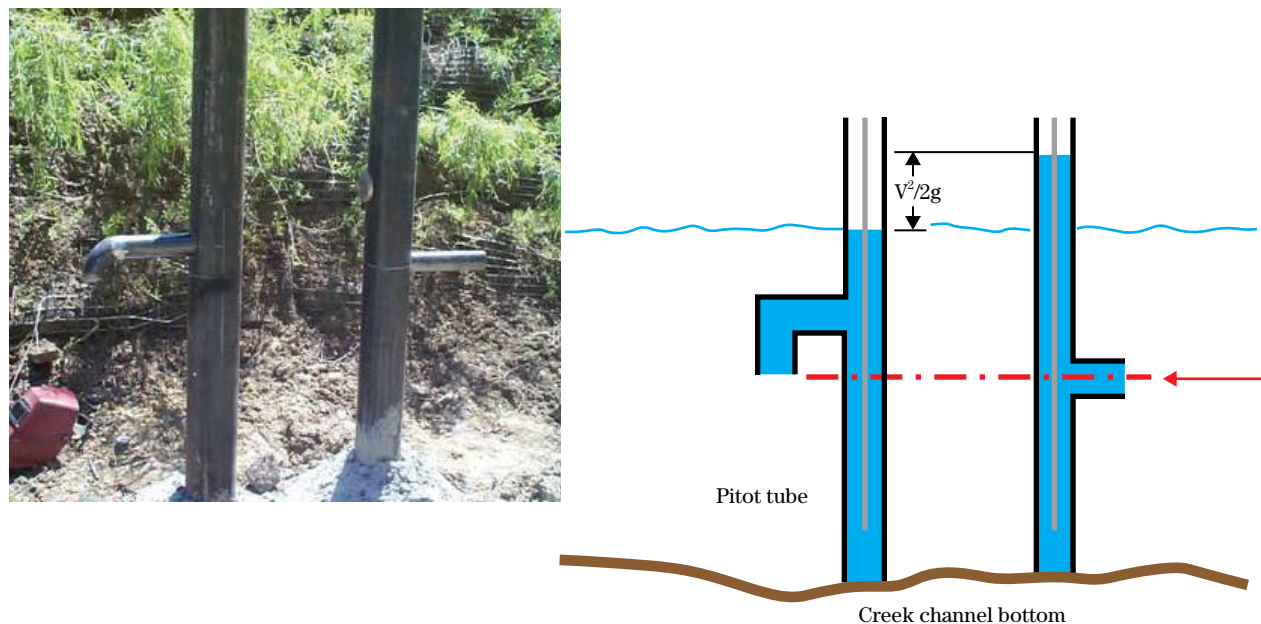
**Figure CS2-5** Water level data loggers inserted in two standpipes to monitor water elevation and velocity

TxDOT spent approximately \$466,400 to replace the bridge, repave the road, and stabilize a streambank of 160 meters. Four layers of vegetated geogrids were installed. The construction activities and timing are listed in table CS2-1. The construction of streambank stabilization was completed in March 2001, followed by the postproject evaluation. Monitored variables include creek flow velocity (point measurement (fig. CS2-5)), flow elevation (point measurement), channel

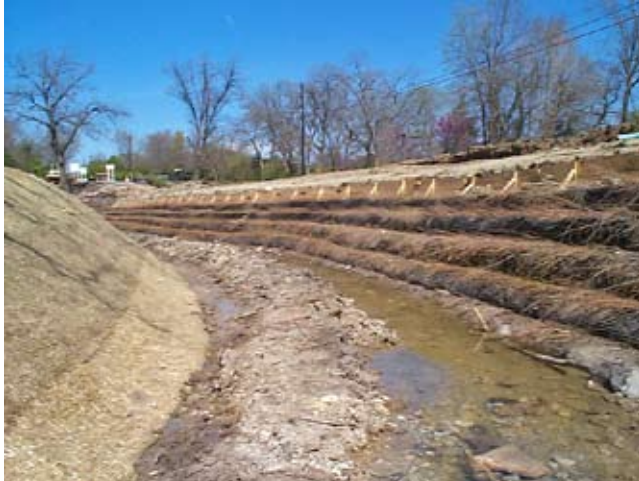
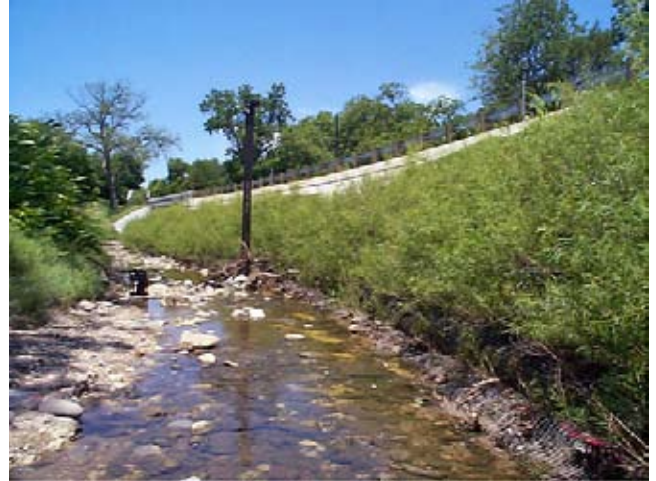
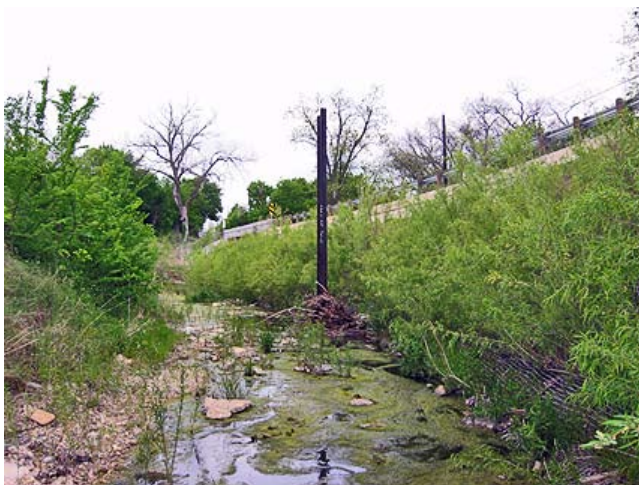
**Figure CS2-7** (a) Mar. 2001—Goode Road embankment was stabilized with vegetated geogrids. The opposite bank on the left was protected with soil erosion blankets; (b) Apr. 2003—biomass increases with time; (c) May 2002—black willow covered the entire bank 1 year after construction.

of willow cuttings are above 90 percent even though no supplemental irrigation was provided, and channel deformation is within an acceptable range (figs. CS2-7, CS2-8, and CS2-9). In summary, this project demonstrates the successful use of soil bioengineering to complement traditional structural streambank stabilization techniques in hot climate areas.

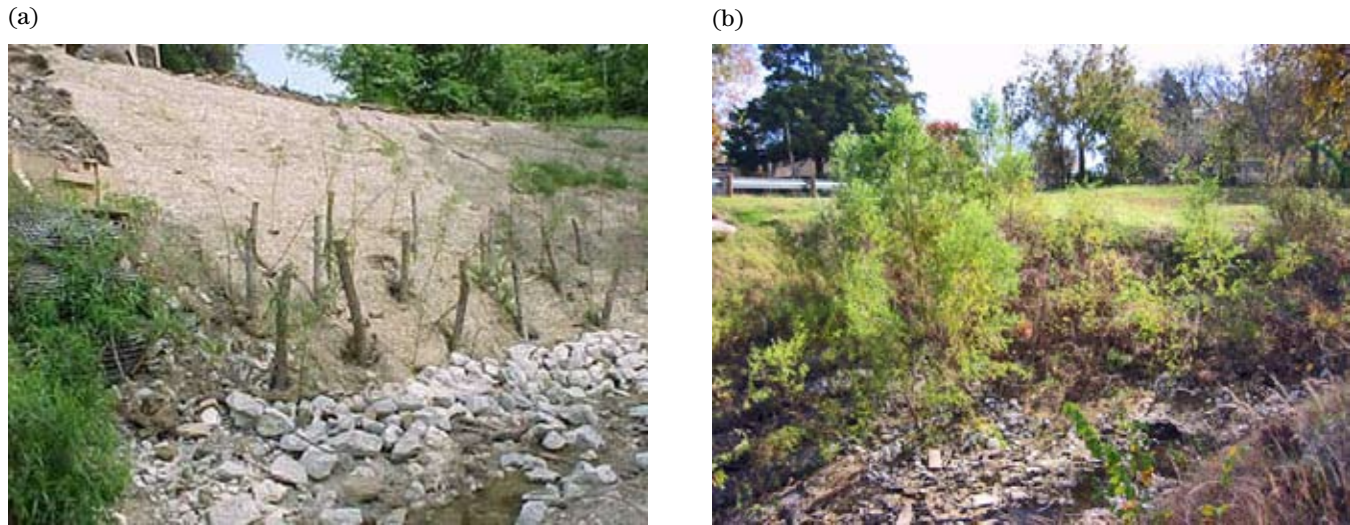
**Figure CS2-8** (a) May 2001—dormant black willow posts installed on the first creek bend. Rocks were used to protect the toe area; (b) Nov. 2002—black willow covered the bend 1 year after construction.

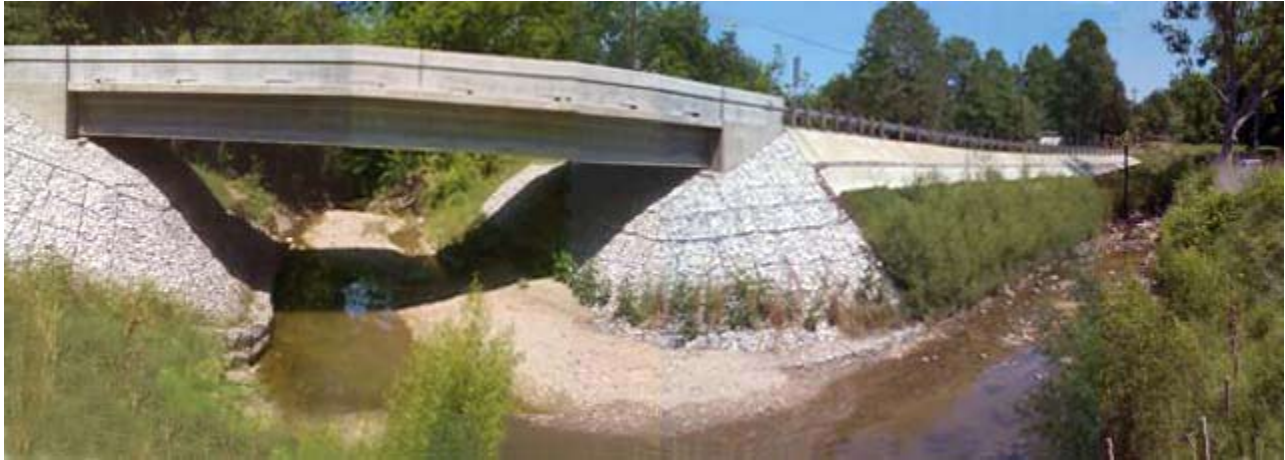
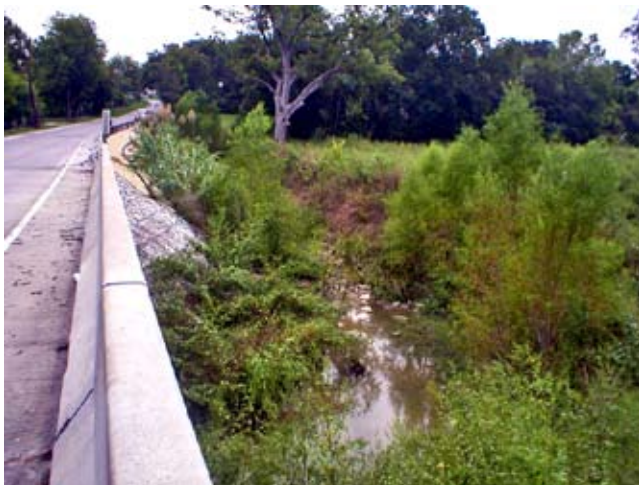
**Figure CS2-9** (a) May 2002—panoramic view of the project; (b) Sept. 2003—postproject conditions (view from the top of the bridge to the creek)
