Case Study 4

**Silver Creek,
Silver Creek, New York**

Reinforced Soil Wall Silver Creek, New York

*By Frank T. Cousin, Jr., soil bioengineer, P.E.;
and Fred Gasper, civil engineer, P.E.; U.S.
Department of Agriculture, Natural Resources
Conservation Service, East Lansing, Michigan*

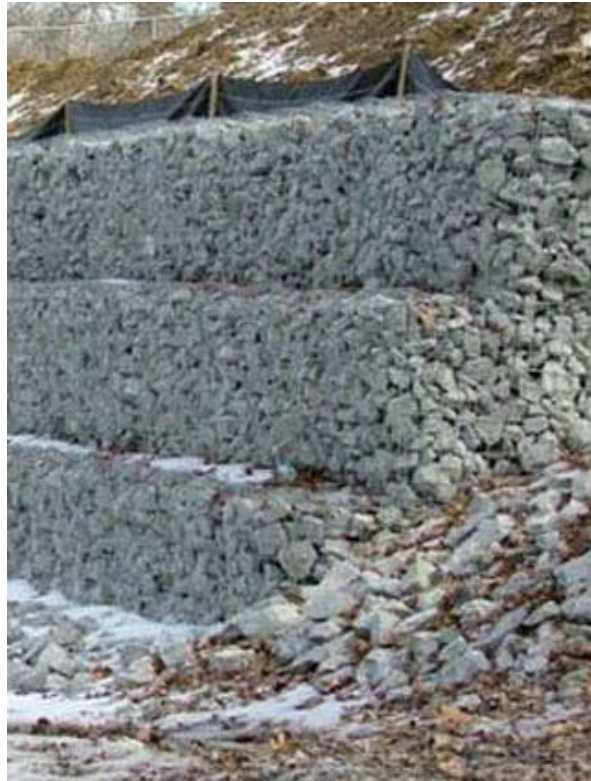
Figure CS4-2 Gabion wall

The gabion wall (fig. CS4-2) was not selected because of abrasion expected from bed-load and suspended load.

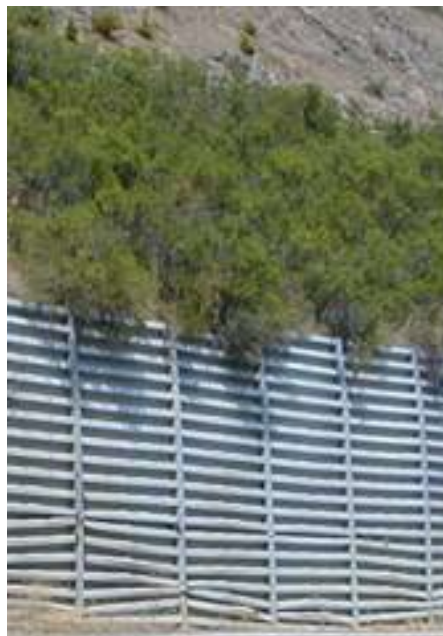
Figure CS4-3 Bin wall

Both the bin wall (fig. CS4-3) and the concrete retaining wall (fig. CS4-4) were considered as viable alternatives. The cost estimate for a bin wall or concrete retaining wall was \$90,000.

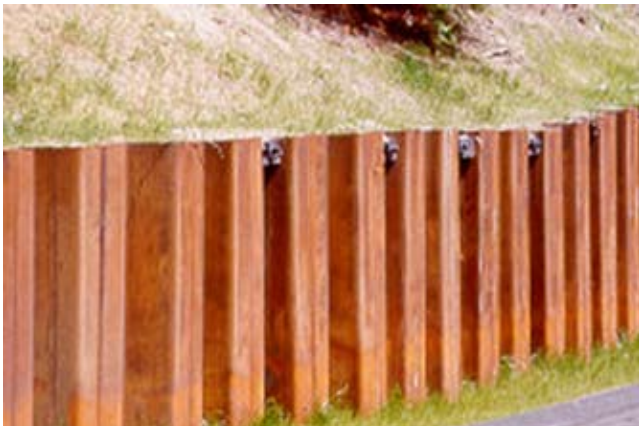
Figure CS4-1 Sheet pile wall

The sheet pile wall (fig. CS4-1) was not considered a viable alternative because of the shale bedrock foundation.

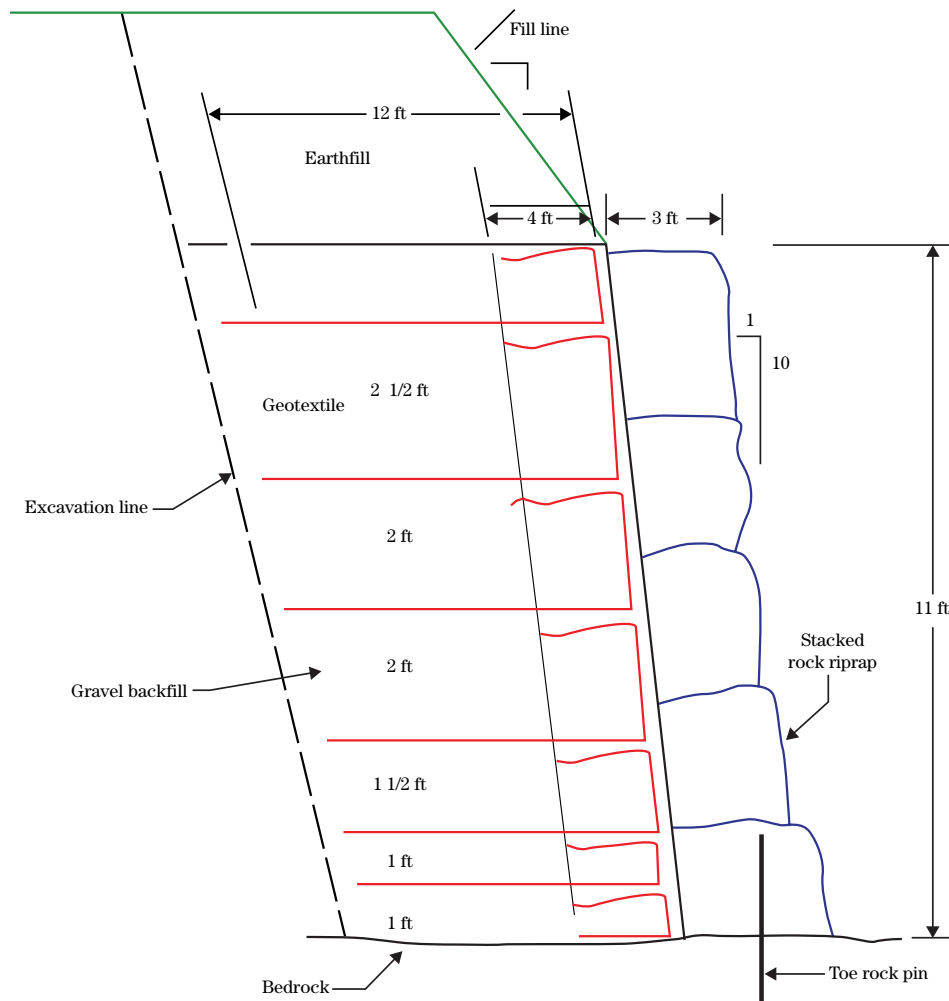
Figure CS4-5 Reinforced soil wall detail, Silver Creek, NY

A fourth alternative, a reinforced soil wall or slope, was investigated (fig. CS4-5). The estimated cost for a reinforced soil wall or slope was \$45,000. After researching this technique, it was chosen as the best alternative for stabilizing the site.

The height of the slope varies from 4.6 meters (15 ft) to 5.8 meters (19 ft). The height of the reinforced soil wall is 3.4 meters (11 ft) (fig. CS4–5).

The spacing of the geotextile ranged from 0.31 meters (1 ft) to 0.76 meters (2.5 ft), with an embedment length equal to the height of the wall (fig. CS4–5). No secondary reinforcement was required because the backfill soil was compacted against the rock riprap facing. This resulted in no sagging of the geotextile-wrapped face.

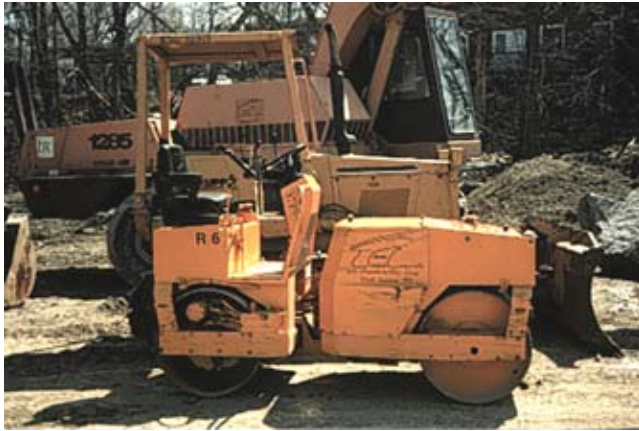
Figure CS4-6 Compaction equipment

The geotextile reinforcement and gravel backfill were “brought up” with the stacked riprap facing (figs. CS4–8 and CS4–9). The gravel backfill was compacted with a rubber-tired Case 1285 backhoe, a small bulldozer (Caterpillar® D4 equivalent), and a manually directed vibrating drum roller (figs. CS4–6 and CS4–7). The backfill within 2 feet of the wall facing was compacted with a manually directed power tamper (plate).

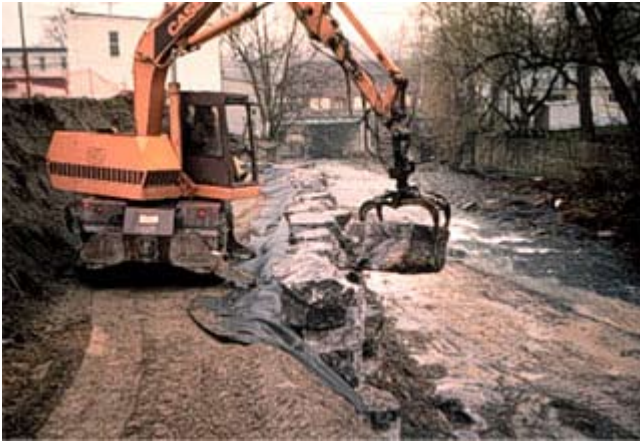
Figure CS4-10 Stacked riprap face placement

One of the big advantages of using stacked rock riprap as the facing was that the gravel backfill could be compacted against the facing, eliminating the need for slip forms or some other method of compacting the backfill material near the facing. Small pieces of limestone were used to fill in the voids between the larger stacked riprap to protect the wrapped geotextile face.

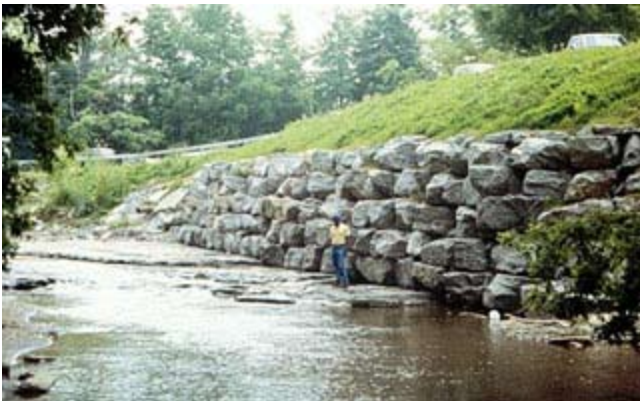
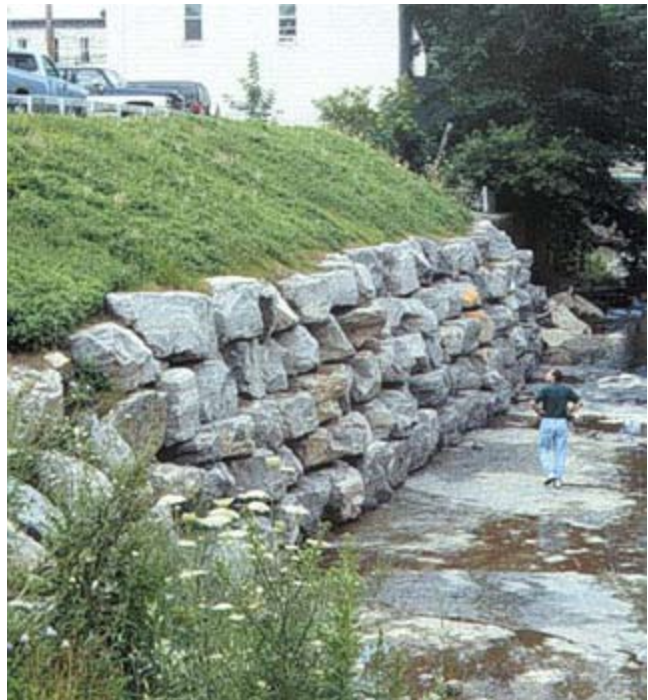
Figure CS4-12 Completed wall

The reinforced soil wall was completed within 15 construction days (figs. CS4–12 and CS4–13). John Burt, Silver Creek Village Manager, reported that 2 weeks after the wall was completed, flows within Silver Creek came within 2 feet of the top of the wall. He stated that, “we would have lost the (Spencer Place) road for sure without the wall.”

The reinforced soil wall has been tested by high flows and is functioning as designed. The limestone riprap provided an aesthetically pleasing face. There is some herbaceous vegetation growing on ledges and openings within the rock face. Over time, sediment trapped within the interstices of the stacked riprap should expedite vegetation growing on the rock face. This will add to the aesthetics of the reinforced soil wall.
