Case Study 7

**Spafford Creek, Otisco Lake
Watershed, New York**

By David Walowsky, civil engineering technician, U.S. Department of Agriculture, Natural Resources Conservation Service, LaFayette, New York

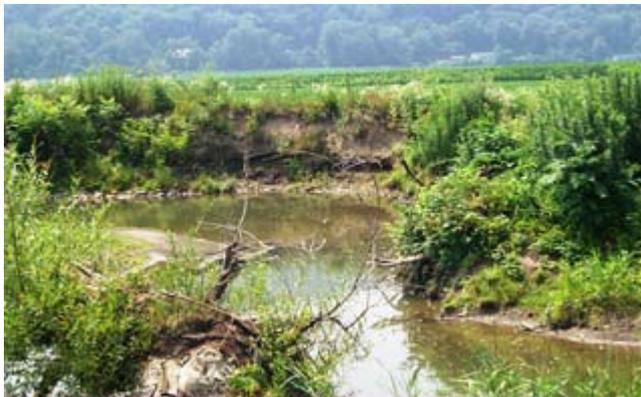
Figure CS7-1 Typical picture of streambank erosion along entire project reach south of Sawmill Road, Spafford Creek, NY

Until the 1930s, the landscape included a riparian forest buffer approximately 250 feet in width on both sides of the stream channel. Clear-cutting and straightening of the channel have detrimentally impacted the fish habitat and water quality. In 1998, the riparian forest buffer was eliminated by the landowner. Large, mature black willow and sycamore were cut and removed from the stream corridor, with stumps left in place. Banks are steep to vertical, and the vegetation varies from none to moderately dense grasses and weeds. Some redosier dogwoods are present. Bank materials are mostly fine-grained with one gravel lens.

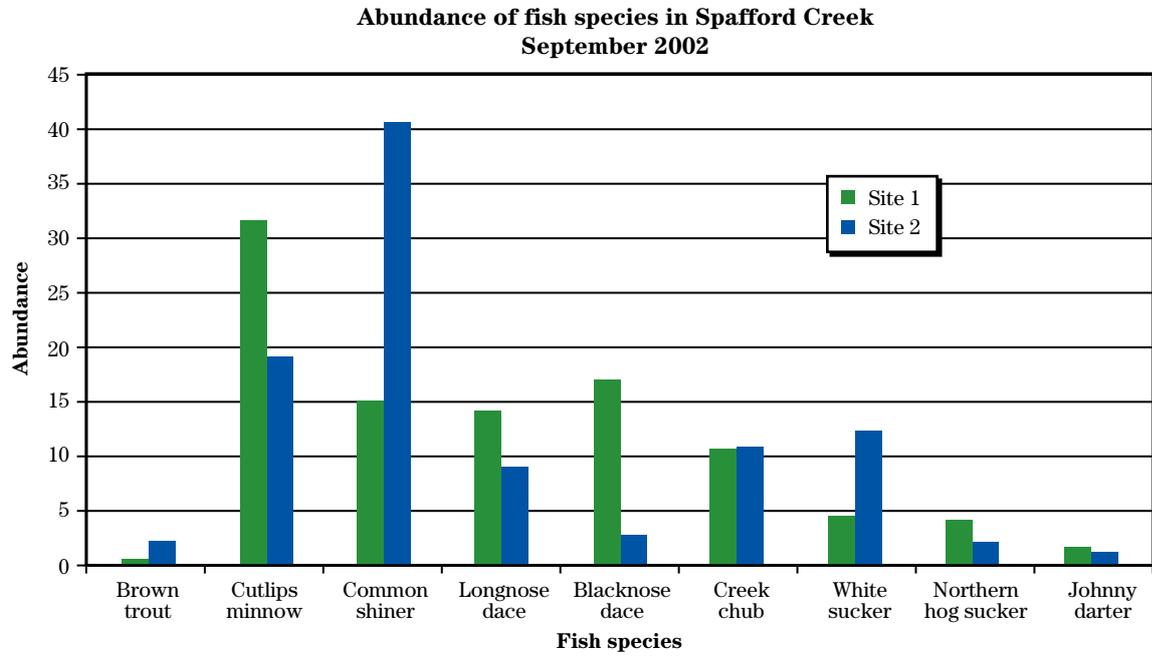
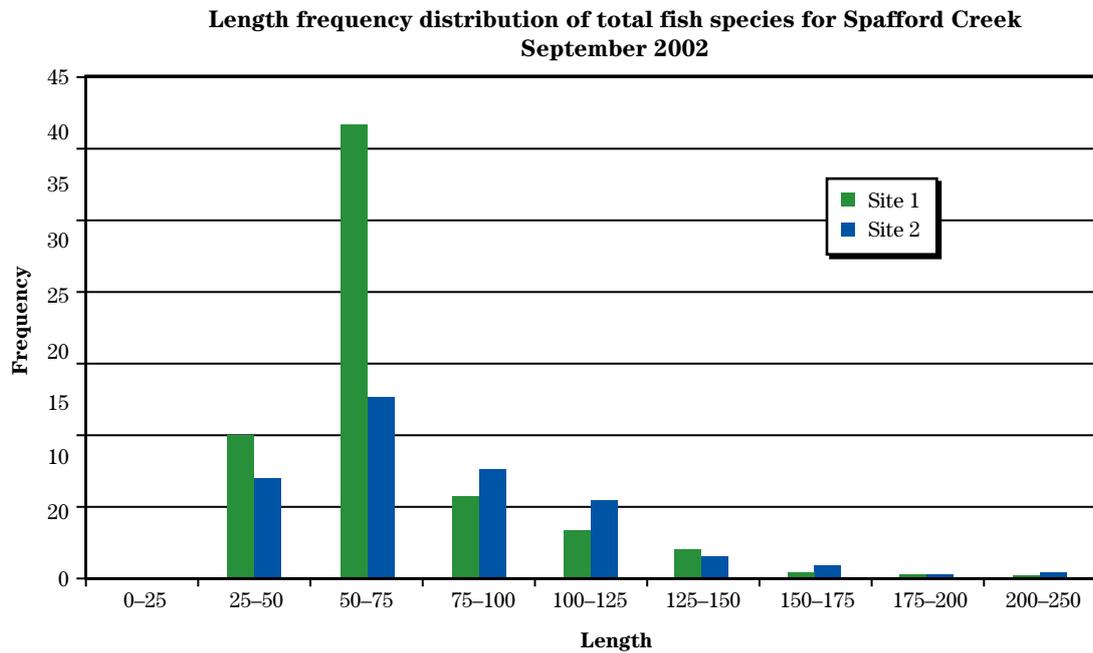
Figure CS7-2 Results of fish sampling in Spafford Creek

The biological attributes of the site were analyzed during the summer of 2001 and September 2002. The data shown in table CS7-1 are from the USFWS State Office located in Cortland, New York. The results of the fish sampling are shown graphically in figure CS7-2.

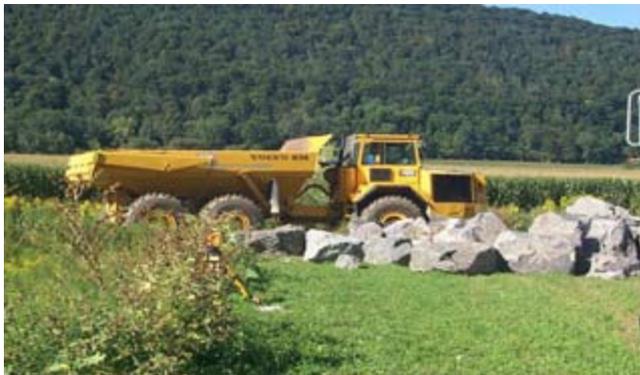
Figure CS7-3 Equipment and rock used for construction, Spafford Creek, NY

The riprap was hand selected at the quarry and identified with marking paint for shipment to the site (fig. CS7–3). The large riprap for the project was to be limestone of at least 4,200 pounds and stackable. The riprap was selected from the Callanan Quarry located north of Morrisville, New York. The riprap was hauled to the site by RMS of Dryden, New York. A total of 29 loads of riprap were delivered to the site. Delivery took approximately 6 days.

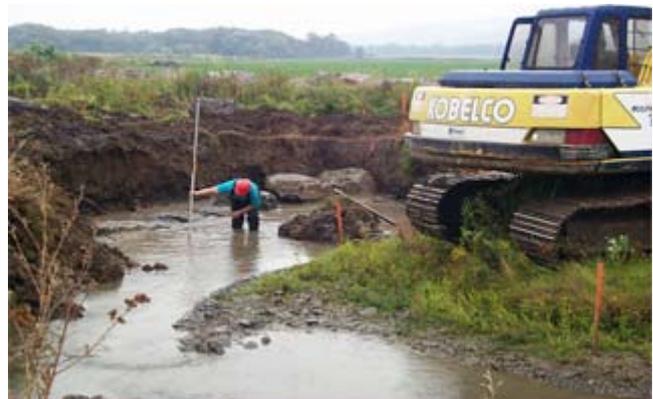
Figure CS7-4 Installation of a J-hook vane, Spafford Creek, NY

A series of 34 J-hooks and 18 cross vanes were installed. The design angle of the vanes is 25 degrees with a vane length of 21 feet. The J-hook vanes and cross vanes provided stability for the bed and banks and also provided wildlife habitat, in addition to the specific seed mixture used for bank stabilization and wildlife cover. The cross vanes are designed to:

Figures CS7-4 and CS7-5 show the installation of a J-hook vane. The J-hook vanes are designed to:

- redirect velocity distribution and high velocity gradient in the near bank region

- stabilize the streambanks
- provide energy dissipation in the deep pool that they create
- create cover for fish spawning and protection

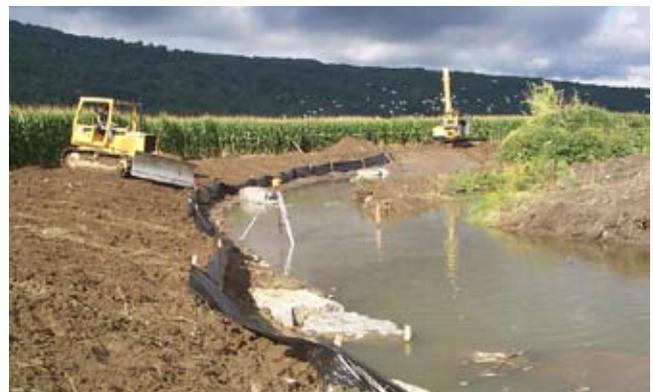
Figure CS7-5 J-hook vane installed and final grading of streambank followed by seeding and mulch, Spafford Creek, NY

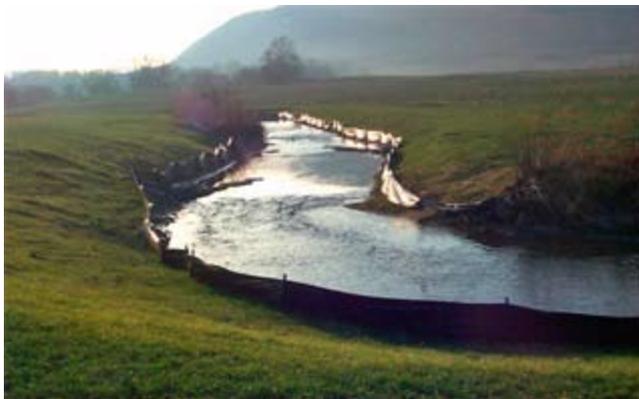
Figure CS7-6 Completed section of streambank stabilization, Spafford Creek, NY

The design performed as planned except for some minor shifts in the top course of stone of four J-hook vanes. These stone shifts have not negatively impacted the streambanks. The original goals were met. It will be interesting to evaluate the habitat that has been created and the number and species of fish that hopefully have used this project area for spawning.

The designed structures chosen appear to be working as planned. The vegetation that was planted on the streambanks is still intact. The silt fence used dur-

ing construction was left in place through the winter months (figs. CS7-6 and CS7-7).

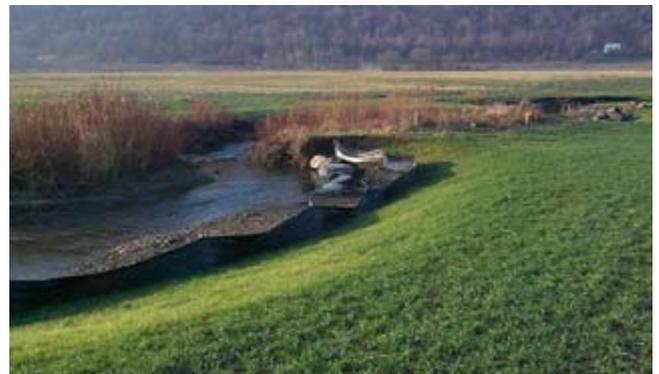
Figure CS7-7 Completed section of streambank stabilization to include J-hook vane and intentional point bar, Spafford Creek, NY
