Case Study 7

**Spafford Creek, Otisco Lake
Watershed, New York**

Spafford Creek, Otisco Lake Watershed, New York

By David Walowsky, civil engineering technician, U.S. Department of Agriculture, Natural Resources Conservation Service, LaFayette, New York

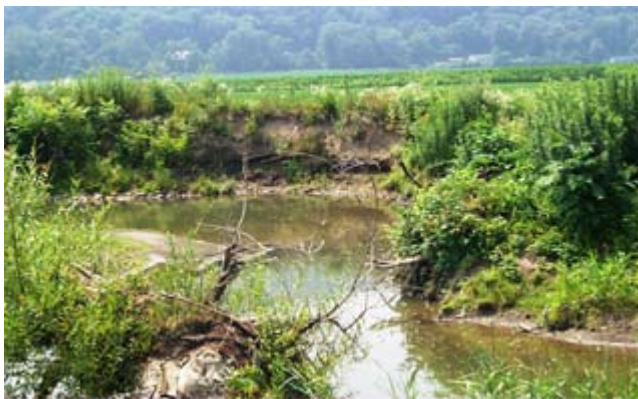
Figure CS7-1 Typical picture of streambank erosion along entire project reach south of Sawmill Road, Spafford Creek, NY

Until the 1930s, the landscape included a riparian forest buffer approximately 250 feet in width on both sides of the stream channel. Clear-cutting and straightening of the channel have detrimentally impacted the fish habitat and water quality. In 1998, the riparian forest buffer was eliminated by the landowner. Large, mature black willow and sycamore were cut and removed from the stream corridor, with stumps left in place. Banks are steep to vertical, and the vegetation varies from none to moderately dense grasses and weeds. Some redosier dogwoods are present. Bank materials are mostly fine-grained with one gravel lens.

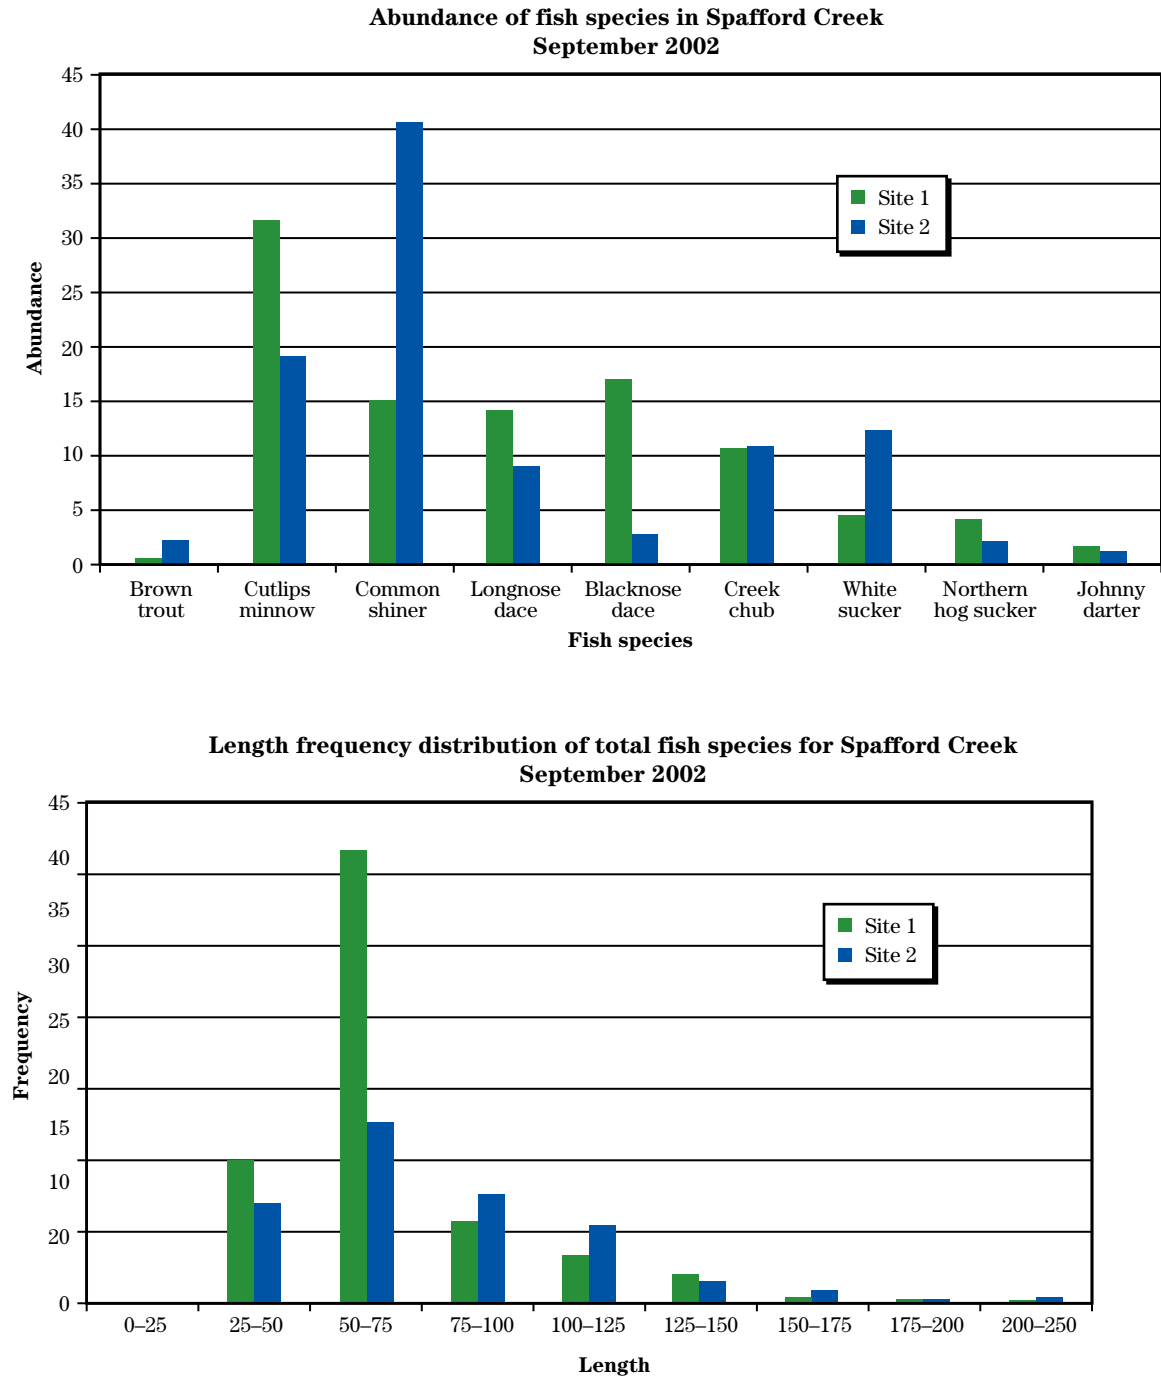
Figure CS7-2 Results of fish sampling in Spafford Creek

The biological attributes of the site were analyzed during the summer of 2001 and September 2002. The data shown in table CS7–1 are from the USFWS State Office located in Cortland, New York. The results of the fish sampling are shown graphically in figure CS7–2.

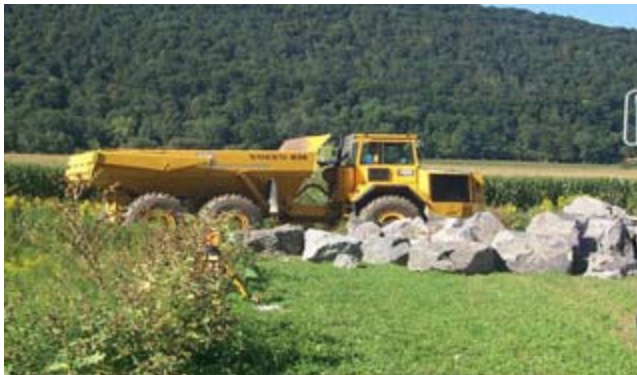
Figure CS7-3 Equipment and rock used for construction, Spafford Creek, NY

The riprap was hand selected at the quarry and identified with marking paint for shipment to the site (fig. CS7–3). The large riprap for the project was to be limestone of at least 4,200 pounds and stackable. The riprap was selected from the Callanan Quarry located north of Morrisville, New York. The riprap was hauled to the site by RMS of Dryden, New York. A total of 29 loads of riprap were delivered to the site. Delivery took approximately 6 days.

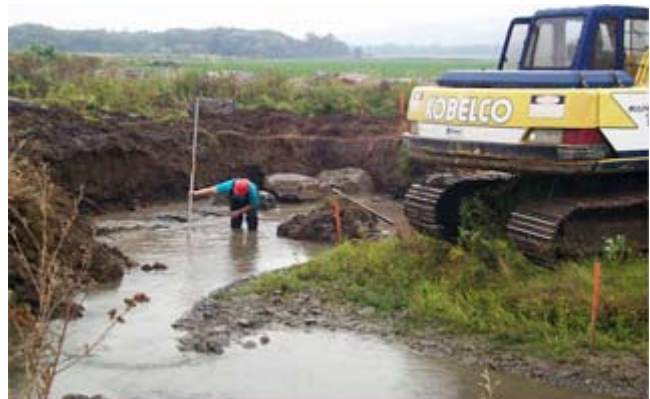
Figure CS7-4 Installation of a J-hook vane, Spafford Creek, NY

Figures CS7-4 and CS7-5 show the installation of a J-hook vane. The J-hook vanes are designed to:

- redirect velocity distribution and high velocity gradient in the near bank region

- stabilize the streambanks
- provide energy dissipation in the deep pool that they create
- create cover for fish spawning and protection

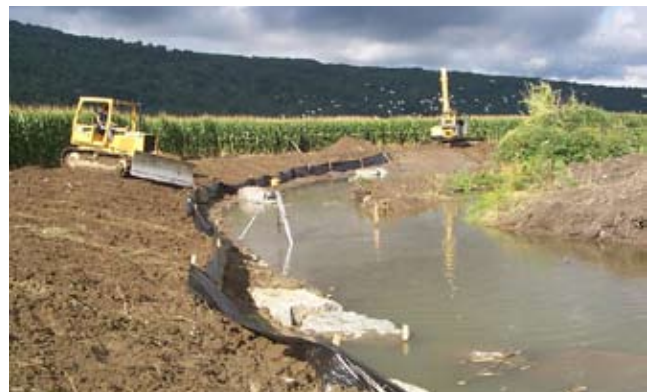
Figure CS7-5 J-hook vane installed and final grading of streambank followed by seeding and mulch, Spafford Creek, NY

The vegetation present within this reach is sparse redosier dogwoods, sumac, and weeds of various types. The mature trees that once existed had been eliminated in November 1998. The proposed vegetation for this reach was a mixture to be seeded on the finished streambanks and the 20-foot vegetated buffer established along both sides of the top of streambanks (table CS7-5). Note: The seed mixture was broadcast-seeded and mulched within the confines of the streambanks and no-till-drilled within the buffer area.

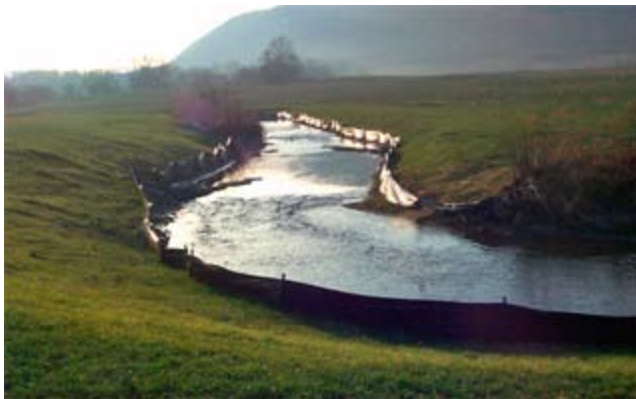
Figure CS7-6 Completed section of streambank stabilization, Spafford Creek, NY

The design performed as planned except for some minor shifts in the top course of stone of four J-hook vanes. These stone shifts have not negatively impacted the streambanks. The original goals were met. It will be interesting to evaluate the habitat that has been created and the number and species of fish that hopefully have used this project area for spawning.

The designed structures chosen appear to be working as planned. The vegetation that was planted on the streambanks is still intact. The silt fence used dur-

ing construction was left in place through the winter months (figs. CS7-6 and CS7-7).

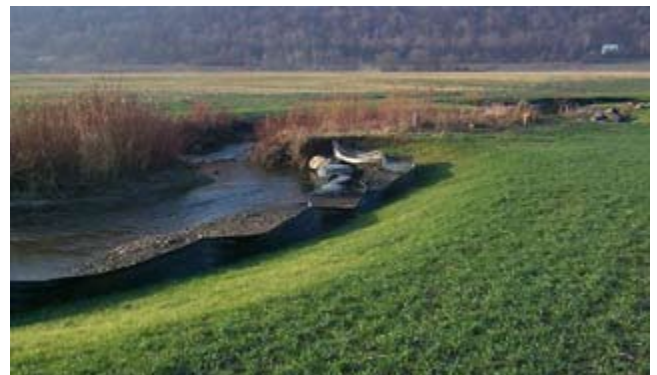
Figure CS7-7 Completed section of streambank stabilization to include J-hook vane and intentional point bar, Spafford Creek, NY
