### Abstract

This technical supplement presents an example of using an aerial assessment and classification of streams in the deep loess region of western Iowa. This is a large-scale effort directed by the Hungry Canyons Alliance involving approximately 5,250 miles of stream in 22 western Iowa counties. This effort has determined areas of active stream erosion and the impact streambed stabilization structures have had on controlling stream degradation. The stream assessment consisted of flying along streams in a small helicopter videotaping the stream channel and recording positions with a global positioning system receiver. Streams were classified based on a six-stage channel evolution model to describe the dominant channel processes occurring along stream reaches. Streams across the region in 1993 and 1994, and in a smaller area in 2000, were similarly classified.

The purpose of Hungry Canyons Alliance (HCA) is to focus attention on the problems and develop solutions related to stream channel degradation in 22 counties of western Iowa with deep loess soils. The HCA provides cost share to counties to build streambed stabilization structures, building about 20 structures per year

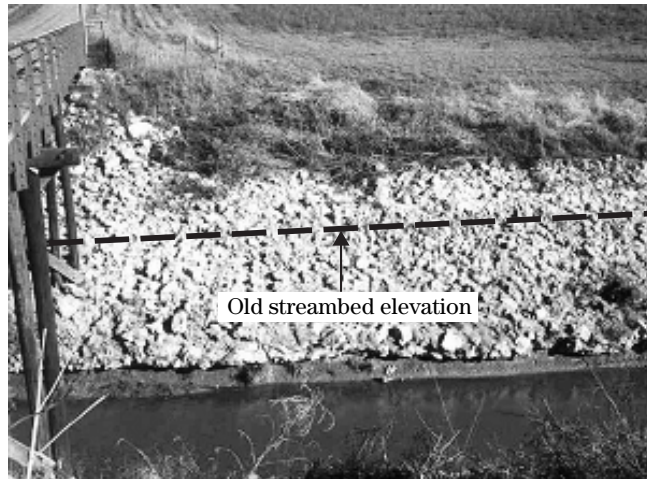
**Figure TS3B-4** An NRCS bank stabilization site that did not include streambed stabilization, (Page County, IA)

Streambed stabilization is the key to preventing further erosion and protecting infrastructure (fig. TS3B-4). After the stream downcut 6 feet in 7 years, the bank stabilization was left high and dry. Dams or weirs at regular intervals will help streams stabilize by changing their profile from a steep incline to a stable stair-step pattern. Structures normally have a raised weir section, like a low-head dam. Most structures use steel sheet pile driven into the streambed 20 to 25 feet (6.1–7.6 m) and riprap to protect the banks (fig. TS3B-5).

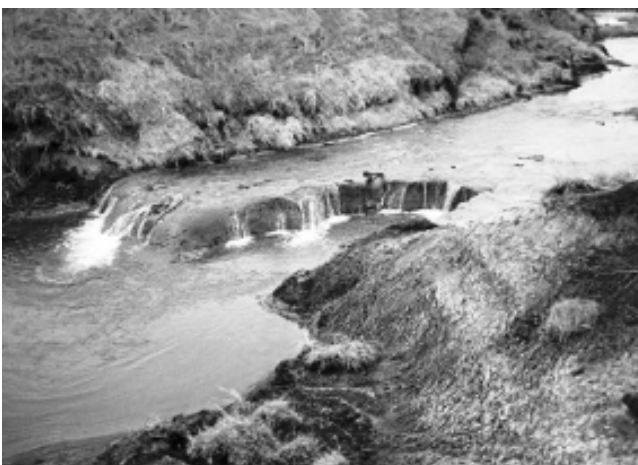
**Figure TS3B-3** Nickpoint eroding headward

Nickpoints, which are naturally occurring overfalls (fig. TS3B-3), will continue to erode and advance upstream, eventually affecting the entire watershed. Bed degradation of stream channels will force the channel's tributaries to also adjust to the lowered base level, often initiating gully formation where no channel had previously existed.

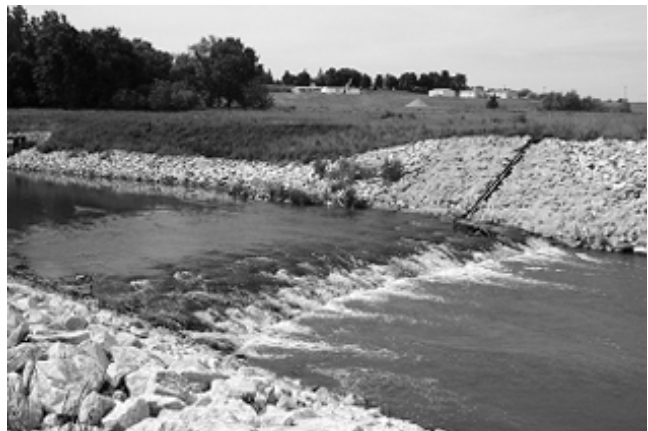
**Figure TS3B-5** HCA steel sheet pile weir with riprap and cement grout that protects a large sewer main for the City of Denison, IA

Streambed stabilization structures have many benefits. They decrease the slope of the streambed, reducing water velocities. They prevent further downcutting, protecting farmland, bridge pilings, and utility lines from future erosion. They create an upstream backwater condition which allows sediment to settle out, reducing sediment loads and improving water quality. The backed-up water often helps to protect bridge pilings by submerging them.

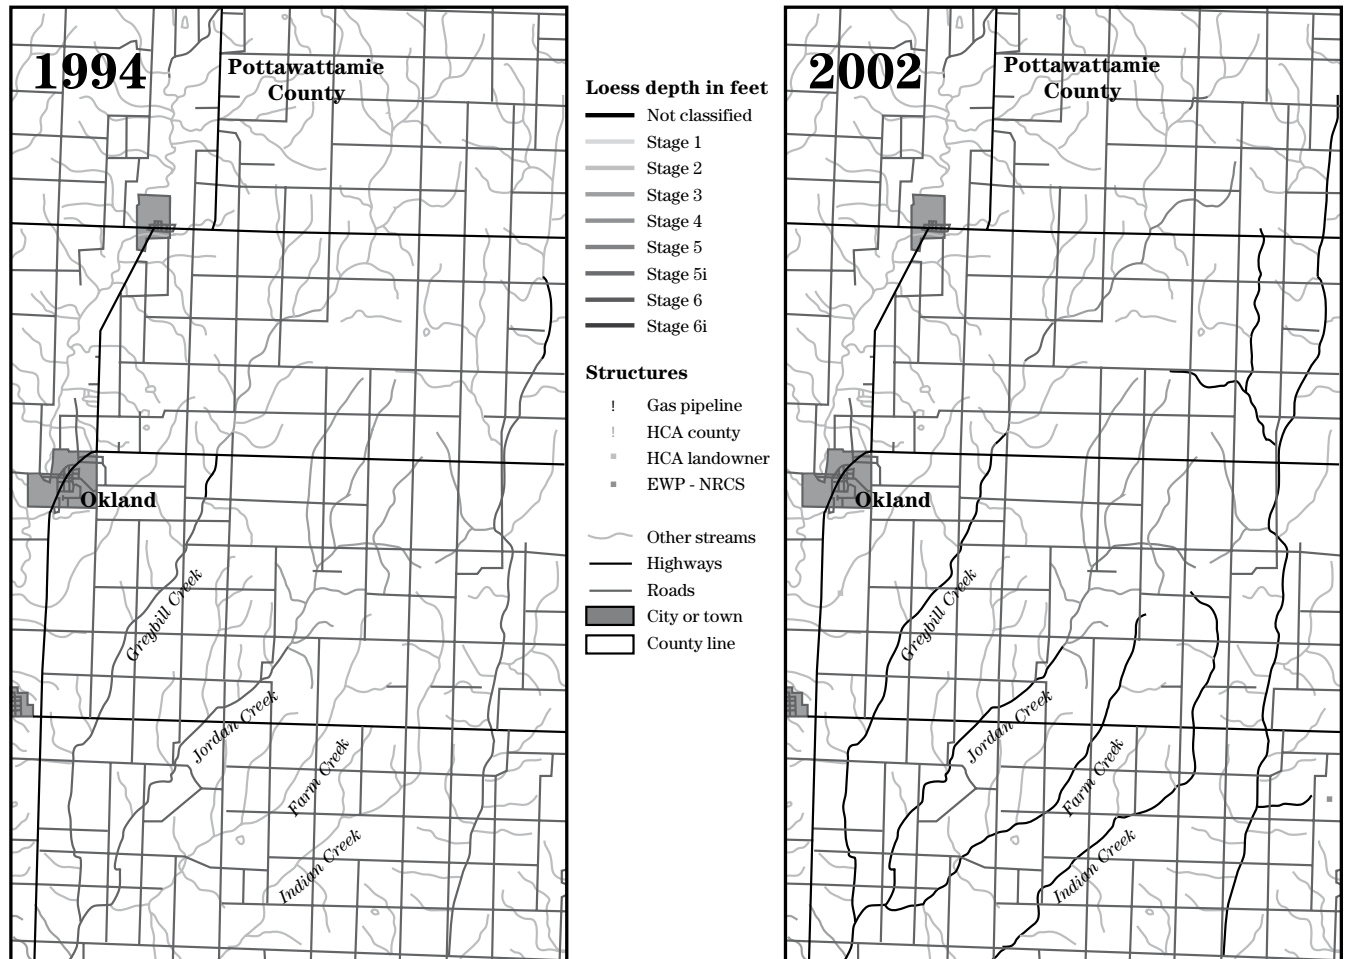
**Figure TS3B-8** Comparison of two classified stream reaches on Graybill and Jordan Creeks in 1994 and 2002

To determine the progression of erosion through time and the impact streambed stabilization structures have had on controlling stream degradation, two segments of stream that were classified in 1994 and again in 2002 are shown for comparison in figure TS3B-8. In 1994, Graybill and Jordan Creeks in Pottawattamie County were predominately stage 4, with stage 3 farther upstream in the watersheds. Only two structures had been built on these streams at that time. The arrow

points to a bridge where 23 feet (7 m) of degradation was recorded between 1972 and 1993. By 2002, 14 additional structures had been built on these two creeks. The streams have become less erosive and more stable, with the average stream at stage 5.

Degradation has migrated about 5 miles (8 km) upstream with stages 3 and 4 occurring only near the headwaters of the streams.

Grade control structures appear to have helped stabilize large stretches of stream. Streambeds up to 1 mile (1.6 km) upstream from the structures have been stabilized (fig. TS3B-8). For example, the rapid stabilization of Graybill and Jordan Creeks is largely due to the construction of grade control structures at regular intervals.
