# Case Study 10

# Newaukum River, Lewis County, Washington

Issued August 2007

# Case Study 10 Newaukum River, Lewis County, Washington

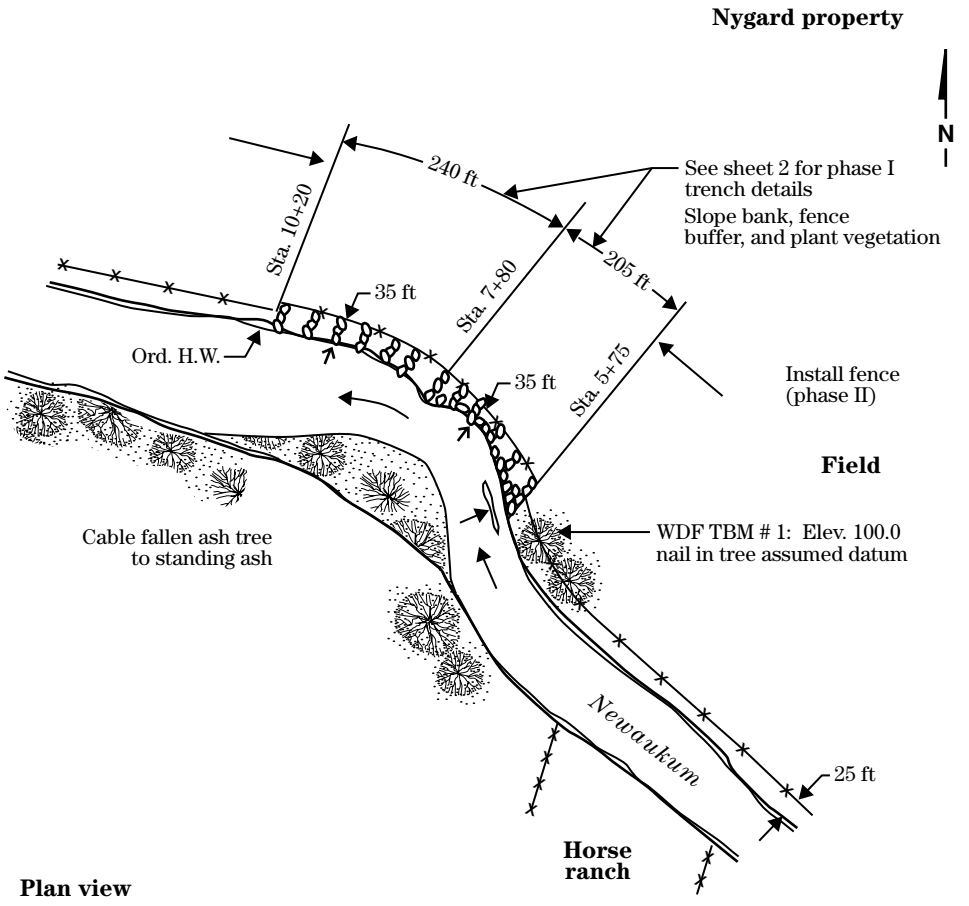
**Figure CS10–2** Nygard site plan—excerpt from original drawings

The Nygard site has a moderate R:W ratio and perhaps is the more consistent of all the sites in steady progress towards stability. It, too, has experienced the flood events and dry seasons, but lower losses (50%) from infestation of the willow borer and not significantly affected by beaver activity. The treatment at this site combines toe rock with the RB structures in the upper curved portion of the reach. Very little bank shaping was done at this site, other than what occurred during excavation of the rock and brush trenches. The steep bank slope was still evident during the site visit in 2005. As figure CS10–7 shows, the water level was above the toe rock. The RBs continue downstream through a shallower bend without toe rock. The thalweg remains at the toe of the bank in the upper curved reach. The willows are dense and extend out over the stream providing heavy shading over the thalweg.

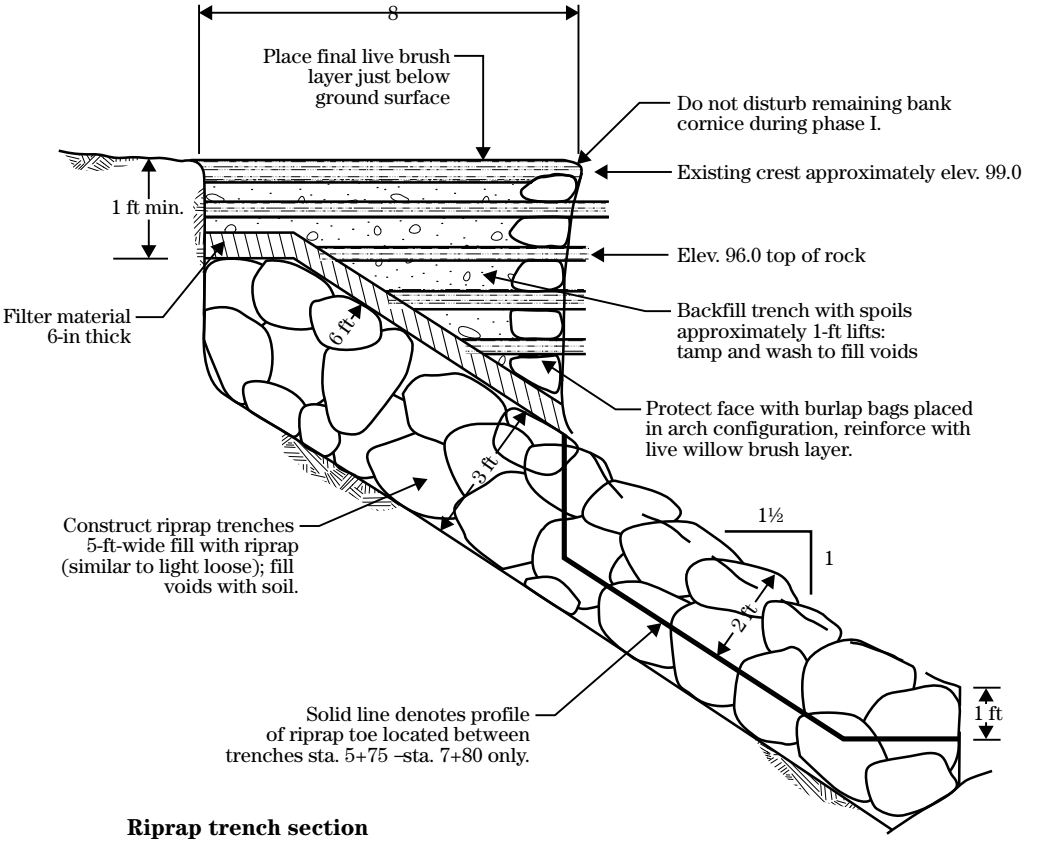
**Figure CS10–3** Nygard site, RB detail—excerpt from original drawings

| Rock and brush structures (RB) | RB structures were 5-ft-wide trenches excavated into the bank perpendicular to streamflow. The trench bottom was excavated into the bed approximately 3 ft and filled with rock sloping up the bank at a 1.5H:1V slope to a predetermined elevation. Above this elevation, the trench was excavated into the bank 5 to 8 ft and filled with layers of rock and brush. The trenches were spaced at 25-ft intervals. Figures CS10–2 and CS10–3 are excerpts from the original design showing layout and detail of these trenches which later became known as RB structures. The design intent of this structure was threefold, (1) establish a hard point on the bank that would control bank cutting during flood events, (2) increase hydraulic roughness, and (3) provide points with dense woody vegetation for habitat enhancement. Some of these structures were installed in conjunction with toe rock and at other locations without toe rock. Installation required excavation at the bank toe and placement of rock under water. |
