Case Study 15

Streambank Stabilization in the Guadalupe River Basin, Santa Clara County, California

Issued August 2007

By John McCullah, Watershed Geologist, CPESC, and Kaila Dettman, Watershed Hydrologist of Salix Applied Earthcare

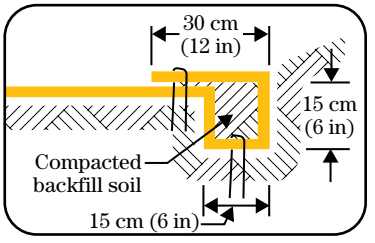
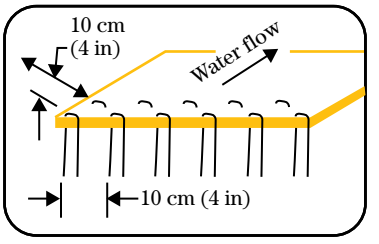
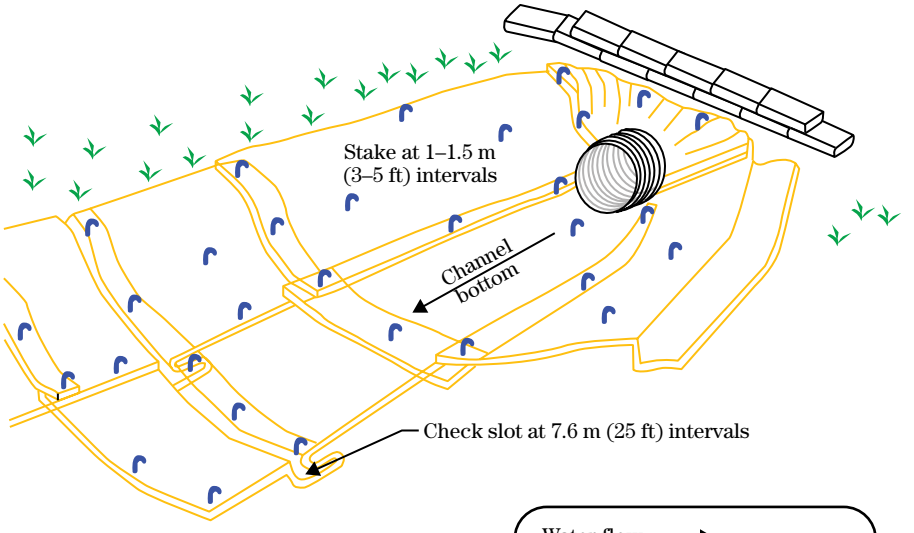
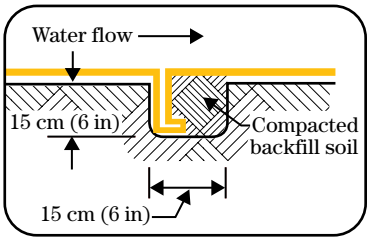
Figure CS15–7 Erosion control blankets channel installation

The authors determined that the blankets had been installed incorrectly because the application had been applied based on the principles of slope stabilization, not channel stabilization. Channel installation requires that blankets be oriented parallel to the flow and include anchor slots (fig. CS15–7). Prior to coir blanket application, the slope was regraded, top soil was placed on terraces and compacted to 85 percent of optimum density, and mulch and seed were applied hydraulically to the slope. Longitudinal slots (horizontal) and check slots (vertical) were dug into the fill material on the middle and upper portions of the bank to serve as footings for anchoring the blankets and coir logs.
