Case Study 16

Project background

In October 2000, an extreme flood event caused severe erosion and lateral instability of a portion of Coffee Creek located along the southeastern edge of the Steeplechase subdivision in Edmond, Oklahoma (fig. CS16–1).

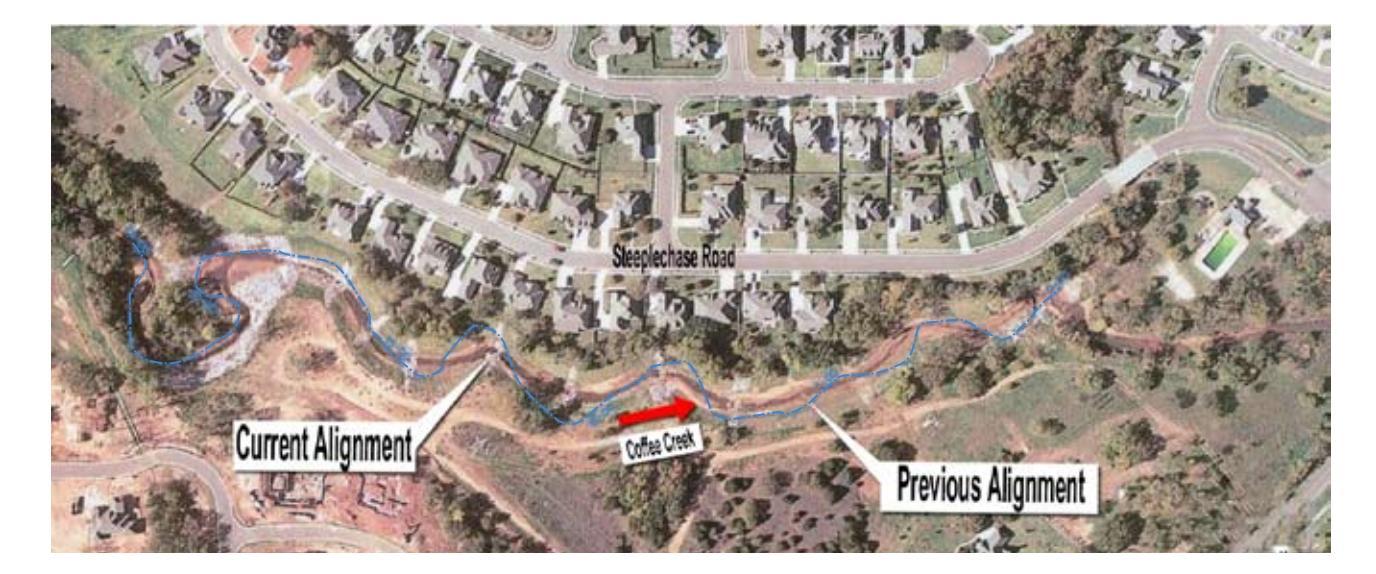
Figure CS16–6

6 Aerial view of project channel alignments

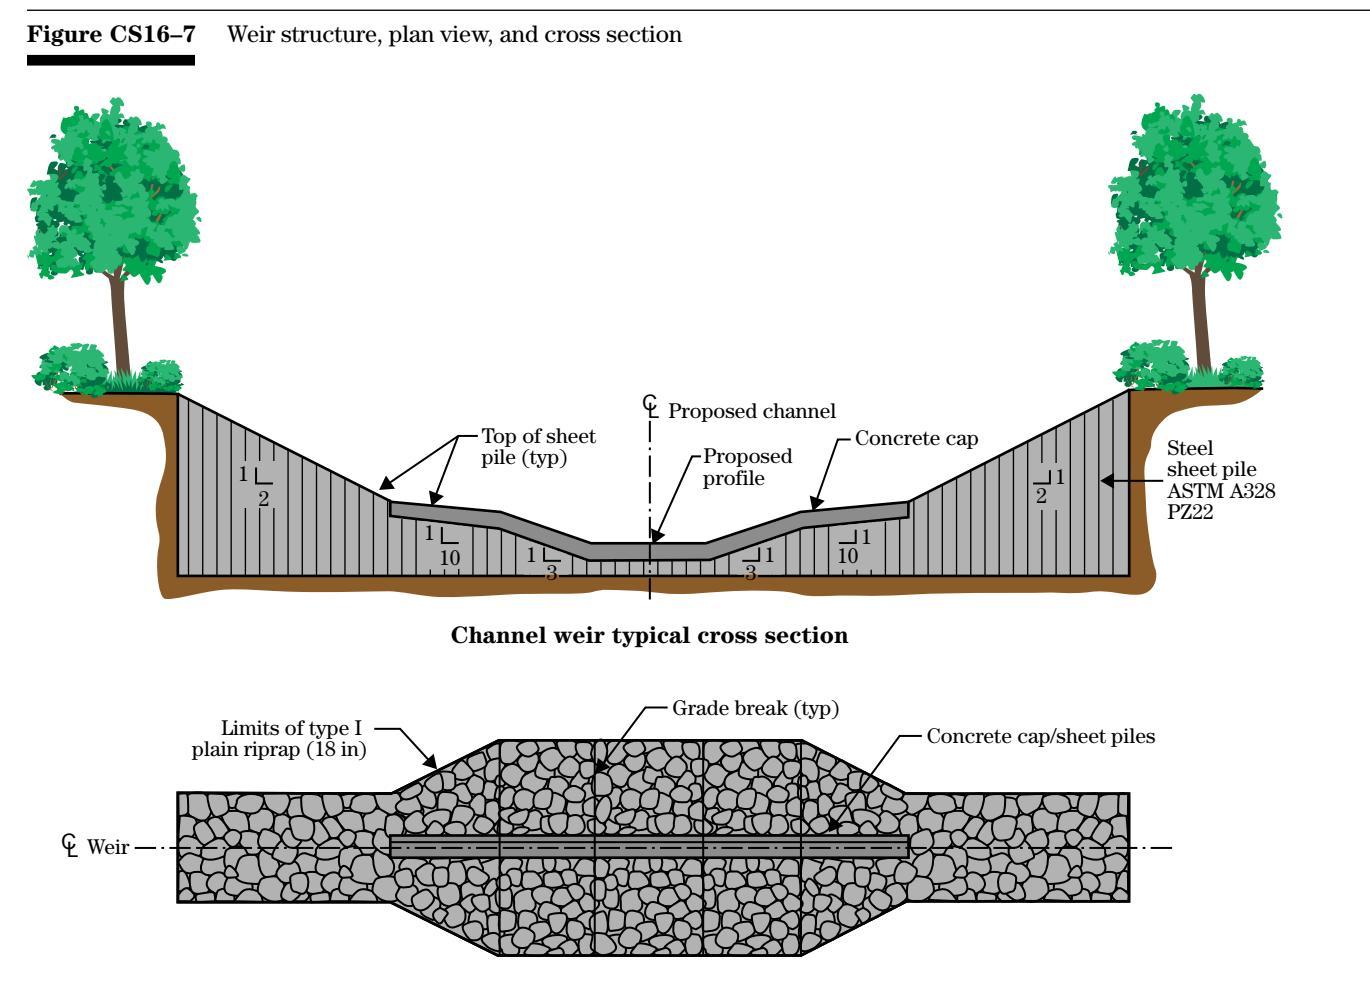
Channel weir plan view

the alignment. A typical section and plan view of the weir structures is provided in figure CS16–7.

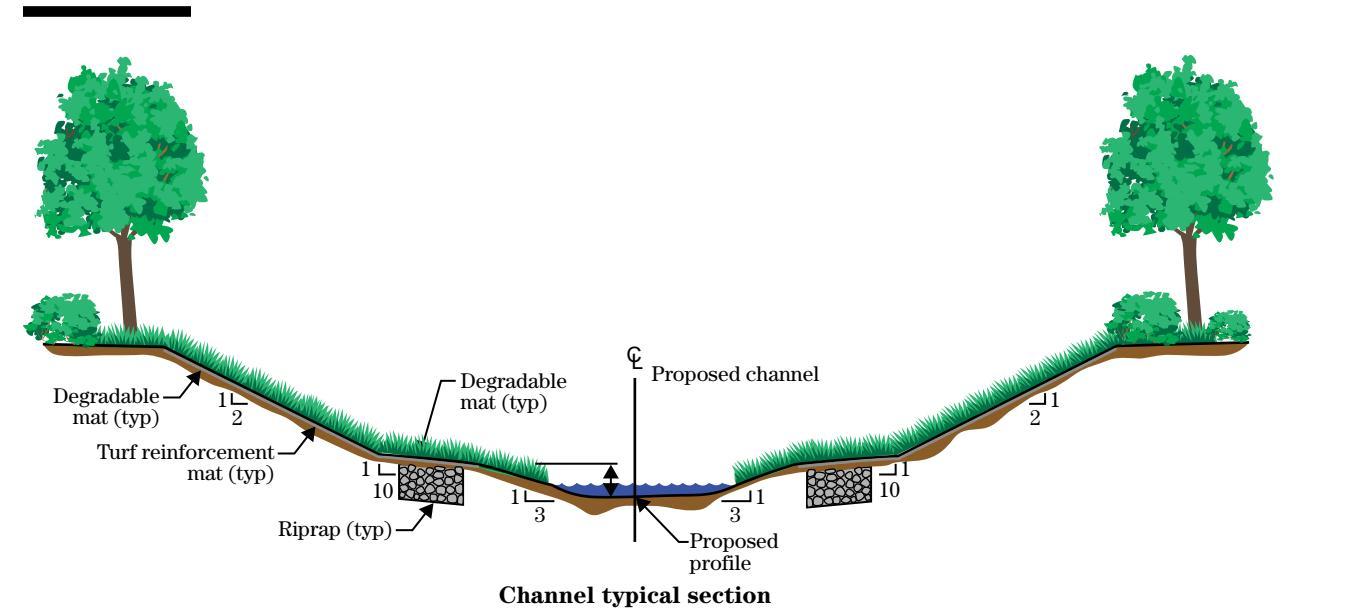
Figure CS16–8 Typical channel cross section with toe slope protection

by the turf reinforcement mat was not necessary. A typical section of the channel is provided in figure CS16–8.
