## Case Study 3

## Little Elk River, Price County, Wisconsin

# Little Elk River, Price County, Wisconsin

*By Mary K. King, Area Engineer, U.S. Department of Agriculture, Natural Resources Conservation Service, Altoona, Wisconsin. Photographs courtesy of Price County Land Conservation Department*

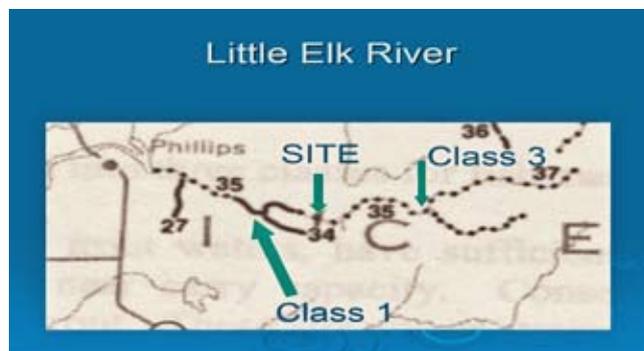
**Figure CS3-1** Site of Little Elk River

In 2002, 1,400 feet of the Little Elk River was restored. This portion of the river has a drainage area of 26 square miles. The watershed is predominantly wooded with some cropland. The stream bottom is rocky. The soils are mapped Stambaugh silt loam, a glacial outwash material. Most of the Little Elk River is a Class 3 trout stream; however, there is a 2.6-mile stretch of Class 1 trout stream located 0.8 miles downstream of the site (figs. CS3-1 and CS3-2 (WDNR 2002)).

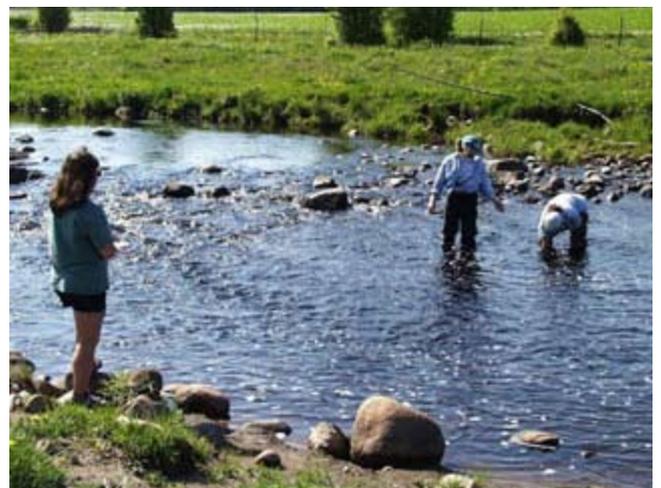
**Figure CS3-8** Performing the Wolman pebble count

The following spring, the morphological description of each section was compared by applying the Rosgen Stream Classification System. Entrenchment ratio, width/depth ratio, sinuosity, stream slope, and channel material were calculated (Wolman pebble count method) (fig. CS3-8).
