Case Study 11

Streambank Stabilization in the Red River Basin, North Dakota

Issued August 2007

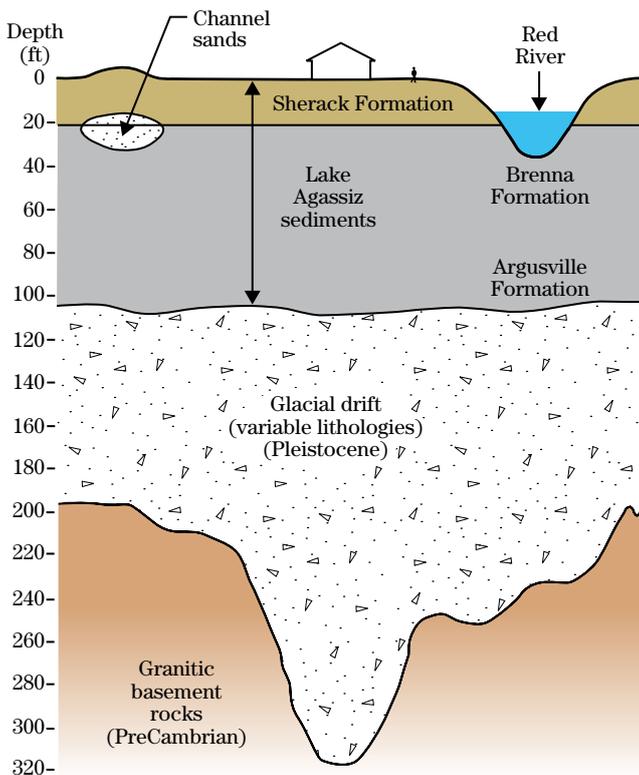
Figure CS11-2 Typical cross section of Red River Valley near Fargo, ND

is the thick highly plastic smectitic clays and silty-clays formed by eroded Cretaceous shales and glacial tills (Schwert 2003). These suspended sediments were deposited over the glacial lakebed in thicknesses of 100 feet or more. The Sherack Formation (fig. CS11-2 (Schwert 2003)) comprises the upper 20 to 30 feet and consists of light colored, silty, laminated clays that were deposited in shallow water of the glacial lake (Harris, Moran, and Clayton 1974). Beneath this are the dark, highly plastic clays of the Brenna/Argusville formations (fig. CS11-2) that were deposited in deep water during higher lake levels (Harris, Moran, and Clayton 1974). Soil tests of the two formations yield high plasticity index values and liquid limit results and consistencies that range from very soft to rather stiff.
