Case Study 11

Streambank Stabilization in the Red River Basin, North Dakota

Issued August 2007

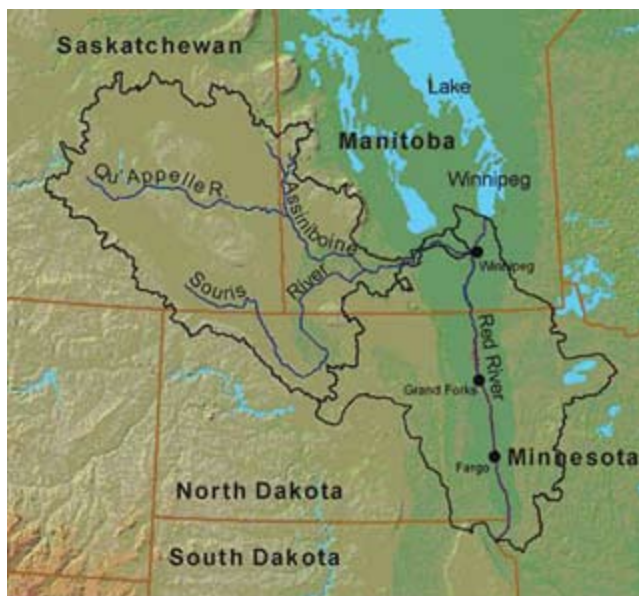
Figure CS11-1 Boundaries and shaded relief of the Red River Basin

Geologic and geographic features of the Red River Valley in North Dakota, Minnesota, and southern Manitoba create unique geotechnical challenges for slope and streambank stabilization efforts (fig. CS11-1 (University of North Dakota (UND) Energy and Environmental Research Center). The extremely low-gradient landscape (0.2 to 1.5 ft/mi) formed less than 10,000 years ago by the retreat of Glacial Lake Agassiz and is frequently subjected to overland and out-of-bank flooding from the Red River and its tributaries. The relatively young river network of the valley cuts sinuous chan-

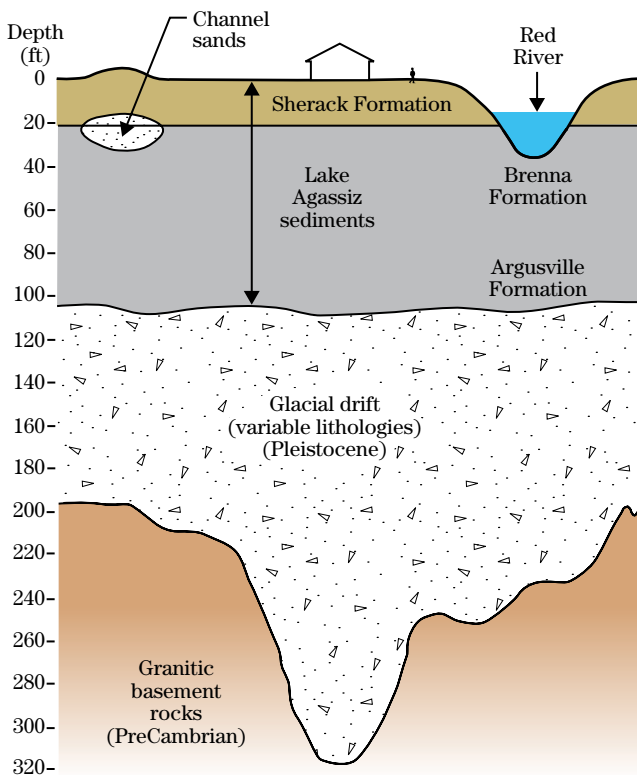
Figure CS11-2 Typical cross section of Red River Valley near Fargo, ND

is the thick highly plastic smectitic clays and silty-clays formed by eroded Cretaceous shales and glacial tills (Schwert 2003). These suspended sediments were deposited over the glacial lakebed in thicknesses of 100 feet or more. The Sherack Formation (fig. CS11-2 (Schwert 2003)) comprises the upper 20 to 30 feet and consists of light colored, silty, laminated clays that were deposited in shallow water of the glacial lake (Harris, Moran, and Clayton 1974). Beneath this are the dark, highly plastic clays of the Brenna/Argusville formations (fig. CS11-2) that were deposited in deep water during higher lake levels (Harris, Moran, and Clayton 1974). Soil tests of the two formations yield high plasticity index values and liquid limit results and consistencies that range from very soft to rather stiff.
