**Case Study 14**

**Streambank Stabilization in the  
Merrimack River Basin,  
New Hampshire**

*By Ghislan Brunet, Maccaferri, Bioengineering and Ecological Systems, Maryland*

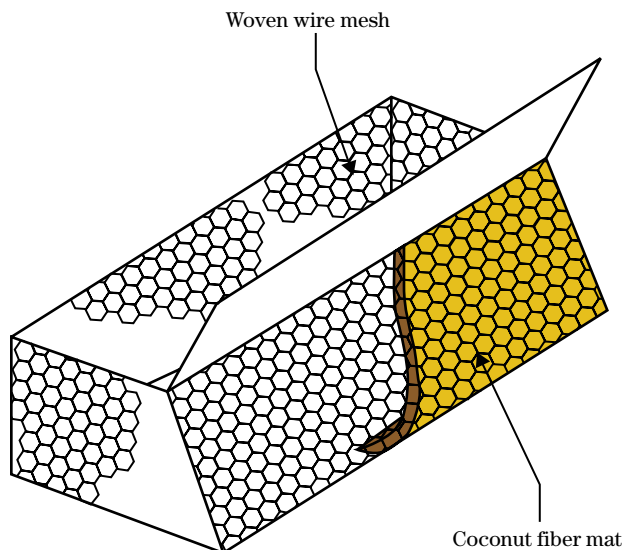
**Figure CS14-4** Green Gabion<sup>®</sup> schematic

The voids of a gabion structure (30 to 40%) are filled with topsoil. The topsoil helps to retain the moisture in the structure to promote growth of the vegetation and also acts as a substrate for the propagation of the root
