Cover photo: Treated section of Coffee Creek in Edmond, Oklahoma

Case Study 16

Coffee Creek, Edmond, Oklahoma

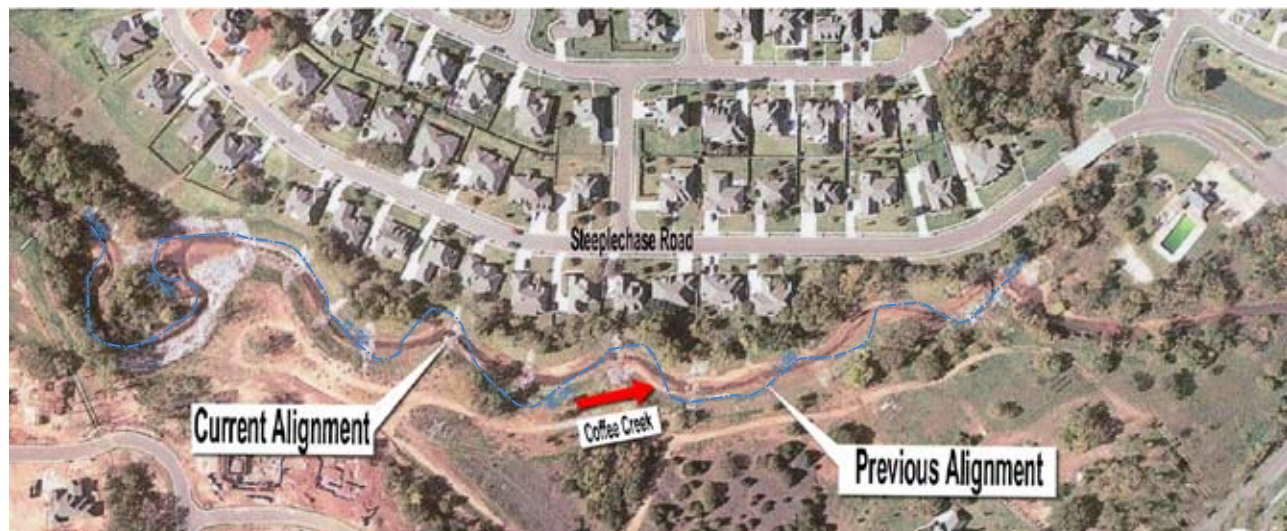
Figure CS16-6 Aerial view of project channel alignments

- A horizontal alignment was developed to move the creek away from the threatened infrastructure to the greatest extent practicable, while also minimizing encroachment of the creek farther onto the adjacent primary property owner, and minimizing changes to the existing meander pattern. A comparison of existing conditions and proposed channel alignments is provided in figure CS16-6.
