*By Sean Welch, state hydraulic engineer, U.S.
Department of Agriculture, Natural Resources
Conservation Service, Portland, Oregon*

Introduction

The Wiley Creek Streambank Protection Project in Linn County, Oregon, was designed in 2003 and 2004 by the U.S. Department of Agriculture (USDA) Natural Resources Conservation Service (NRCS), Oregon State Office. The project goals included the protection of two structures located 5 feet from the edge of a 23-foot-high vertical bank, bank stabilization, and fisheries habitat improvement.

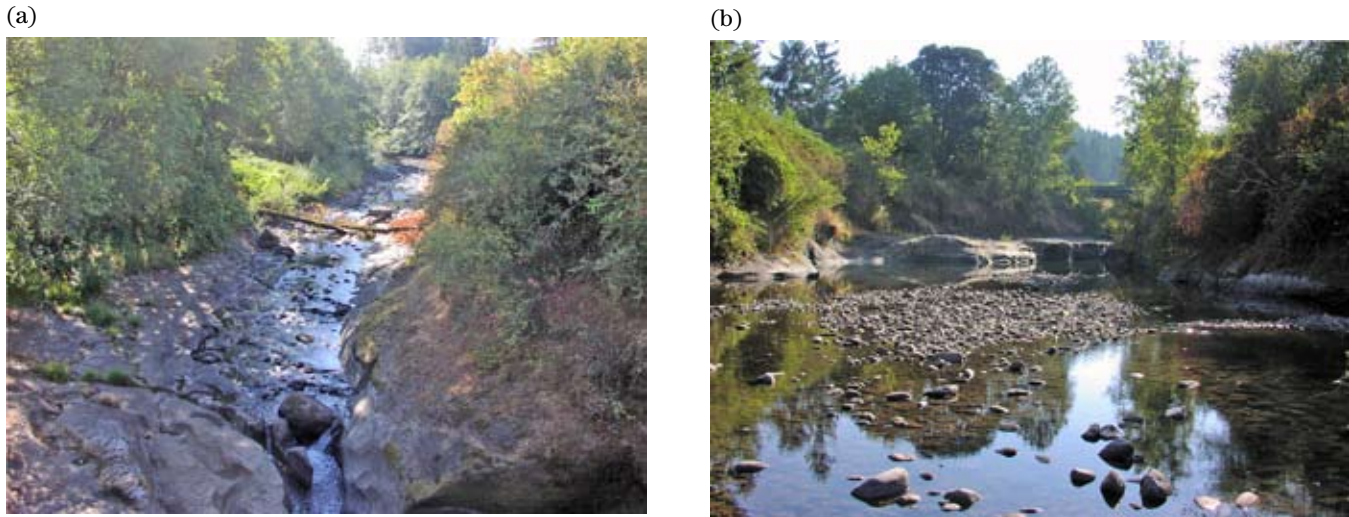
Figure CS18-4 (a) Looking upstream from the Wiley Creek Bridge at the B1c reach above the project; (b) looking upstream to the bedrock overfall ledge. The Wiley Creek Bridge can be seen in the background. This location marked the transition from the B1c to D4 reach.

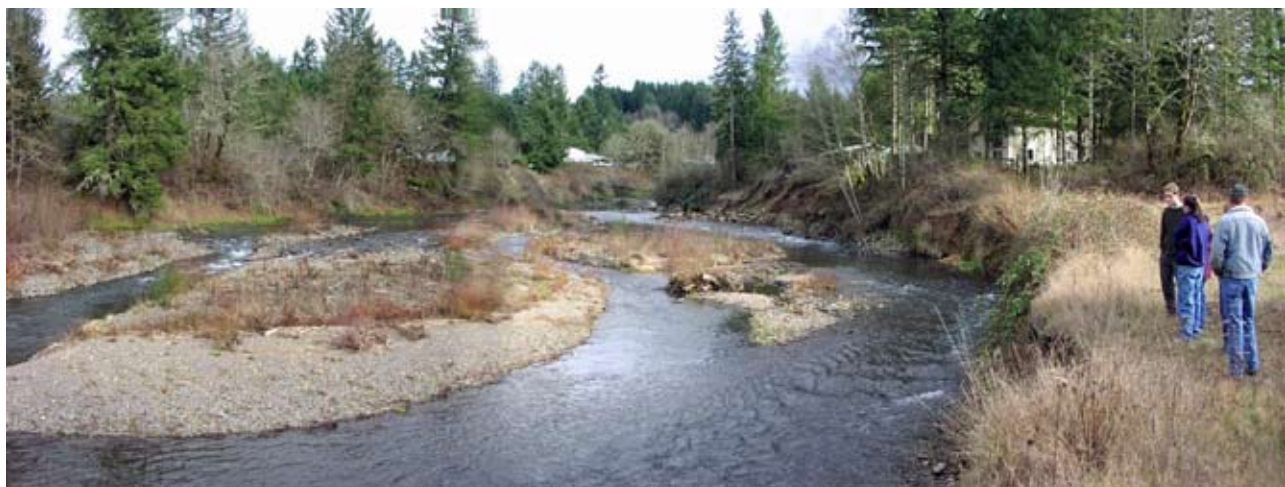
Figure CS18-5 Looking upstream at the D4 reach

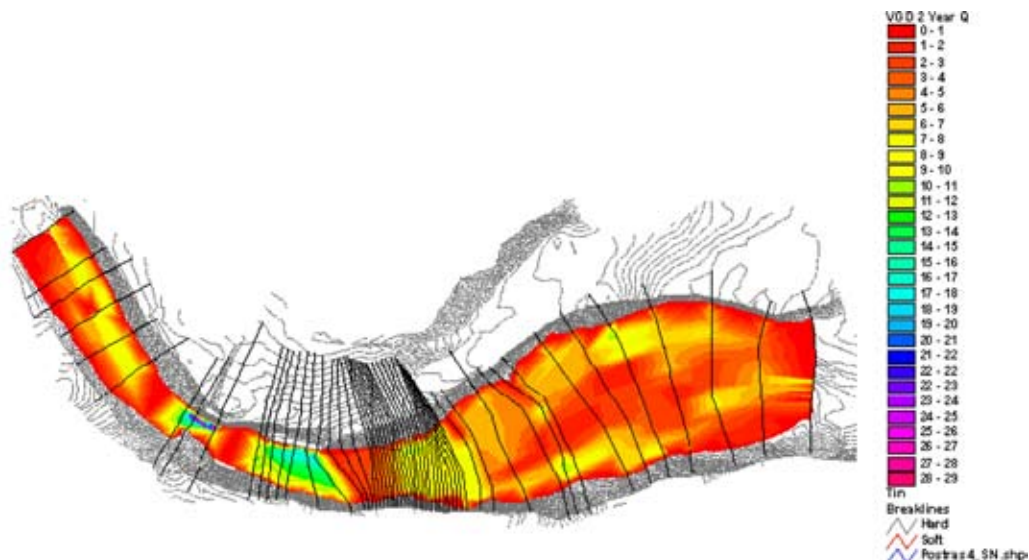
Figure CS18-7 Quasi, two-dimensional velocity distribution for the 2-year flood computed by HEC-RAS. Contours and model cross sections (black lines) are also shown.

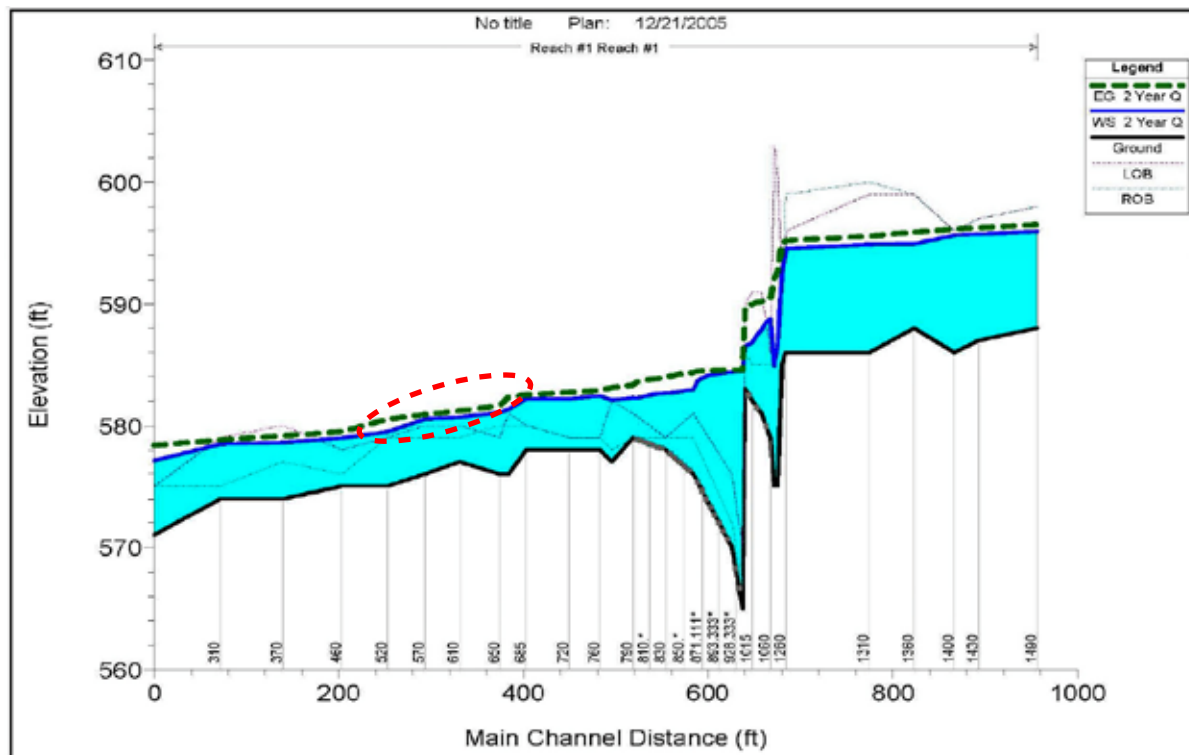
Figure CS18-8 Computed water surface profile and energy grade line for the 2-year flood. Note hydraulic jumps between sections 1260 and 928 across the bedrock overfall upstream of project reach. Project reach is defined by red oval.

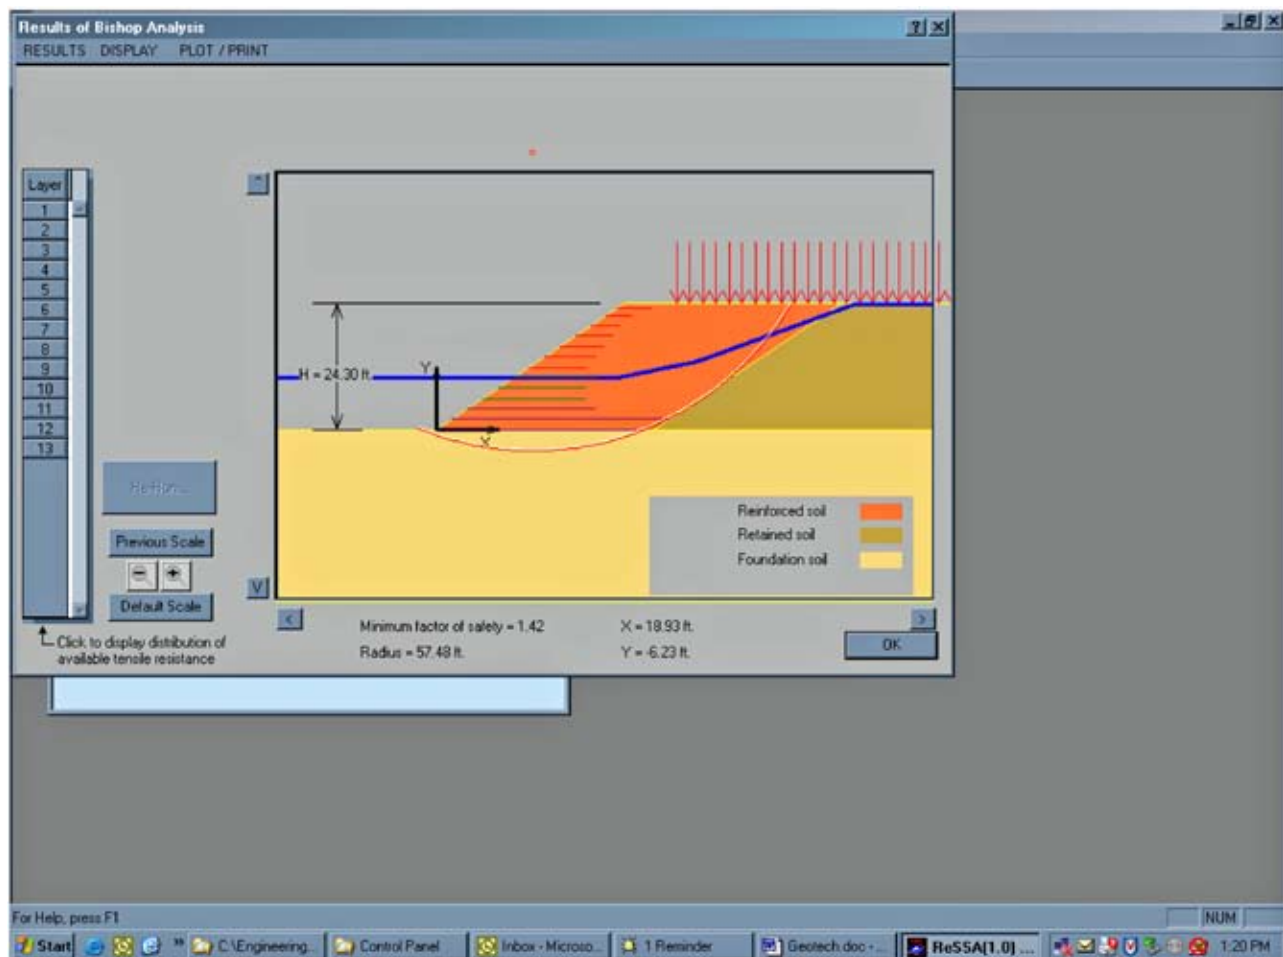
Figure CS18-11 RSSA model showing bank materials, loading, and computed tendon configuration for a mid-bank water table condition

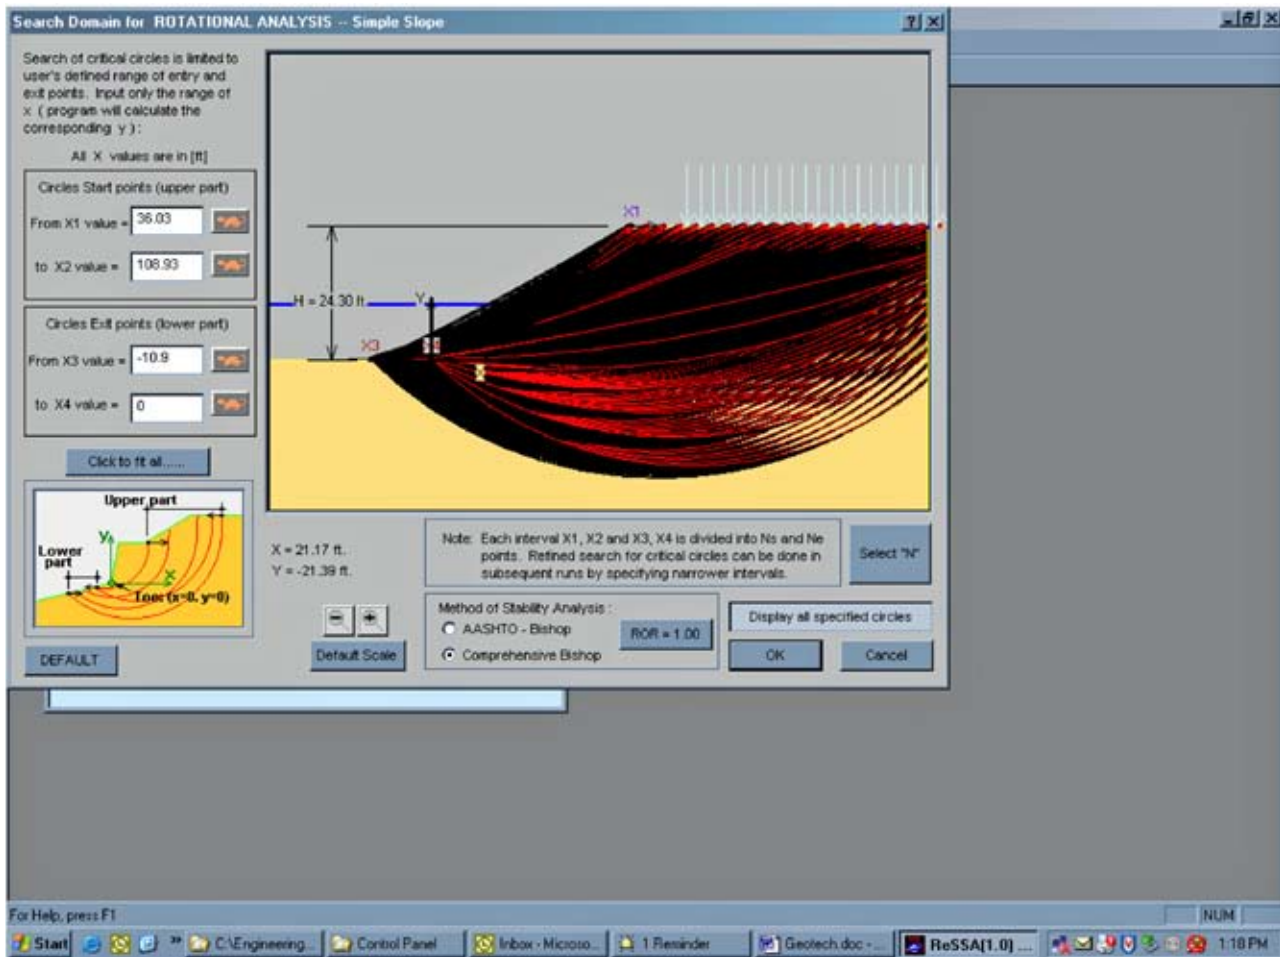
Figure CS18-12 Bishop slices showing optimization results for rotational bank failure
