**Case Study 3**

**Little Elk River, Price County,  
Wisconsin**

# Little Elk River, Price County, Wisconsin

*By Mary K. King, Area Engineer, U.S. Department of Agriculture, Natural Resources Conservation Service, Altoona, Wisconsin. Photographs courtesy of Price County Land Conservation Department*

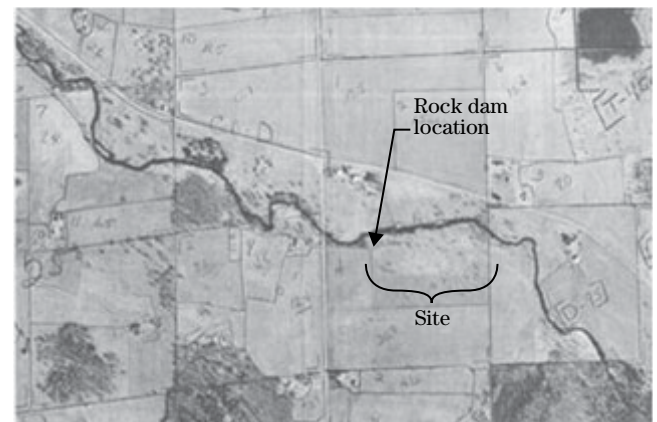
**Figure CS3-2** 1963 aerial photograph of Little Elk River

*Sinuosity* was measured from an aerial photograph (fig. CS3-2).

$$\text{sinuosity} = 8,250 \text{ ft} \times 6,435 \text{ ft} = 1.28$$

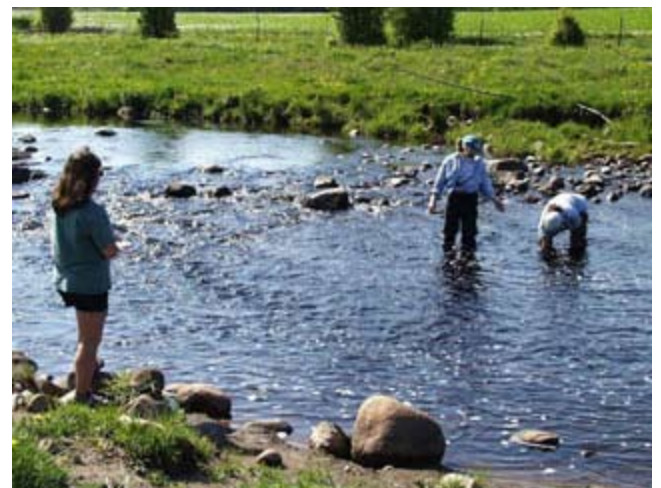
**Figure CS3-8** Performing the Wolman pebble count

The following spring, the morphological description of each section was compared by applying the Rosgen Stream Classification System. Entrenchment ratio, width/depth ratio, sinuosity, stream slope, and channel material were calculated (Wolman pebble count method) (fig. CS3-8).

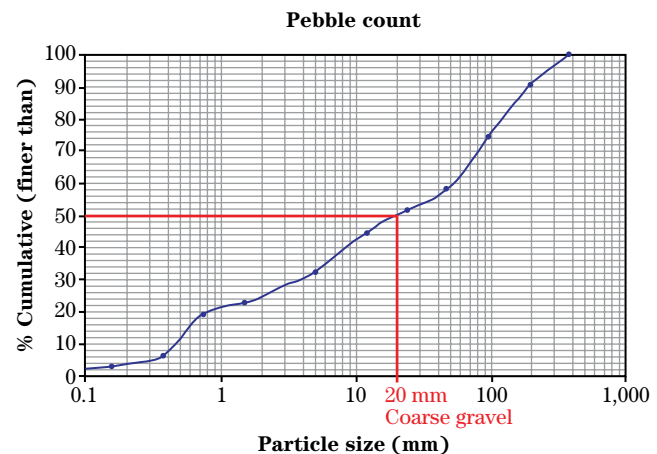
**Figure CS3-9** Channel material  $D_{50}$

Median particle size,  $D_{50}$ , from the pebble count was 20 millimeters, which is a coarse gravel and designates a "4" in the classification (fig. CS3-9).
