Alica J. Ketchem, P.E.; U.S. Department of Agriculture, Natural Resources Conservation Service, Richmond, Virginia

In 1995 and 1996, major storm events caused severe damage to the Rose River in Madison County, Virginia. In 1998, 4,200 feet of the Rose River was restored to a more stable condition and strengthened using a variety of natural and ecologically friendly techniques. This effort included the installation of nine vortex rock weirs and two sets of rootwads. Five years after installation, during Hurricane Isabel, the Rose River flooded again. Although some of the weirs and rootwads were damaged by this flood, the majority of the site remained in a stable condition.

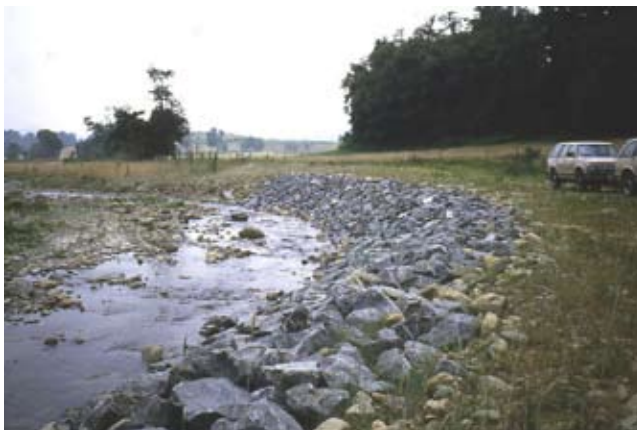
Figure CS5-6 Upper riprap, July 1998, 3 months after construction

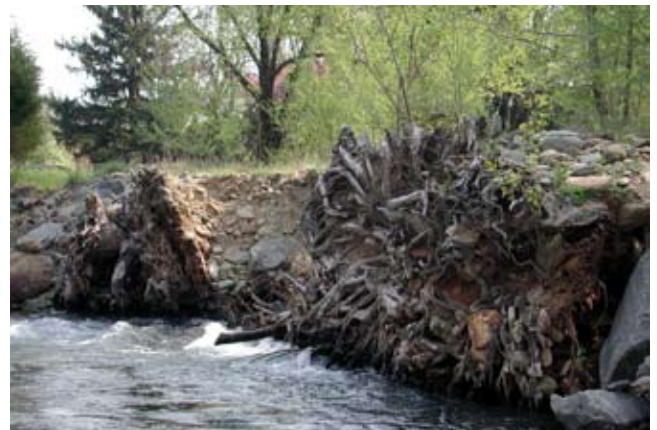
Figure CS5-7 Upper rootwads, April 2003

of this general observation. The upper rootwads were used as part of a gully plug to cut off the manmade channel. The material used behind this was primarily cobble with some purchased riprap. To date, there seems to be little or no deterioration in these rootwads (fig. CS5-16). One possible reason is that the flood plain elevation is at least 4 feet lower on the side across from the rootwads. Previous failures on other sites were because of overtopping. This has yet to occur on this site.

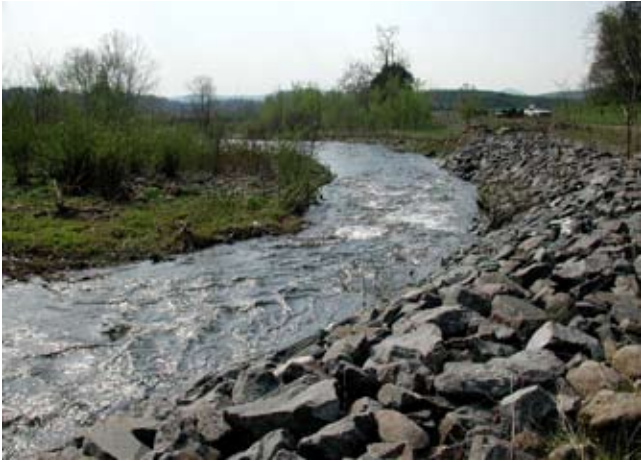
Figure CS5-8 Upper riprap, April 2003

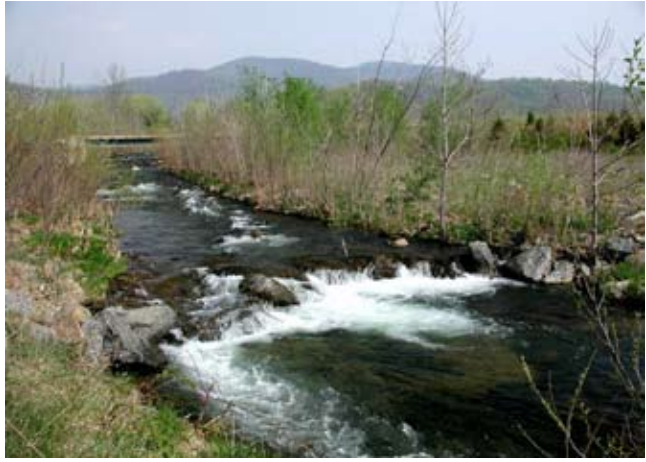
Figure CS5-9 Weir #7, April 2003

After Hurricane Isabel (Sept. 2003), the section of the river immediately below the bridge filled in with about 3 feet of cobble material. Weir #7 was completely covered (fig. CS5-12).

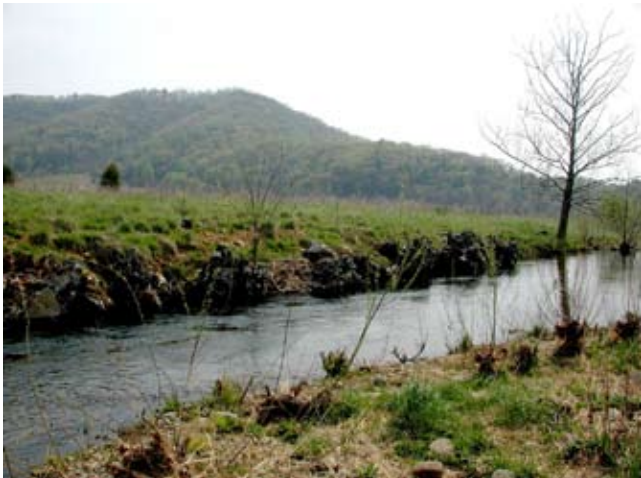
Figure CS5-10 Lower rootwads, April 2003

The lower rootwads were trenched into the bank with 10 to 15 feet of the bole embedded. Some of the rootwads at the upper end of this group are still in place. At the lower end, some of the rootwads are missing entirely, while others appear to have been snapped off. One possible explanation is that the flood plain became more entrenched immediately above the rootwads. Starting at the bridge, the right bank was 6 to 8 feet higher than the left bank. The excess cobble had been removed from the left bank to increase the width of the flood plain. Just below weir #6, the left bank intersected the first terrace. This constriction would have increased the flow velocity against the left bank and the rootwads along it. The water elevation may have been above the top of the rootwads, contributing to the problem.

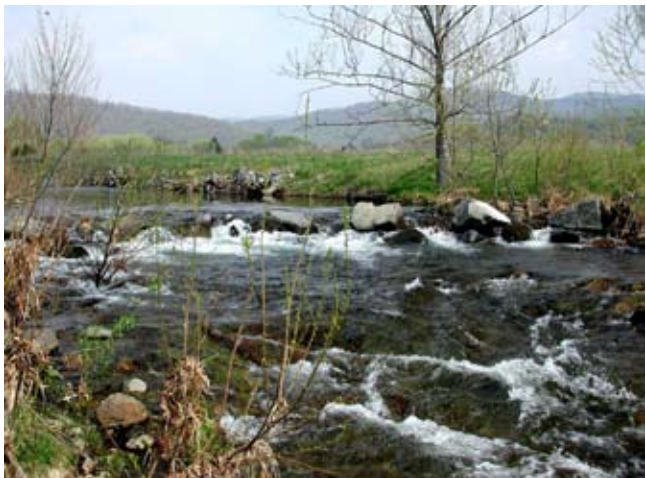
Figure CS5-11 Weir #5, April 2003

Weirs #5 and #4 appear to be unchanged. The drop in the channel grade from the 1997 survey occurred during construction in 1998. Very little channel work was done from weir #4 to weir #3. The survey shows that the river has experienced some fill and some degradation over about 500 linear feet. Based on the photographic record, the majority of this change occurred since April 2003. It is likely that most of it was done in Hurricane Isabel. Some fill also has occurred between weirs #3 and #2, along the riprap. A large pool has developed between weirs #2 and #1. Below weir #1, there seems to be little change in the channel grade.
